Appendix C Fluvial Geomorphic Assessment

September 15, 2022

Subject: Lavender Creek Fluvial Geomorphology Assessment

**Rockcliffe Riverine Flood Mitigation
Municipal Class Environmental Assessment**

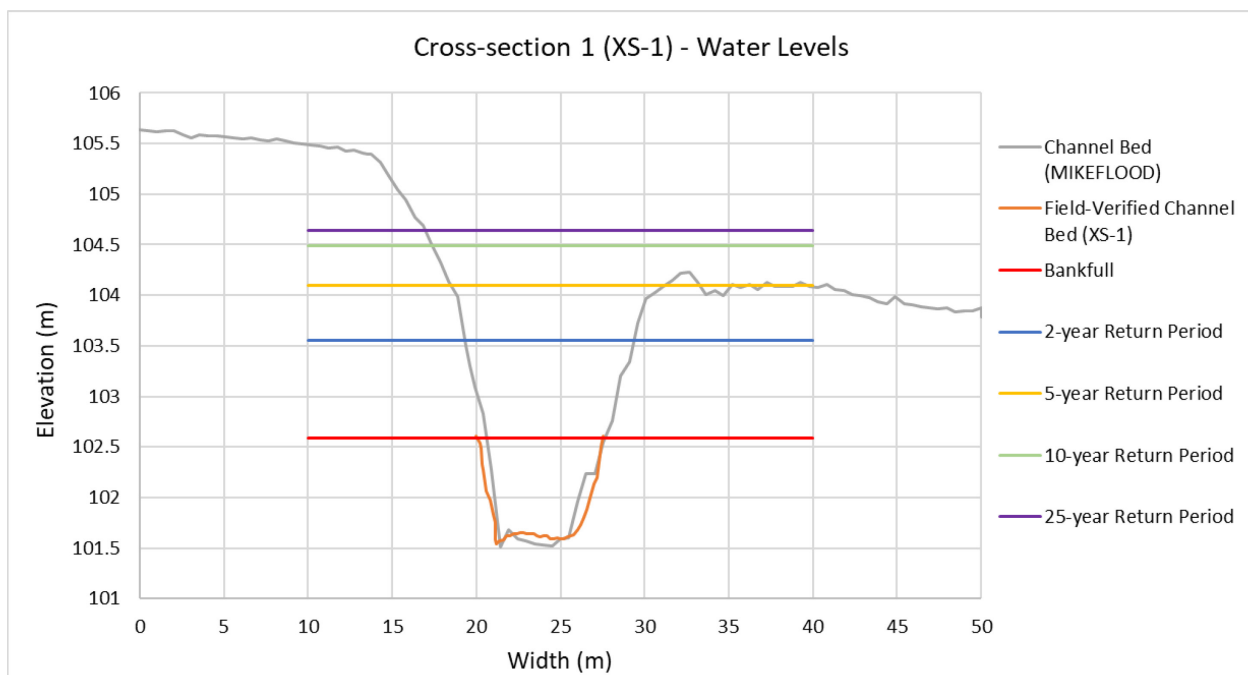
FIGURE 2 Cross-section 1 Showing Bankfull and MIKE FLOOD Water Levels

On average, bankfull dimensions were approximately 6.98 m in width and 0.76 m in depth, with an average entrenchment ratio of 2.88. From these results, the bankfull channel was interpreted to be slightly entrenched on average, with moderate entrenchment measured in the upstream section (XS-1). A channel gradient of 0.65% was obtained from MIKE FLOOD modelling software as part of the hydraulic modelling component of the current project. Using a Manning's n of 0.035, bankfull parameters such as discharge, velocity, and shear stress were calculated. The resulting values are 9.93 m³/s, 1.81 m/s, and 44.5 N/m², respectively. Three cross-sections corresponding to the approximate location of the field-measured cross-sections were exported from MIKE FLOOD software to display the various water levels at specific return periods (Figures 2 to 4). It is noted that the average bankfull discharge calculated using our field-measured cross-section (9.93 m³/s) is significantly lower than the 2-year discharge (23.3 m³/s), highlighting the urban nature of the creek's flow regime. In most cases (XS-1 and XS-2), the 10-year flow event overtops the entrenched creek valley and disperses towards the right bank. Beyond the 10-year flow event, Lavender Creek is highly influenced by backwater from Black Creek.

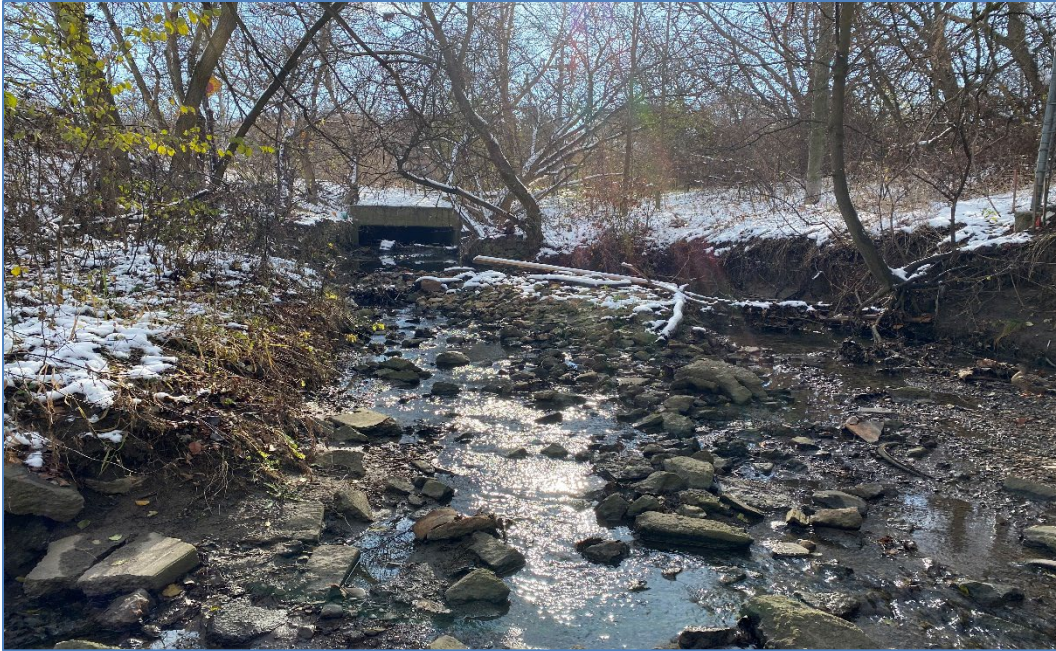
1. Lavender Creek downstream of Symes Road crossing; debris jam immediately downstream of culvert and channel bed is heavily armoured with riprap.

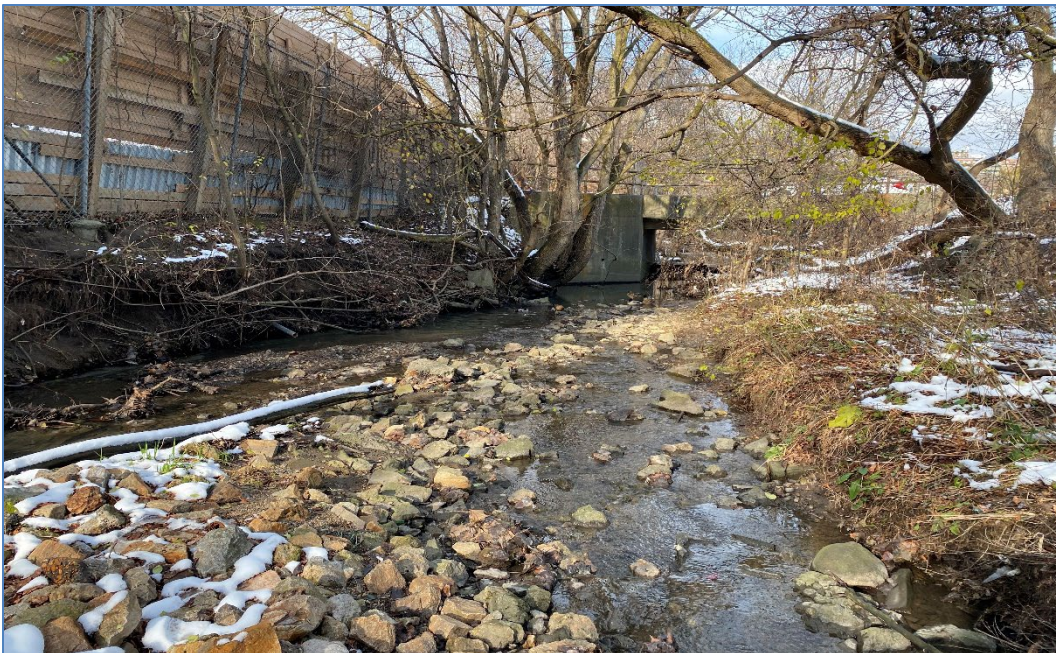
2. View downstream of Symes Road; left bank is actively eroding as evidenced by exposed tree roots, leaning trees, bank undercutting, and leaning fence atop the bank.

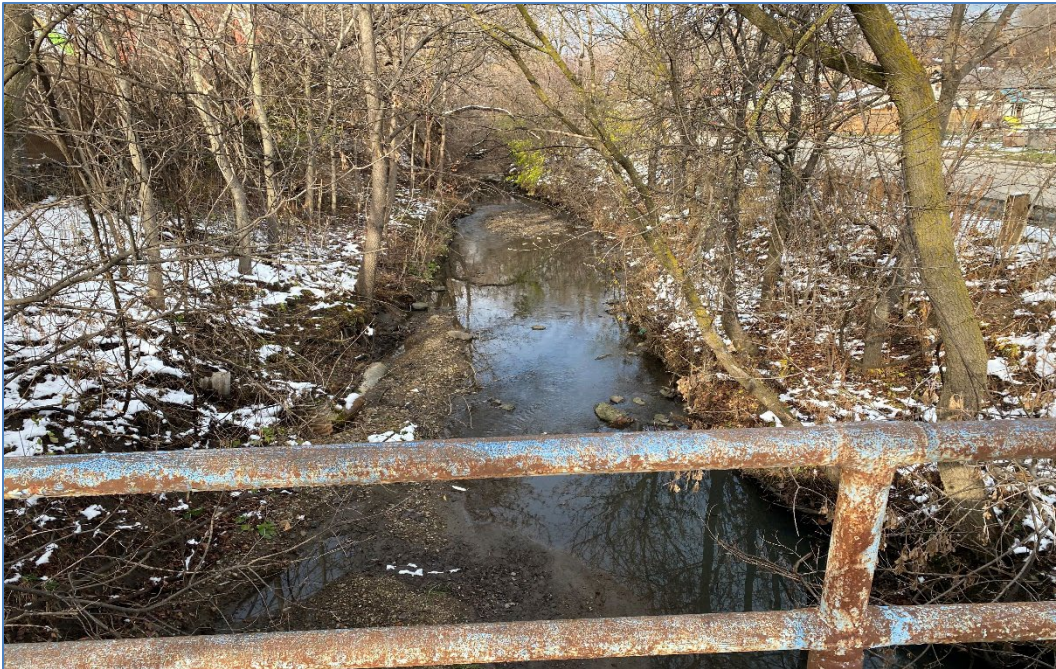
3. View downstream; channel follows a relatively straight planform; most banks are undercut and contain exposed tree roots and leaning trees.

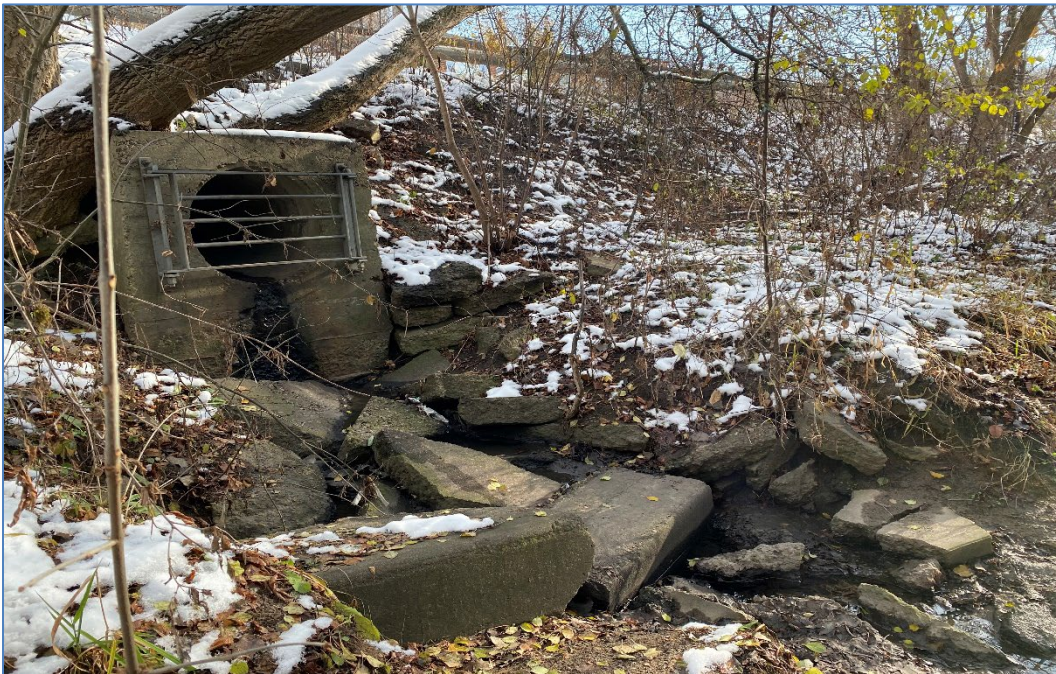
4. Elevated storm sewer outfall on left bank; concrete pad along bank at been undermined and is failing.

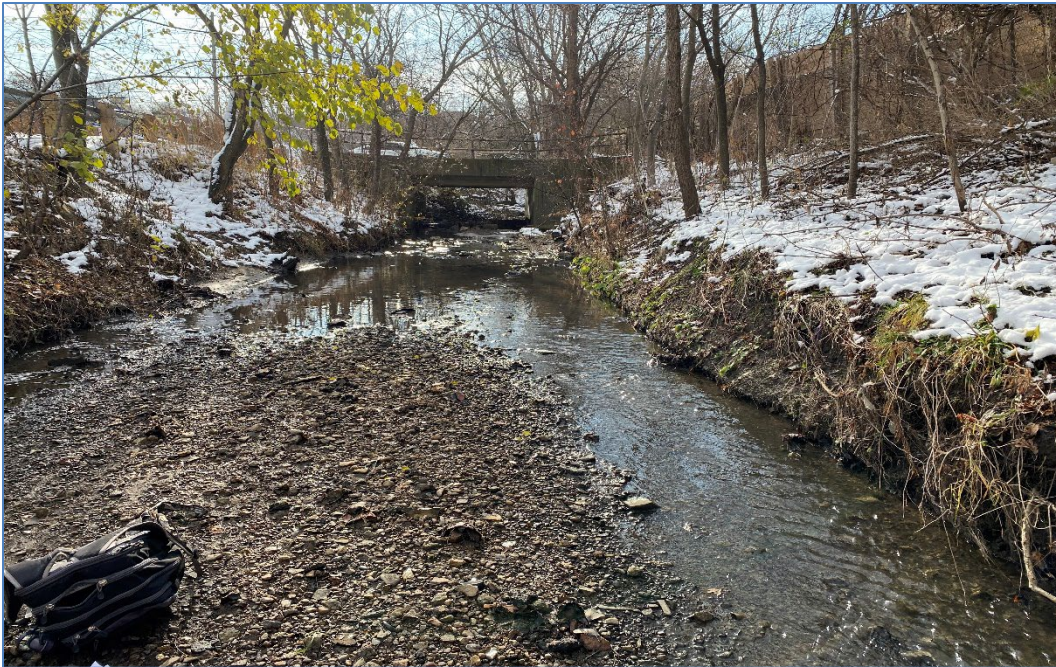
5. View upstream towards bridge crossing; large, well-sorted gravel medial bar with dominant flow path towards left bank.

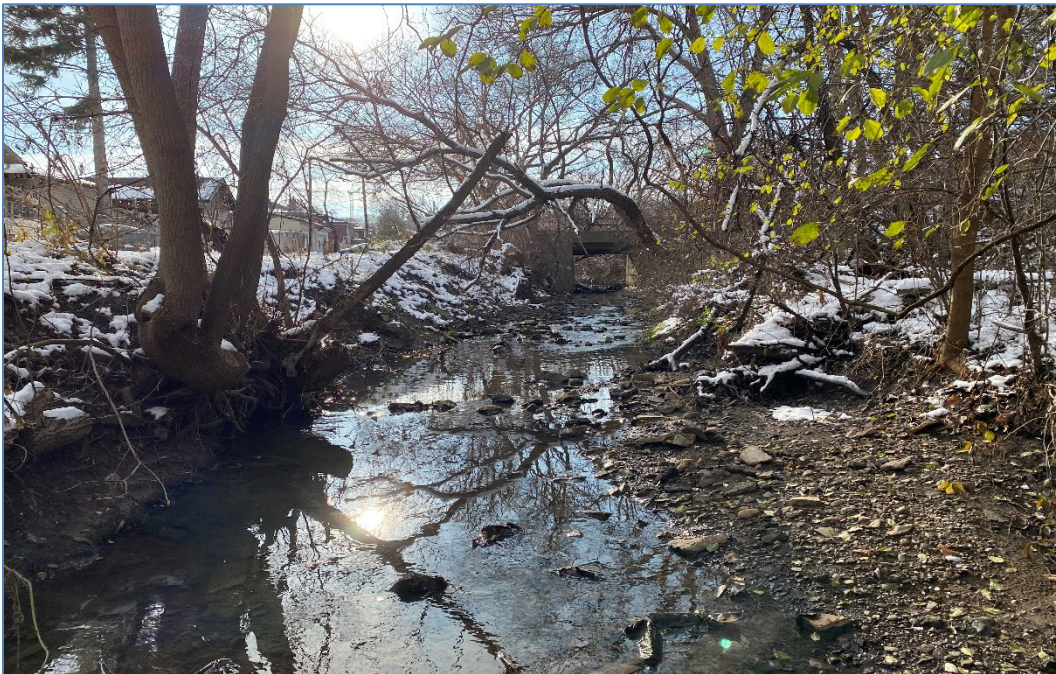
6. View upstream; right bank actively eroding, bank contains exposed parent material.

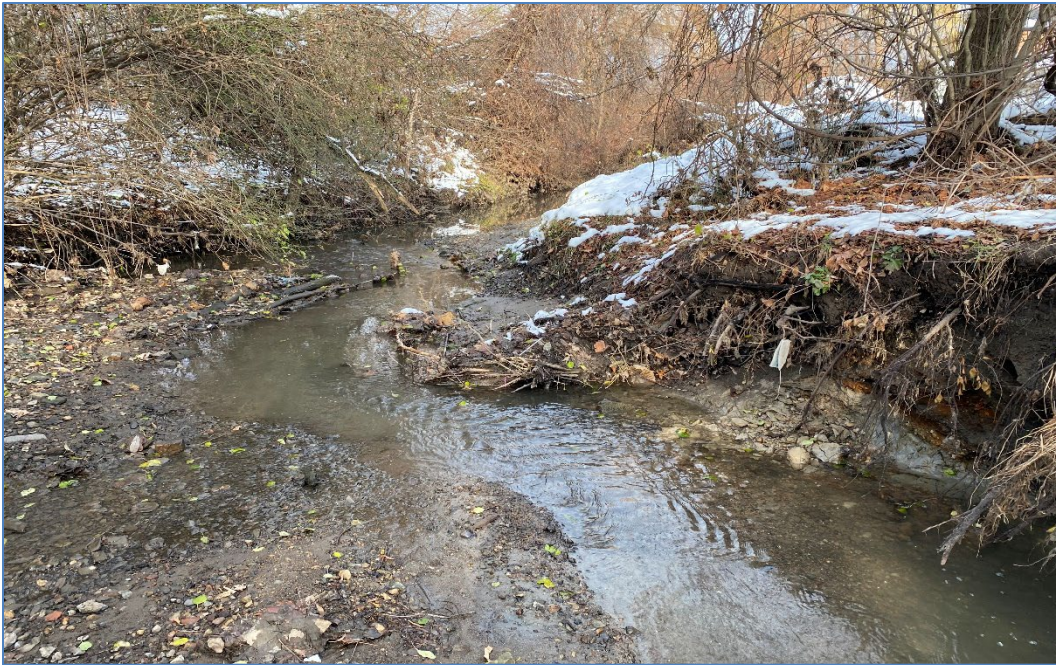
7. View towards downstream extent of Lavender Creek; on inner bank, note exposed parent material at toe of bank and bank slumping.

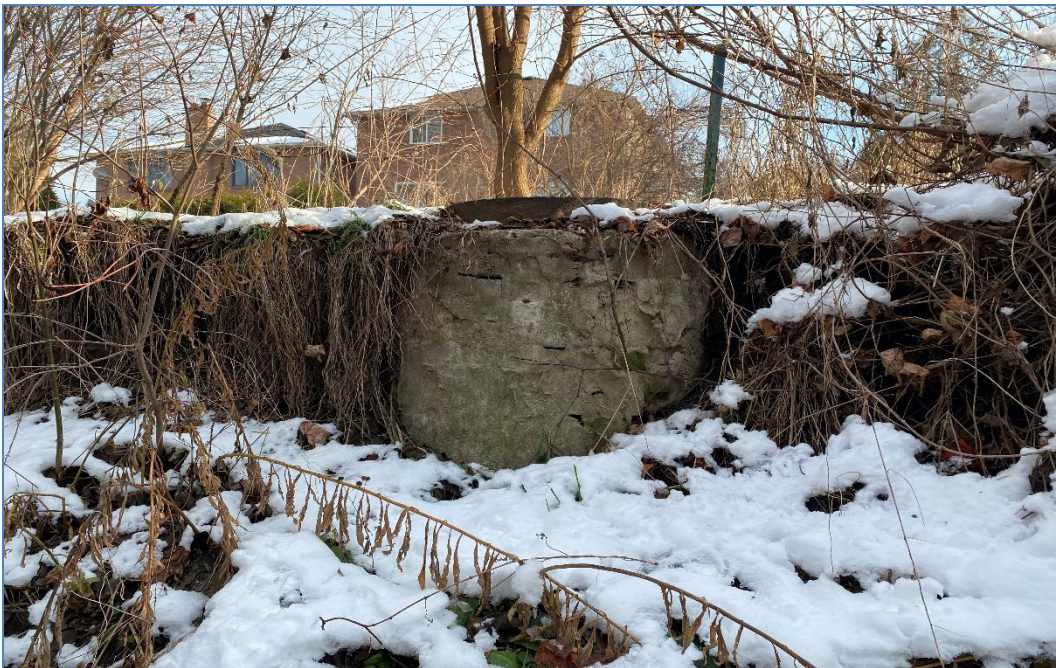
8. Exposed manhole on right bank; bank is near vertical and continues to erode.

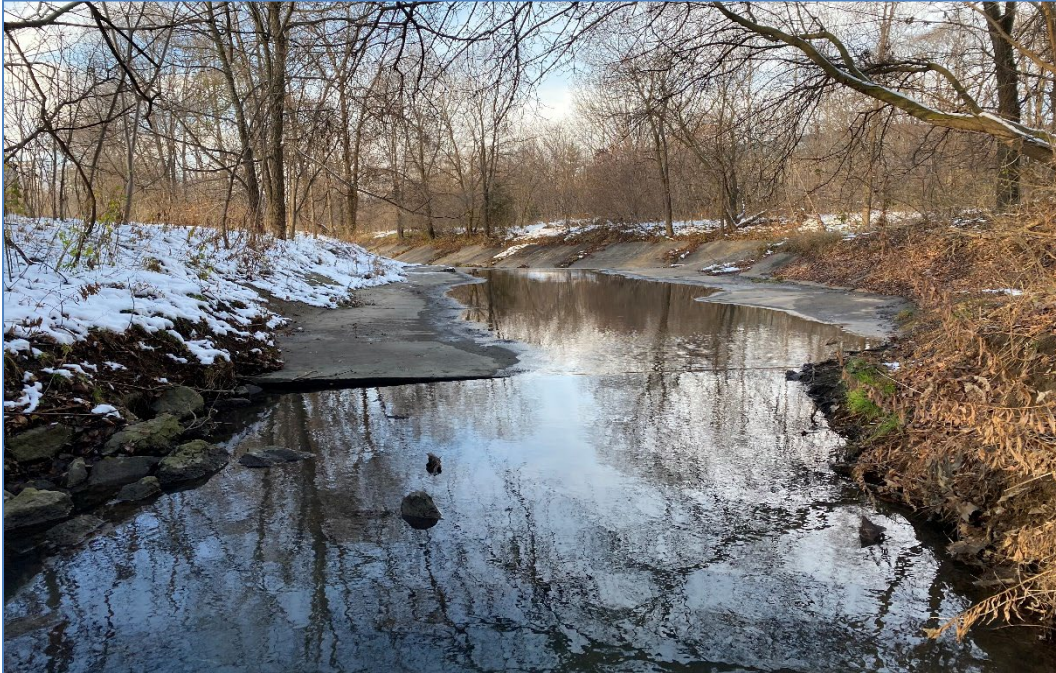
9. View downstream towards confluence with Black Creek; channel bed and banks become concrete-lined as approaching Black Creek.

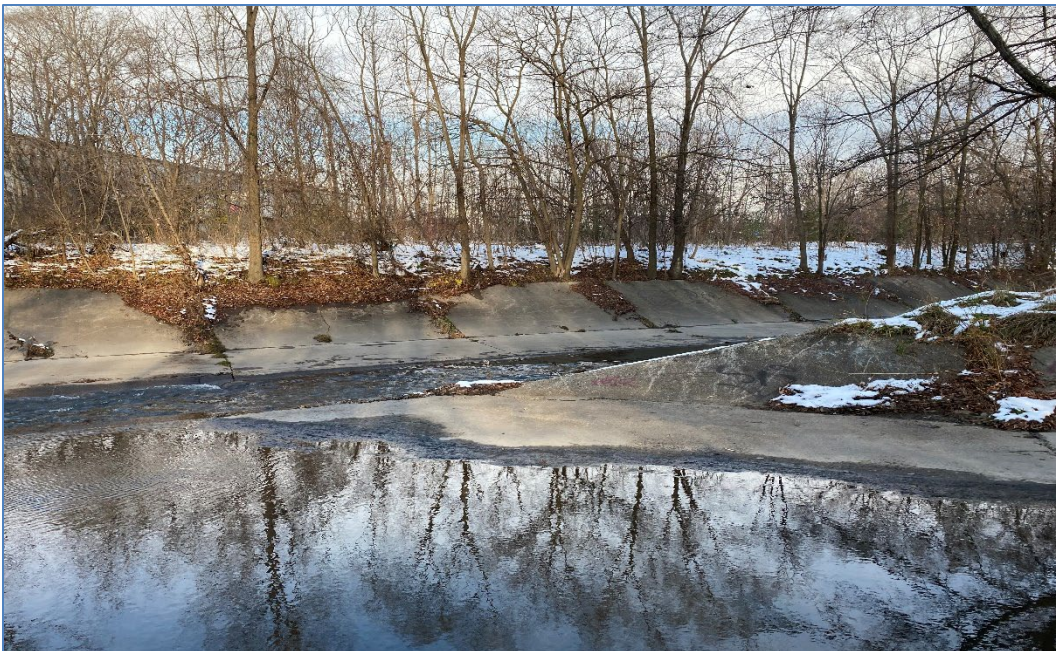
10. Confluence with Black Creek; note large vertical drop ~1m in height in concrete where Lavender Creek discharges into Black Creek.
