## Appendix D

### Reach 30 Detailed Analysis

**Reference # 13579.101.L05.Rev0**

**RE: HAZARD MAPPING REACH 30 DETAILED ASSESSMENT**

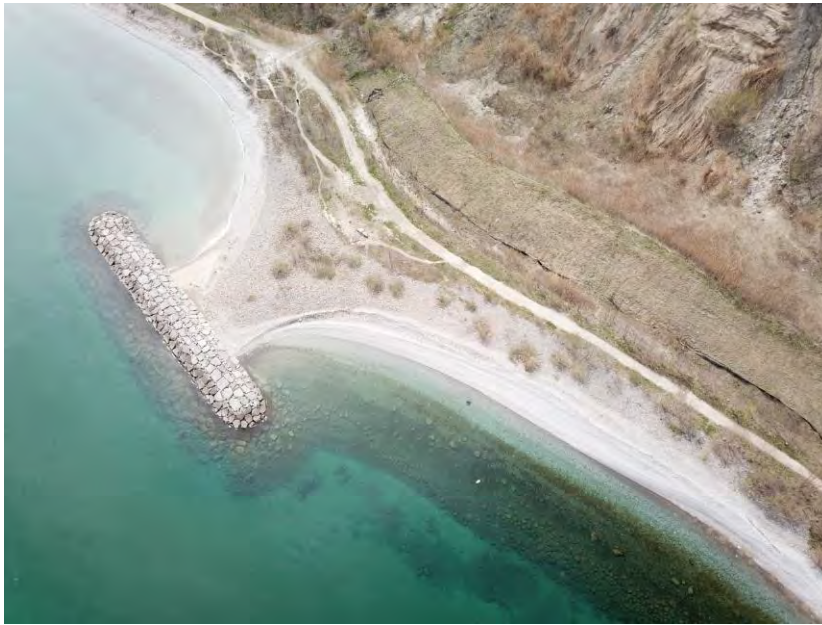
**Figure 3: Headland at Sub-reach A, Meadowcliffe Drive**

Inspection of these headland structures shows stone sizes that align with the design documents. Toe depths in front of the structures will limit the wave height that will impact the structures. Wave heights and required stone sizes after downcutting are in alignment with the observed stone sizes and design. Therefore, we are not concerned about the size of the stone relative to the anticipated design wave conditions.

The bigger concerns with these structures are the toe scour protection and general degradation of the stones over time. The toe of the structure has two armour stones excavated into the lakebed. These would likely move (slump or roll lakeward) if, over the next 100 years, 2 m of downcutting was experienced. On the armour stone face, the method of packing smaller chinking between larger (loosely packed) armour stone is not a common practice in typical coastal works and gradual loss of this chinking is expected. Overall, we expect some slumping of these structures over the next 100 years; however, they are expected to remain mostly in place albeit at a lower elevation. This could impact the extent to which they protect the tombolo formation and the stability of the cobble beach.

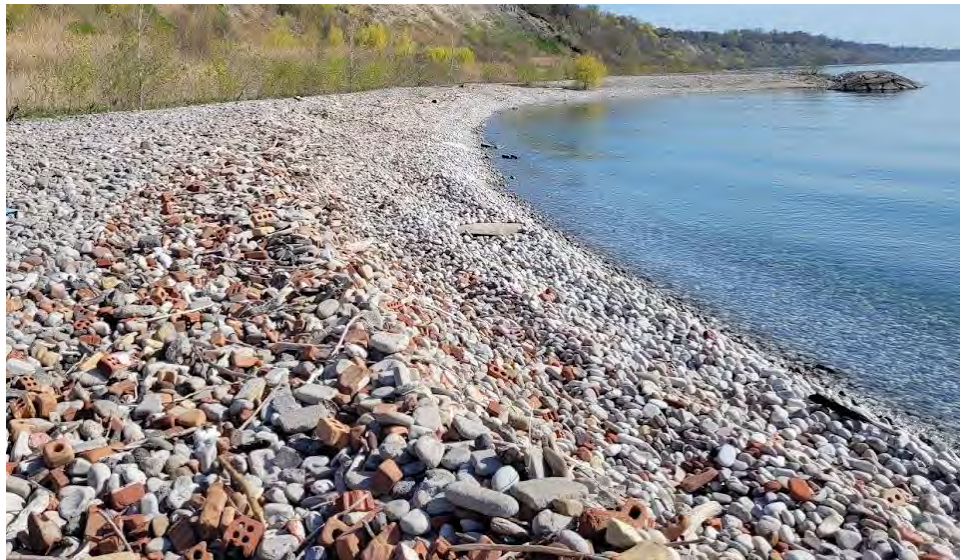
Bricks and concrete were visible in some areas of the beach, suggesting that the profile has already been reshaped enough to reach into the lower layer below the cobbles. Any significant downcutting of the shoreline would likely result in loss of cobbles into the nearshore scoured area and a reduction in the height and width of the crest.

**Figure 5: Cobble / Concrete / Brick Beach in Sub-reach A**

The conclusion for Sub-reach A is that some reshaping of the shore protection is expected over the next 100 years, especially if significant downcutting occurs. However, there is a significant volume of material along the shoreline and at the very least, these cobbles and armour would act as a reef if it was significantly damaged. This would reduce the wave energy reaching inland of the beach position towards the bluff toe.

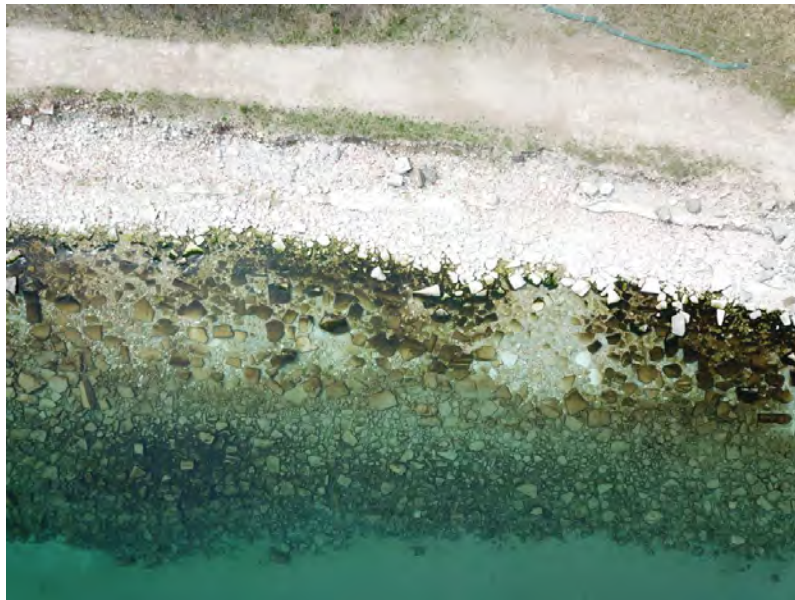
This sub-reach is 270 m in length and consists of a poorly constructed rubble shoreline built from construction rubble. The TRCA inspection records show construction in 1999, although this was likely a narrower structure (lakefill) than what is present today. Significant filling and widening of the structure took place between 2009 and 2013. We are not aware of any drawings or reports for this section. The elevation at the toe is approximately 73 m, with some evidence of local scour. The slope of this structure is about 6:1 (H:V) and it has probably been shaped by waves to achieve this slope. Inspection reports from TRCA suggest that the structure needs major repairs and in 2019 TRCA noted that erosion had reached the path. An overhead view (UAV imagery), of one section of this shoreline is shown in Figure 6.

During storm events when the structure is exposed to significant wave energy, the cobbles and concrete pieces would experience significant movement and would be expected to degrade with time. In comparison, a well built revetment has limited mobility and there are less concerns with the abrasion and breaking down of material. This suggests that the longevity of the material on this reach would be significantly reduced compared to armour on a robust revetment.

**Figure 6: Cobble / Rubble Shoreline in Sub-reach B**

This is a structure with a short design life. There is evidence of repairs in the past and the need to repeat them after the high water periods of 2017 and 2019.

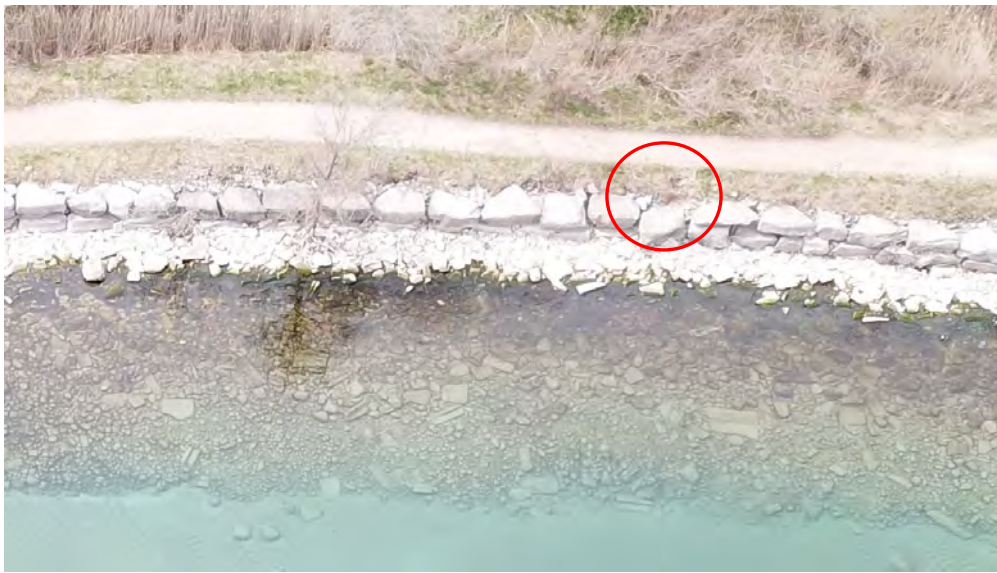
The pocket beaches are a greater concern in terms of the durability of the shore protection. An example is seen in Figure 7, where irregular rubble provides limited protection to the back wall. The back wall exhibits evidence of overtopping and some movement of the armour stone. The displacement is minimal to date but would be expected to progress more quickly if any deepening in front of the wall were to occur (we consider this likely).

**Figure 7: Rubble Beach and Armour Stone Wall in Sub-reach C**

Following displacement and toppling of the wall at some point in the future, there would be large armour stone in the water, close to the water level, which would act somewhat like a submerged breakwater. Erosion would continue behind this wall, but it would be at a much slower rate than the natural condition.

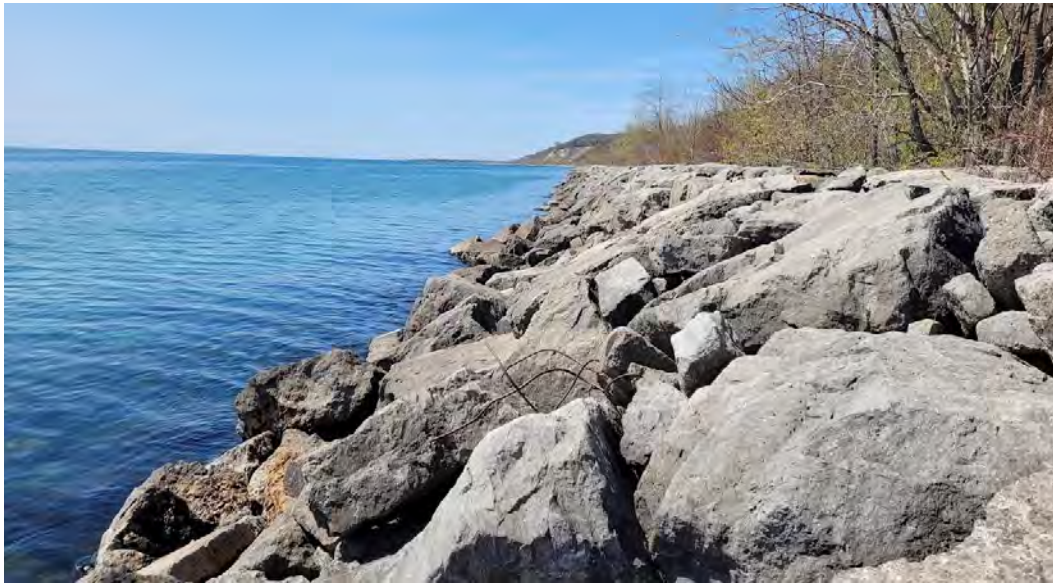
This sub-reach is protected with an 1100 m long revetment that was built in 1992 and reaches from the northeast headland of Sub-reach C to Livingston Rd. The revetment appears to be more robust than the revetment along Sub-reach E (Figure 8). The notes in the TRCA inspection records (WF25) indicate some gradual deterioration along the toe of the structure. This is consistent with our concerns about many of these structures in that they appear to have limited toe stone to accommodate downcutting of the lakebed. There are also notes about some of the smaller material being lost, which is another general comment that we have on the approach of using chinking to fill gaps between loosely packed armour stones. It appears (from aerial

imagery) that the stone in the southwestern 490 m of the section has a different placement (possibly more robust) than the northeastern length, although there is no indication of a difference in design.

**Figure 8: Revetment Face in Sub-reach D**

The central and northeastern part of this section of shoreline shows slightly steeper nearshore slopes (40:1 compared to about 70:1 further south). This steeper slope introduces the possibility of more downcutting of the lakebed and a deeper toe adjacent to the structure. We estimate that after 100 years, the wave height will require armour stone larger than the 4 to 6 tonnes that seems to be common in this area. Our observations were of more widely varied armour stone sizes, ranging from about 2 to 8 tonnes.

This area may see some gradual slumping of the armour stone if toe erosion continues and if some of the chinking is lost. However, while some damage may occur, we do not anticipate any significant erosion of the lakefill behind the revetment (about 40 m width of fill) to an extent that would start to erode the toe of the bluff until significant lowering of the section had occurred.

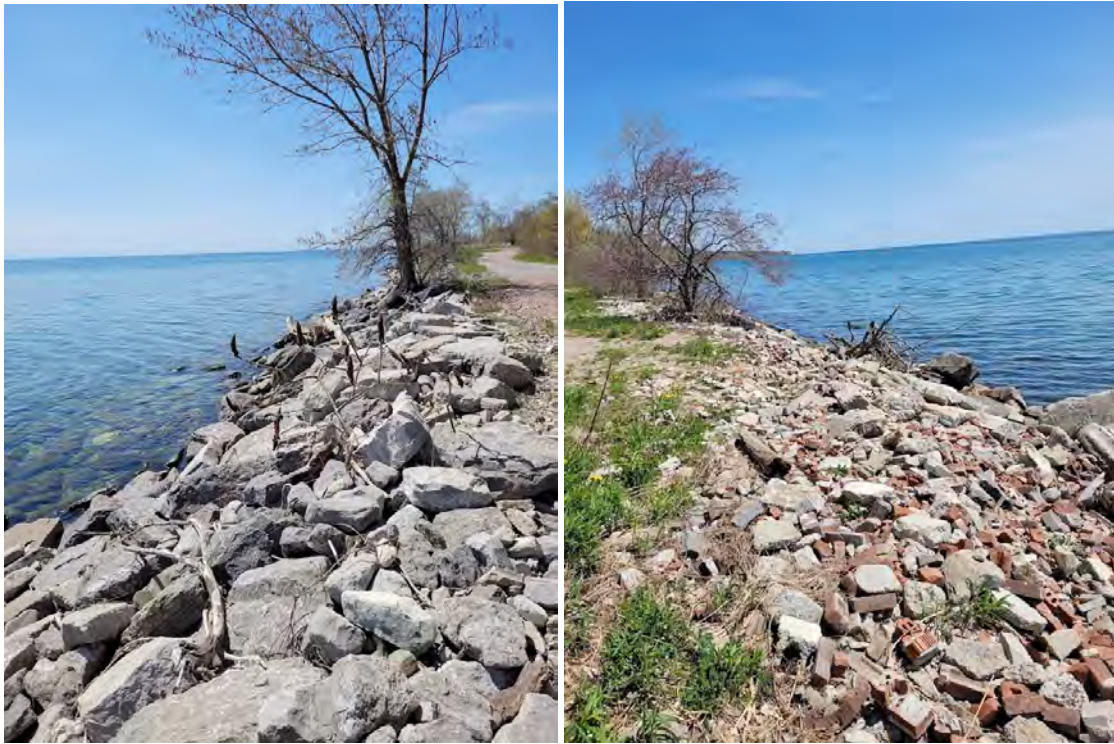
This sub-reach extends over about 900 m and is referred to as WF26 in the TRCA inspection records. The construction date for this revetment and path is unclear; however, it appears that significant repair of slumps and erosion areas were repaired in 2009. This revetment appears to be less robust than the revetment that protects Sub-reach D to the southwest. It was noted in the 2017 inspection that six areas of the revetment were experiencing major erosion (about 50 linear metres), which were subsequently repaired with concrete rubble.

This revetment is in much poorer condition than revetments in other sub-reaches. There are some larger pieces of armour stone, and other areas where there is smaller riprap and scrap concrete / bricks (Figure 9). There is still the potential for lakebed erosion and deepening of the profile. With nearshore slopes of about 38:1 (steeper than other areas) the potential for downcutting is greater than in areas with flatter slopes. This would result in greater wave heights and severely undersized stone in this area. The profile would then be expected to flatten and get lower with more highly mobile and deteriorating shoreline fill.

**Figure 9: Examples of Shore Protection in Sub-reach E**

Without maintenance, the shoreline revetment would incur further damage, the crest would be eroded and lowered and the structure would behave more like a reef. This flatter and lower position would have more stable stone (much smaller stone is required in a reef structure) limiting wave heights passing over it. Eventually waves could reach back to the bluff face but would be greatly reduced in height compared to a fully unprotected scenario.

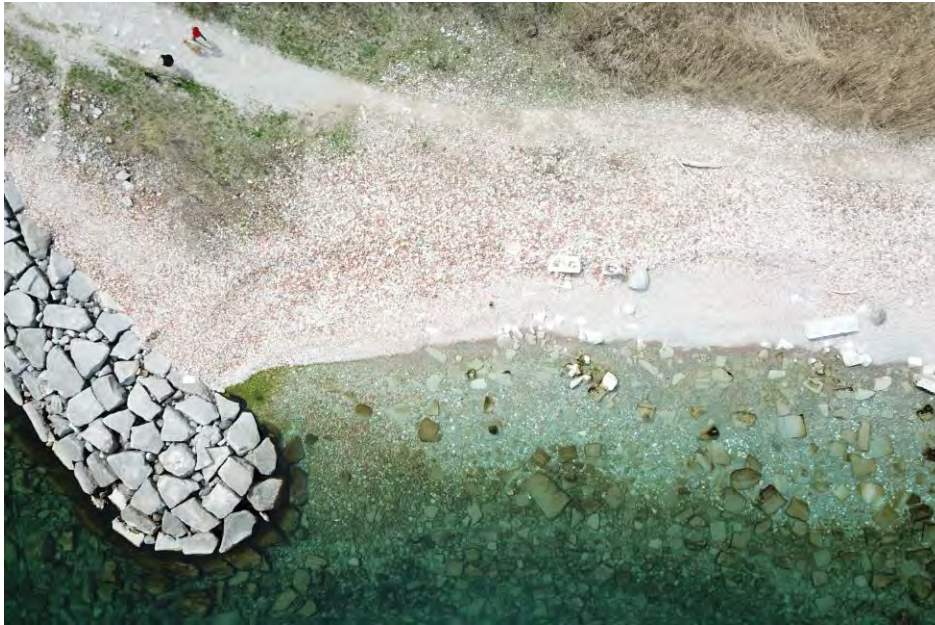
Sub-reach B: This structure is in poor condition and would degrade much more quickly than adjacent sub-reaches. The smaller stone size also means that further degradation and lowering of the profile will be more rapid than in other sub-reaches. Figure 10 shows how cobble and rubble have been pushed inland at the west end of Sub-reach B. The width of fill behind the path is also relatively narrow here.

**Figure 10: Shoreward Progression of Cobble/Rubble at West end of Sub-reach B**

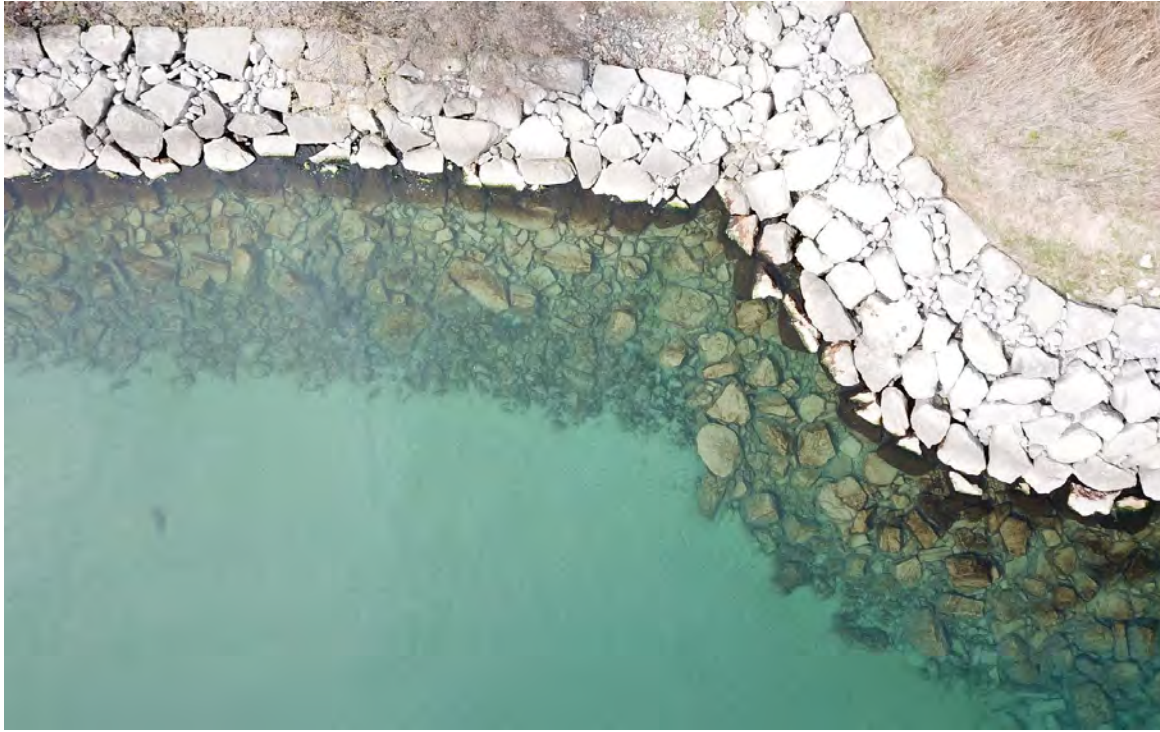
Sub-reach C: The headlands at Sylvan Ave appear fairly robust above the water, although small chinking stone is gradually being lost. The view from the drone shows that the armour has some very large gaps filled with chinking (the armour is widely spaced in some areas) and the armour extends only about one stone below the water level, below which it is a mixture of smaller material. We have not seen any drawings that suggest the armour extends below the visible limit from the drone images. For this reason, the section is described as moderate, rather than good.

**Figure 11: Minimal Below-Water Armour in Sub-reach C (Sylvan Ave.)**

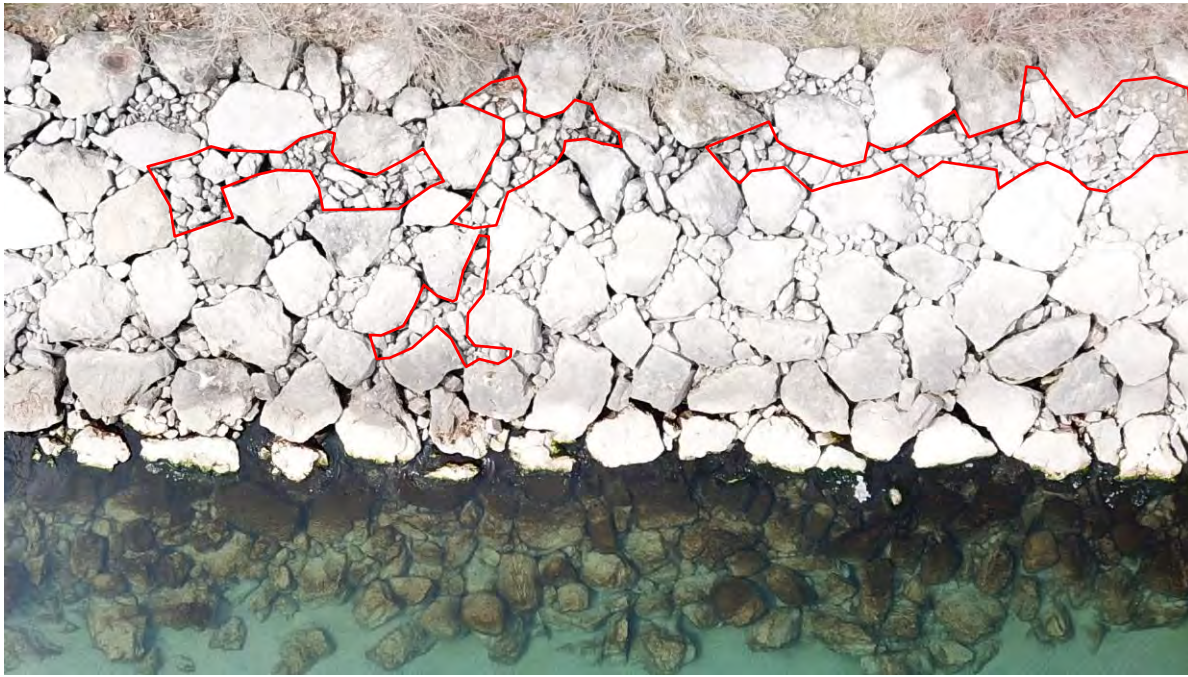
Sub-reach D: This is the most robust looking section of revetment in Reach 30, although there are still some concerns about the excessive use of chinking with small stones between the large stones (Figure 12). When downcutting occurs, there is expected to be some shifting of the armour layers down the slope. There is evidence of more loss of chinking stone lower in the profile and this is expected to continue and get worse as the armour shifts more. This will result in a lowering of the crest of the structure. Despite this, the existing armour stones are large and will provide significant protection even after some settlement.

**Figure 12: Excessive Chinking in Sub-reach D (selected examples in red)**
