BLUFFER'S PARK SOUTHWEST HEADLAND AND BEACH MAJOR MAINTENANCE

Community Liaison Committee Meeting
December 7th, 2017

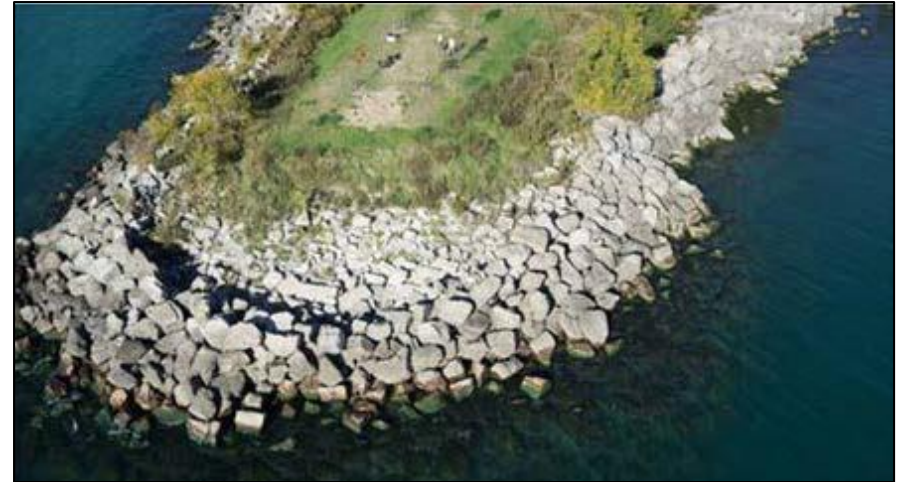
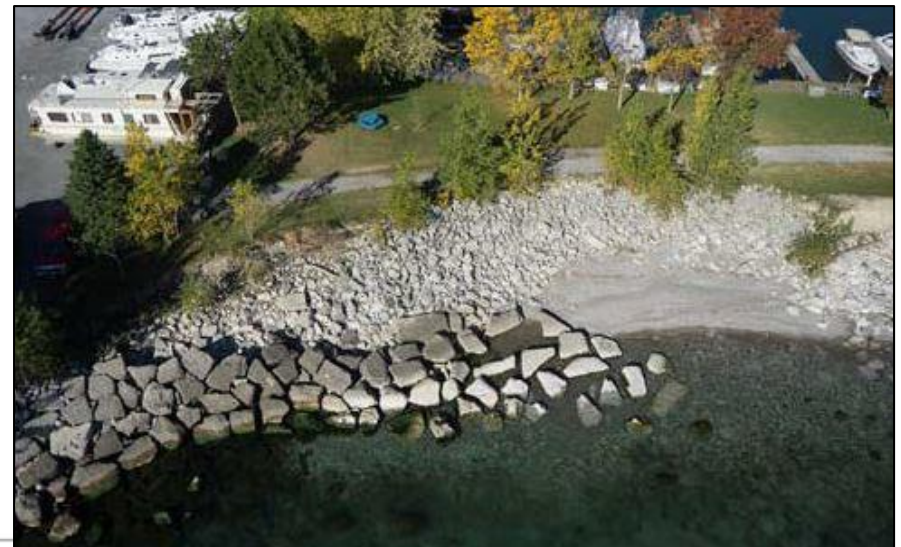
Headland

- Armourstone protection - 165 m long, 31 m wide
- TRCA assessed as 'failing' or 'failed' since 2009
- Erosion visible along the east and west flanks of the headland
- Toe instability, lack of sufficient double-layer of armourstone, lack of sufficient filtering layer beneath armourstone
- Significant damage observed at the head of structure with washouts behind the crest
- Interim maintenance work was carried out in December 2016.

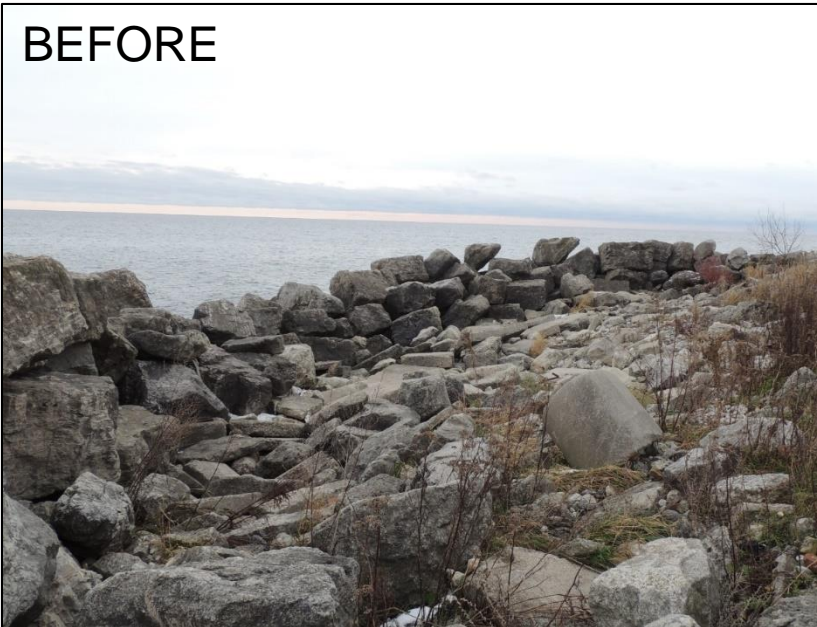
BEFORE

- Void area above headland was backfilled with armourstone
- The material used can be re-used during the final maintenance of the structure

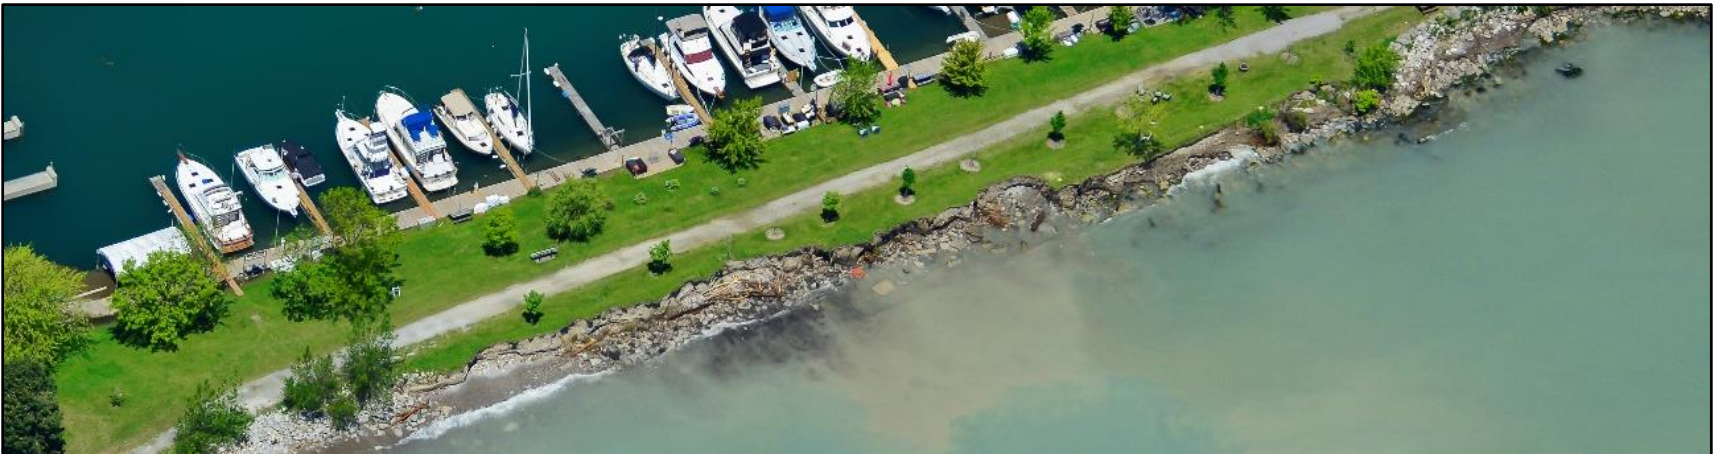
- Cobble-sized material backed by access berm. 194 m long, 6 m wide (at construction)
- West end of beach is backed by rip rap slope
- Middle of beach has actively eroding sandy backshore
- East end beach is backed by stone curb
- TRCA assessed as 'failing' or 'failed' since 2009
- Lack of coarse material to provide stability
- Beach is too narrow to effectively dissipate waves

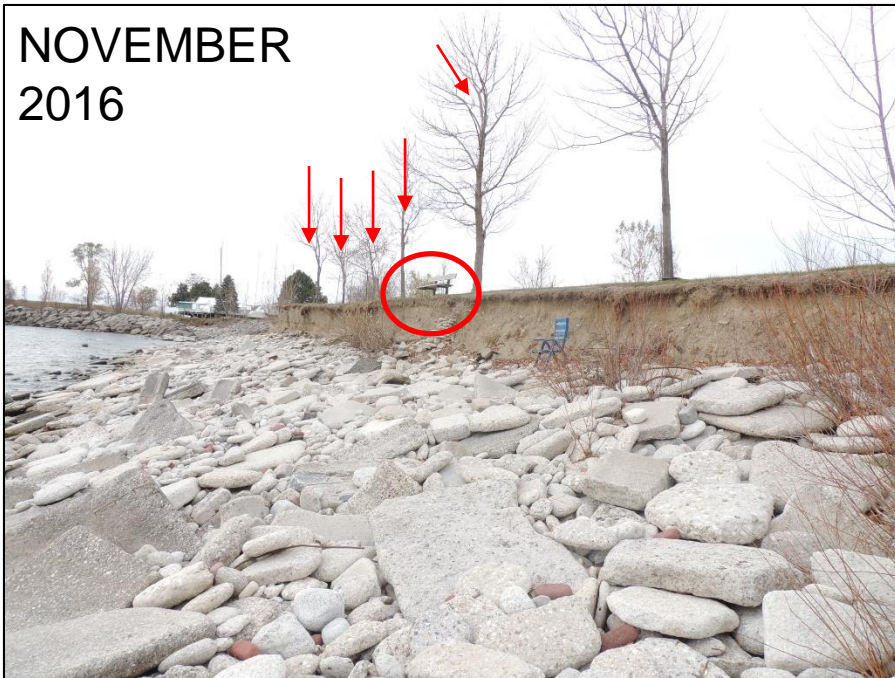
NOVEMBER
2016

- Between November 2016 and August 2017, there was enough erosion to cause a bench and at least 5 large trees to fall
