Mimico Creek

WATERSHED

Report Card 2018

Toronto and Region Conservation has prepared this report card as a summary of the state of our forest and water resources.

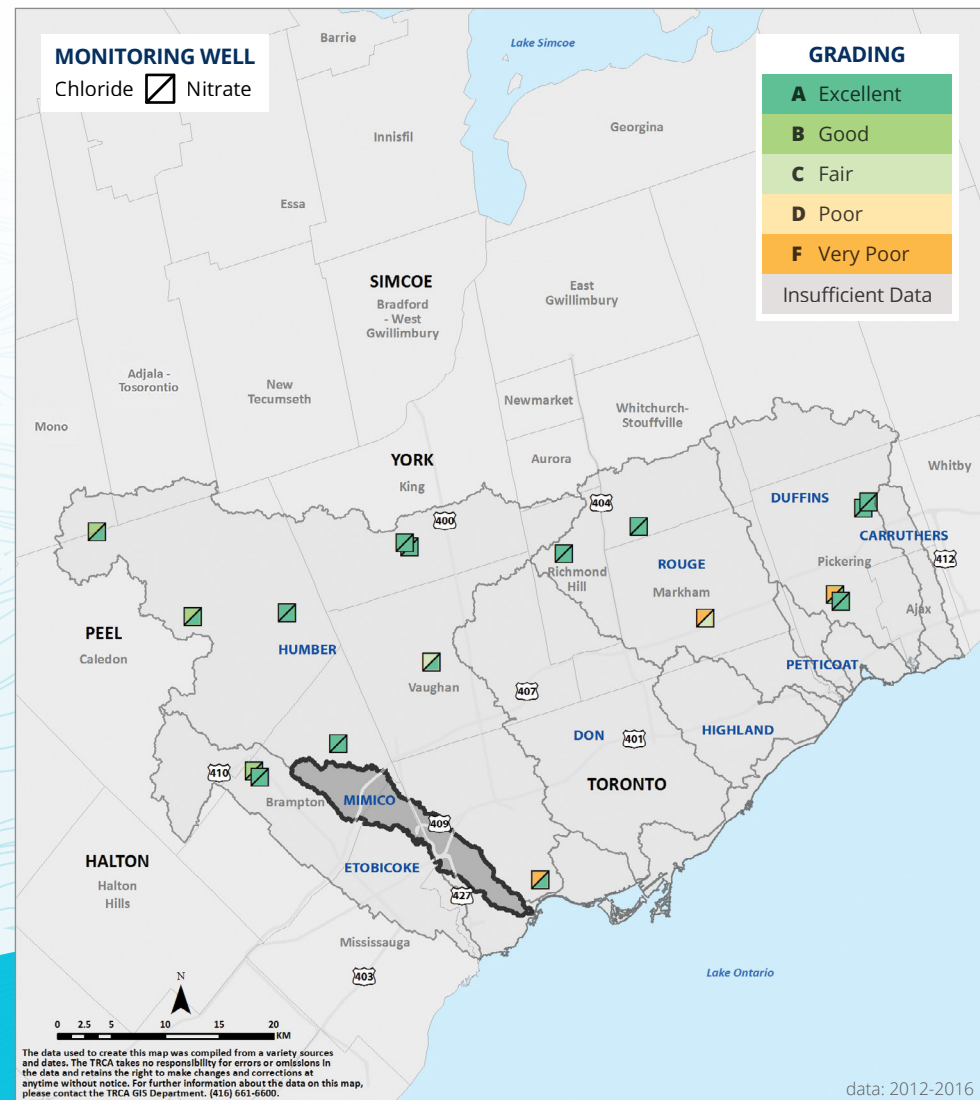
- Generally, concentrations of nitrate in individual wells were better than the drinking water guidelines ('A' grade) across the jurisdiction.
- The 2 wells located in the nearby Etobicoke Creek watershed received 'A' grades for nitrate and a 'B' or better grade for chloride.

Monitoring wells are part of the Ontario Ministry of the Environment and Climate Change's Provincial Groundwater Monitoring Network (PGMN). No wells were located within Mimico Creek watershed.

Fertilizers (nitrogen) and road salt (chloride) are common sources of contamination in groundwater. Concentrations of nitrate and chloride were measured at 17 monitoring wells across the TRCA jurisdiction. Grades were calculated for each well but not for each watershed. Although there are no wells located in the Mimico Creek watershed, there are 2 wells within the neighbouring Etobicoke Creek watershed. Learn more about groundwater at trca.ca/source-water-protection

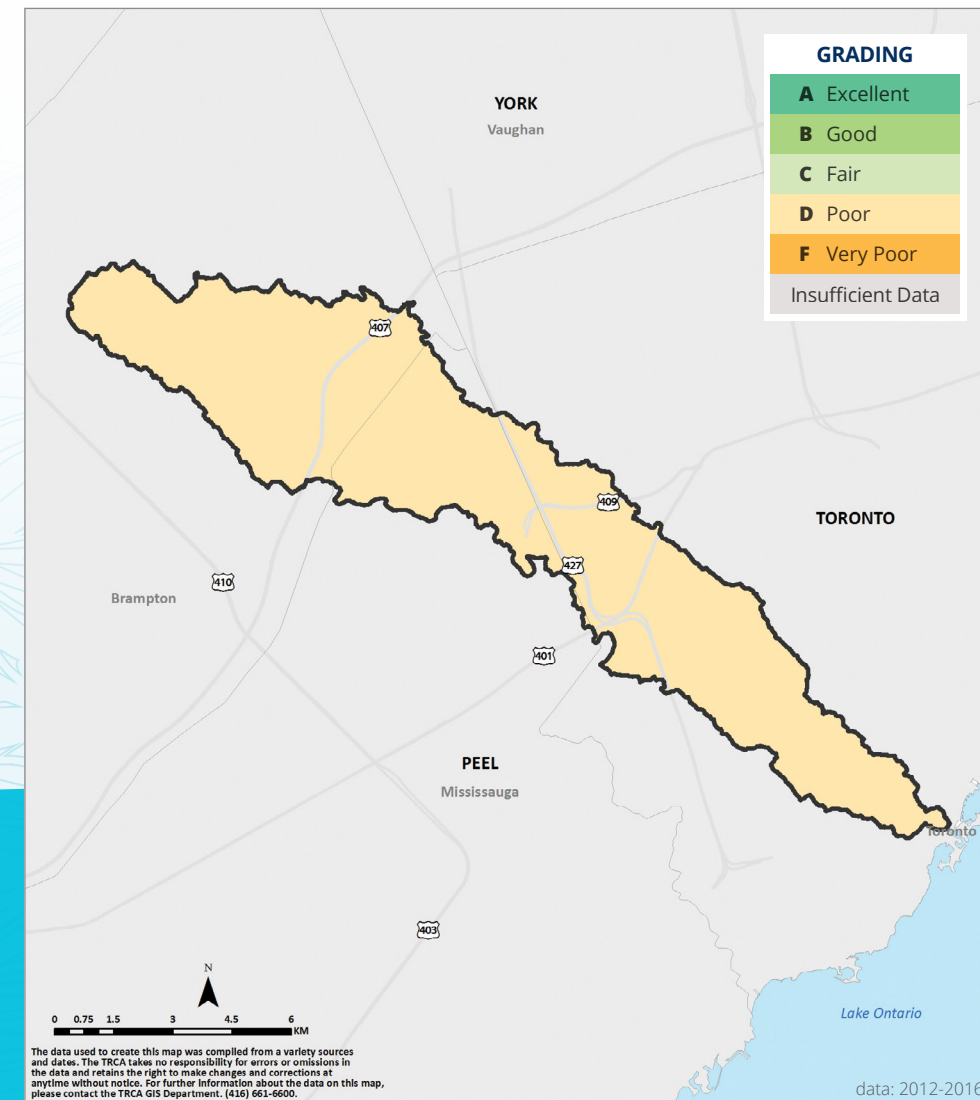
- The Mimico Creek watershed received an overall 'D' grade for surface water quality which improved from an 'F' in 2013 report card.
- Chloride concentrations are not included in the grade, but chloride is an issue in the watershed. Almost every sample collected (98%) had a chloride concentration greater than the recommended guideline. The chloride found in streams is typically from road salt and elevated chloride concentrations can harm aquatic life.

Data are based on surface water quality monitoring stations that are part of the Ontario Ministry of the Environment and Climate Change's Provincial Water Quality Monitoring Network (PWQMN) and/or TRCA's Regional Watershed Monitoring Program (RWMP).

Concentrations of phosphorus and *Escherichia coli* (*E. coli*) bacteria were measured at 2 stations in the Mimico Creek watershed. Benthic invertebrates (small aquatic animals living in the sediment) were identified at 5 stations. The type and proportion of these animals are indicators of water quality conditions. These indicators were combined to provide a grade for the watershed.

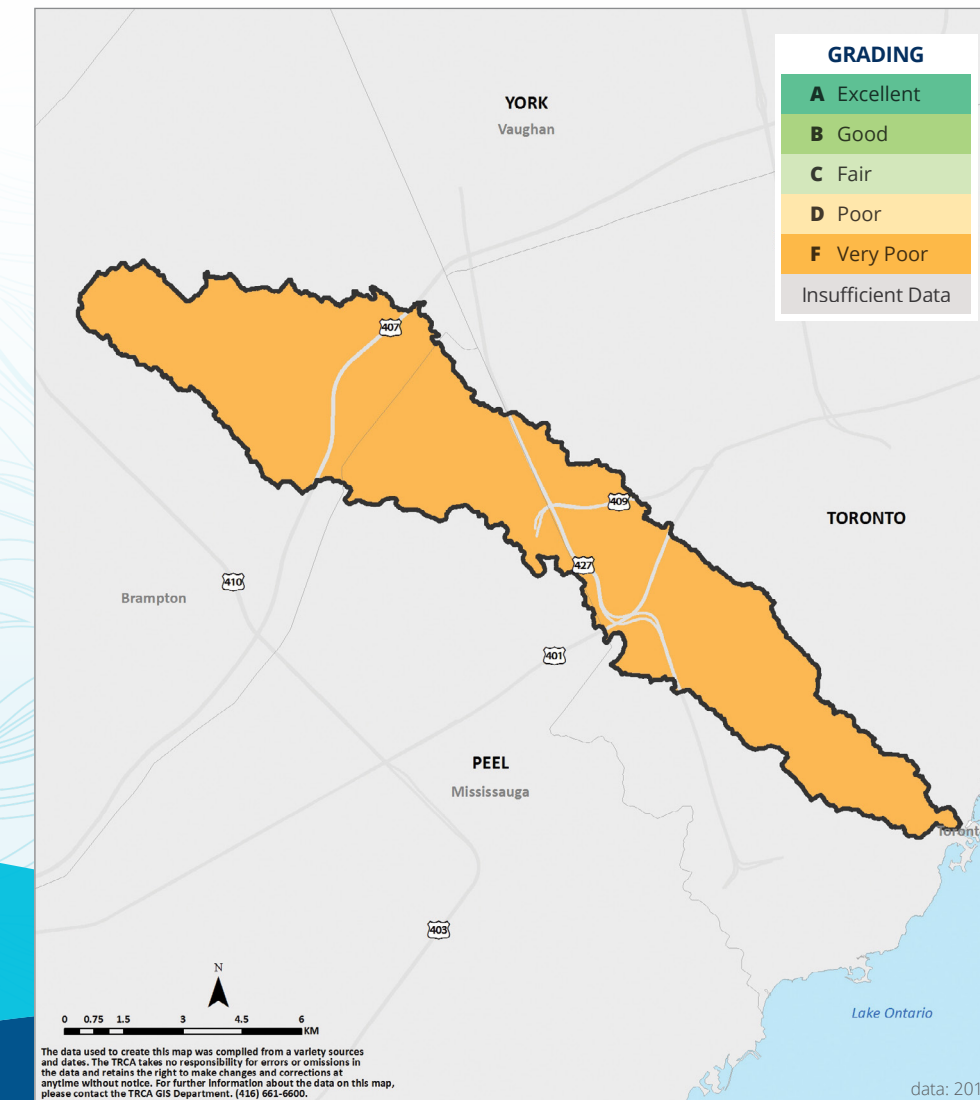
- The Mimico Creek watershed received a 'F' grade for forest conditions which is the same as the previous report card in 2013.
- There was about 2% forest cover, <1% interior forest cover, and 19% streamside cover. Streamside cover has increased by almost 5% since the last report card which is a sign of improvement.

Forest condition targets were set by Conservation Ontario. TRCA has a unique set of targets for natural cover which consists of areas of natural vegetation such as forest, wetland, and meadow. TRCA specific targets are not included in this report card.

Forests help to clean our air and water, provide habitat and shade, improve water infiltration, and help to reduce both erosion and flooding. The percentages of forest cover, forest interior, and streamside cover were measured with Geographic Information Systems (GIS) and combined to provide a grade for the watershed.

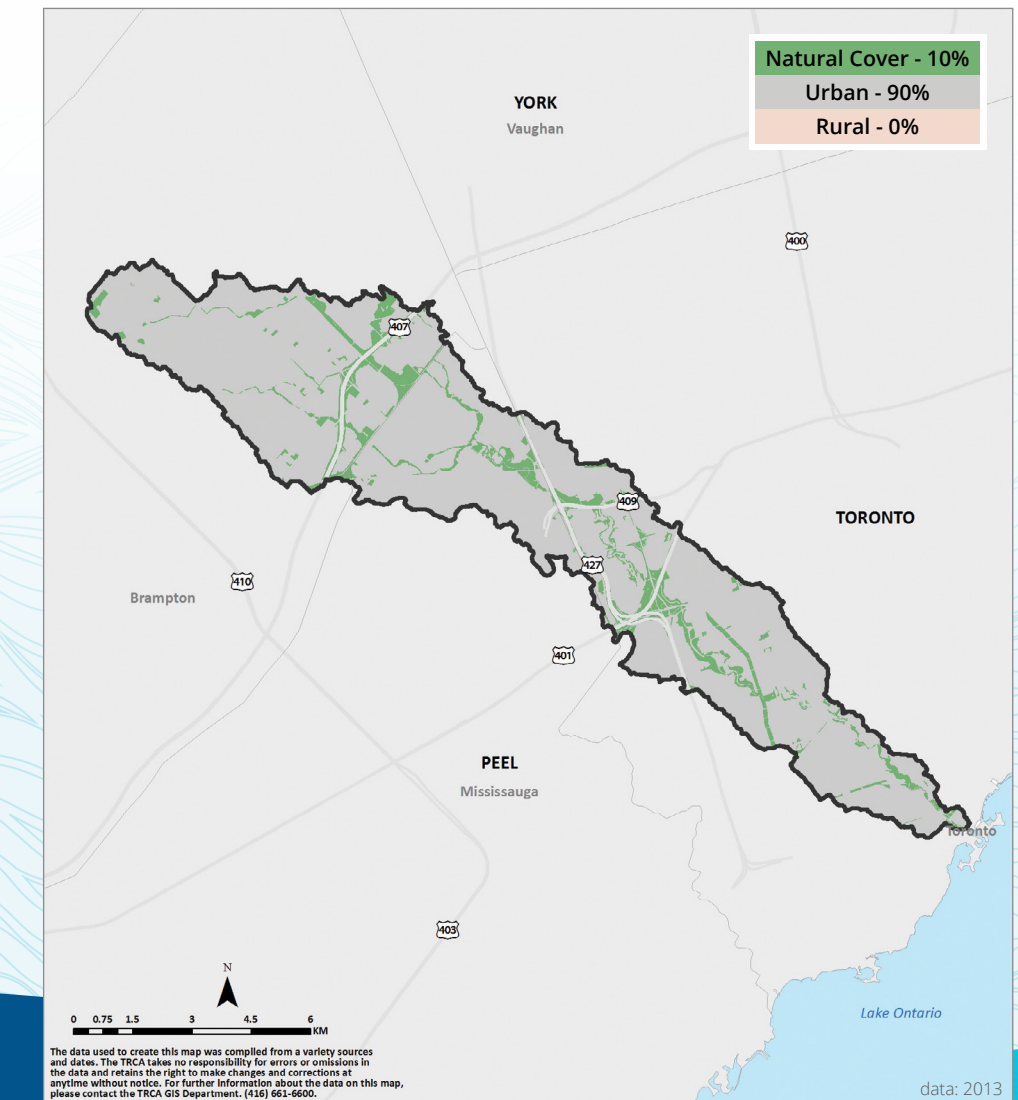
- Mimico Creek watershed has the highest proportion of urban area (90%) and the lowest proportion of natural cover (10%) in the TRCA jurisdiction.
- About half of the population in the watershed (56%) is within 300 m of natural cover greater than 1 ha in size.
- Natural cover is unevenly distributed across the Toronto region. More natural cover would mean additional opportunities to support wildlife populations and habitat, and equal access to nature for residents.

Natural cover consists of vegetation such as forest, wetland, and meadow. Distance to natural cover and size values are based on indicators recommended in scientific literature (e.g. Van den Bosch et al., 2015).

How we use land affects the natural environment and our health. Forests and wetlands have been removed over time because agricultural and urban land uses have expanded. As our region continues to grow, we need to consider how to increase the amount of natural cover and greenspace available so that people can enjoy the many health benefits of nearby nature.
