# 2016

## Road Ecology Study and Mitigation Provincially Significant Wetland – Area “C”

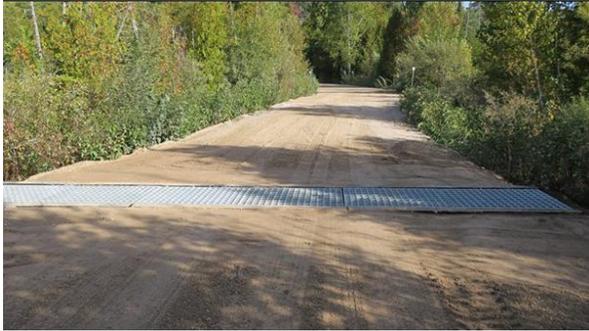
Figure 1 - Bruce Peninsula National Park ecopassage (Credit: Parks Canada)

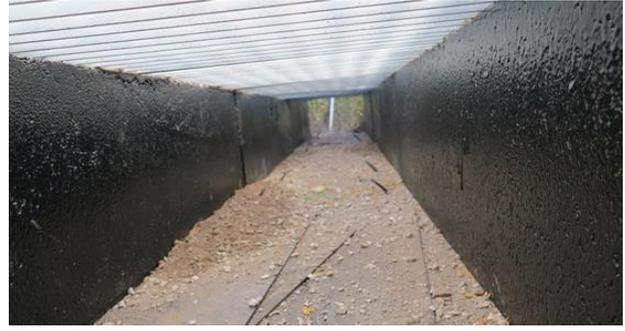
Figure 2 - Bruce Peninsula National Park grated ecopassage (Credit: Parks Canada)

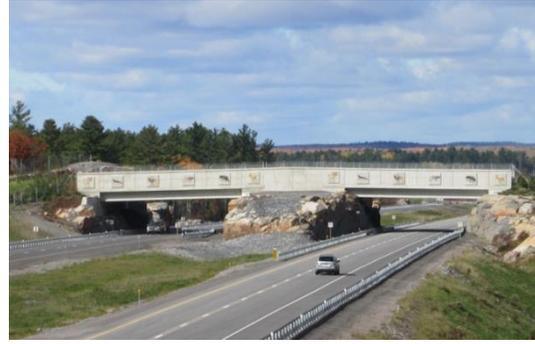
Figure 4 - MTO dedicated wildlife overpass Hwy #69 (Credit: MTO)

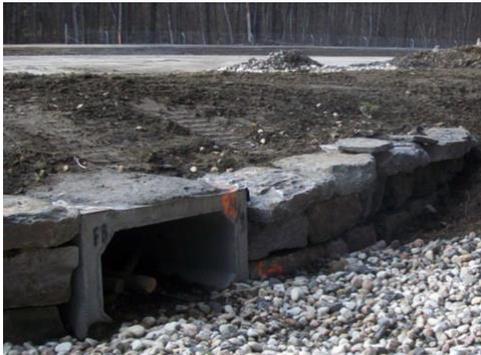
Figure 5 - Wildlife passage/fence Terry Fox Dr, City of Ottawa (Credit: Dillon Consulting Ltd)

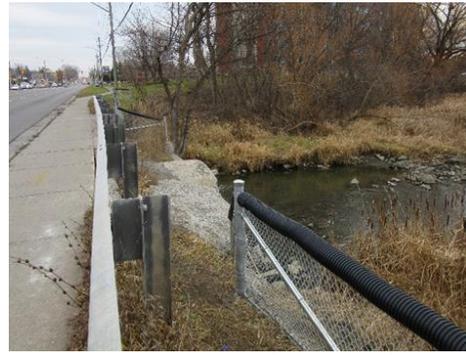
Figure 6 - Turtle exclusion fence City of Kingston (Credit: Mandy Karch)

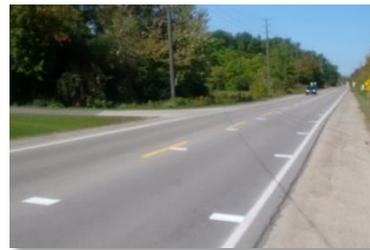
Figure 12 - CoB install optical speed bars to slow traffic

In an effort to modify motorist behaviour to reduce speed, CoB also installed/painted Optical Speed Bars (OSB) on Heart Lake Road (Figure 12). These transverse stripes are spaced at gradually decreasing distances and cause a visual effect intended to reduce drivers' speed as they react to the spacing of painted lines (McGee and Hanscom 2006).

The expectation is that the OSB will encourage slower driving speeds that facilitate motorists to watch for and react to wildlife on the road thereby contributing to the overall goal of preventing WVCs.

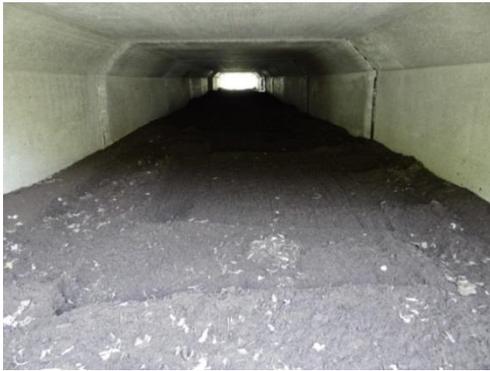
Figure 13 - Oversize culvert as wildlife passage

Wildlife passage design details including construction materials, placement, entry features, lighting, moisture levels and length, all interplay to determine if target wildlife species will successfully enter and pass through. Installation of large tunnels (e.g. oversized concrete box culvert (Figure 13) that maintain good airflow and natural light throughout or smaller tunnels specifically designed for reptiles and amphibians that enhance ambient light and moisture conditions through a grated slot system that lies flush with the road surface are recommended (Clevenger and Huijser 2011). A drawback of the grated slot system (Figure 2) is that wildlife may be exposed to pollution and road runoff (Kintsch and Cramer 2011). Concrete or polymer concrete culverts should be chosen over corrugated steel structures that are cold and may repel herpetofauna due to the un-favourable micro-climate created inside the passage. Following a lengthy investigation process and consultation with project partners, COB and TRCA opted to install a concrete box culvert of suitable dimensions for herpetofauna and mammals of the area. Installation of the culvert commenced on April 18, 2016, when CoB closed Heart Lake Road (Figure 15) to redirect traffic during installation of the passage and was completed on April 20th, 2016 (Figure 16 to 18).

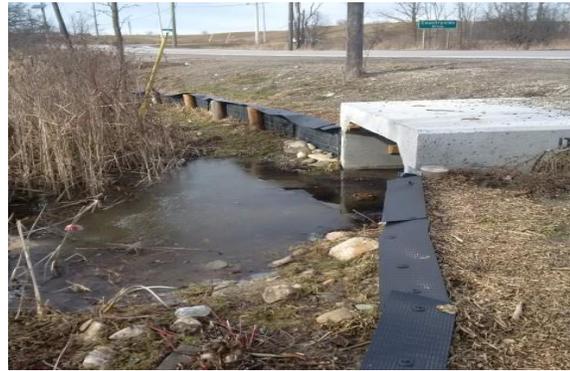
Figure 14 - Passage and wildlife directional fencing

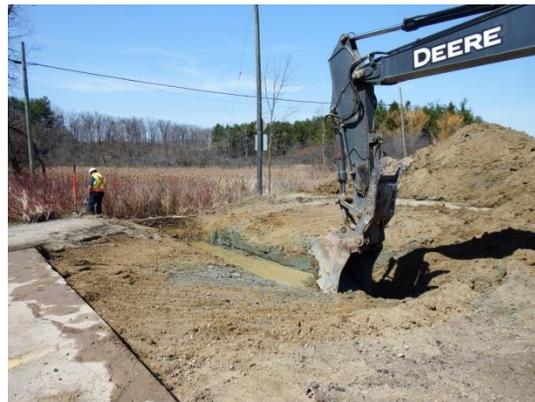
Figure 16 - CoB digs trench at Heart Lake Road to install passage

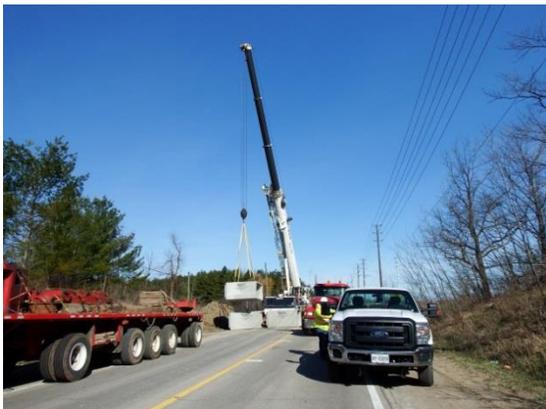
Figure 17 - Oversize concrete culvert sections craned to site

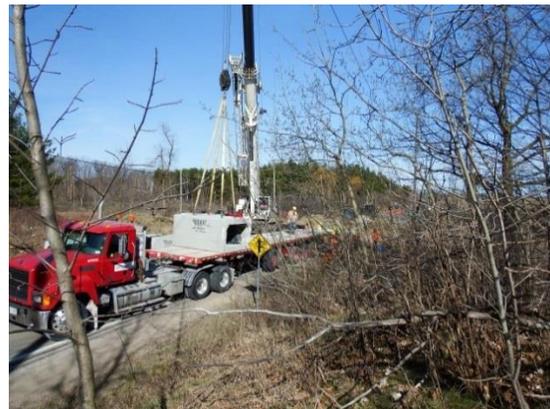
Figure 18 - Oversized concrete culvert sections at site

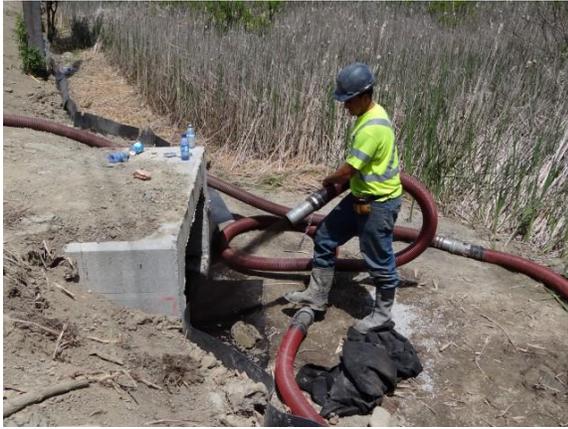
Figure 19 - Soil/mulch substrate being "blown" into passage

A 10 cm layer of natural soil mixture composed of composted leaves and wood chips was blown into the passage (Figure 19) and extended beyond the passage entrance (Figure 20) to provide suitable substrate for wildlife. This soil layer was laid down to enhance the natural texture of the ecopassage and to encourage movement of amphibians and reptiles that might be otherwise subject to desiccation travelling over a concrete surface (Mazerolle & Desrochers, 2005).

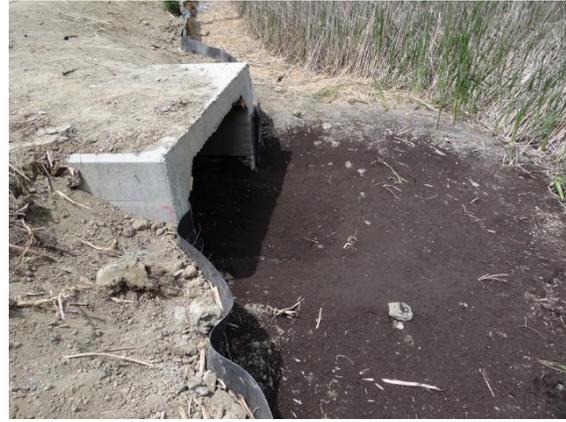
Figure 20 - Soil/mulch substrate extending beyond passage entrance

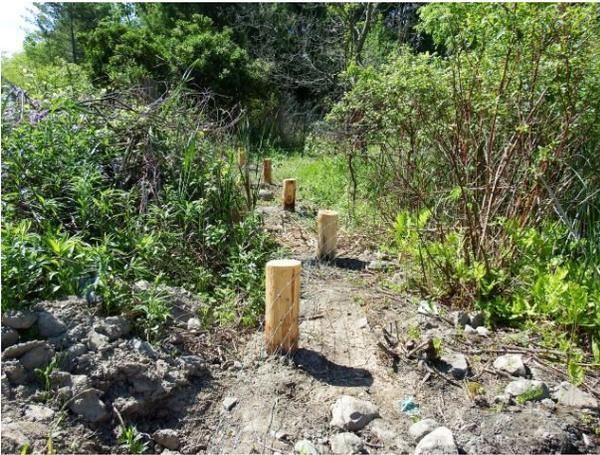
Figure 24 - Wood poles and farm fence installation

Animex wildlife fencing attaches to the round wooden posts and farm fence (Figure 24) and has a smooth interior face (facing the wetland) to discourage climbers (e.g. snakes). There is a 15 cm lip angled back into the wetland to prevent any climbing fauna to gain purchase and breach the fence. However, the outside face of the fence and the lip has a textured grid, which facilitates returning back into the wetlands in the event an animal accesses the road moving from fragmented wetlands. TRCA also augmented the poles with steel T-bars to reinforce where sections were joined (Figure 25 to 27). Fencing was also banked with mulch (Figure 28 and 29) to seal gaps, allow animals on the road to access the wetlands and allow water to filter through during storm events. Banking the edge with mulch also provided support from snow plowing and potential strain from snow/ice weight.

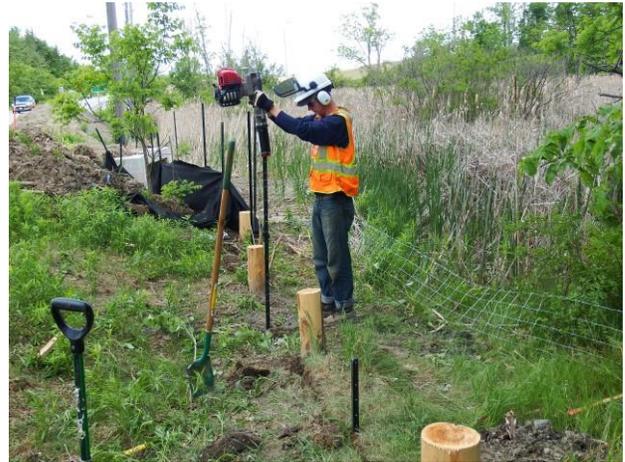
Figure 25 - Installation of steel T-bars for reinforcement

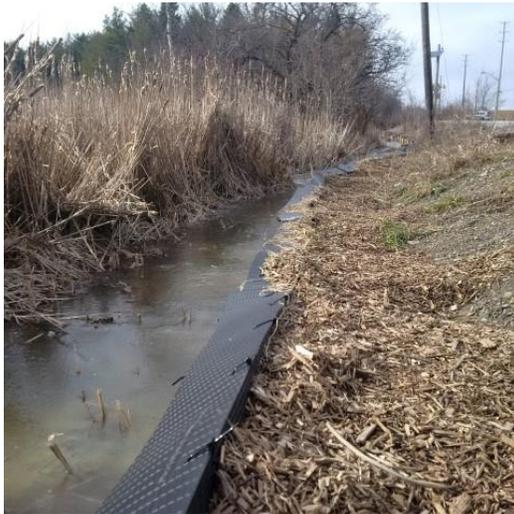
Figure 28 - Animex fencing banked with mulch

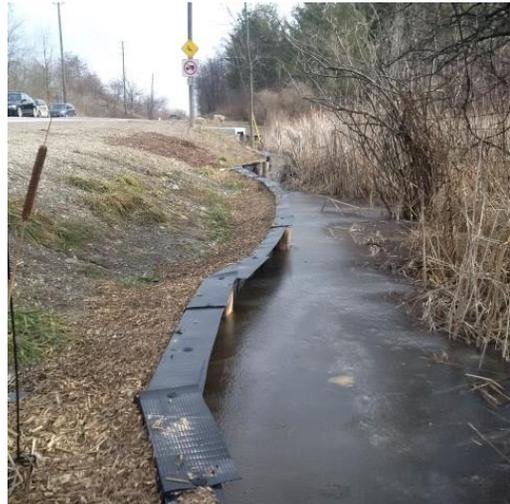
Figure 29 - Animex fencing banked with mulch leading to passage

This specialized fencing was completed on June 16, 2016, on both sides of HLR., south of Countryside Drive. Total length of directional fencing is approximately 190 m on the east side and 140 m on the west side, to reduce herpetofauna accessing the road in these two bisected wetlands. Fencing terminal edges curl around the wetland to re-direct fauna back into the wetland toward the wildlife passage.

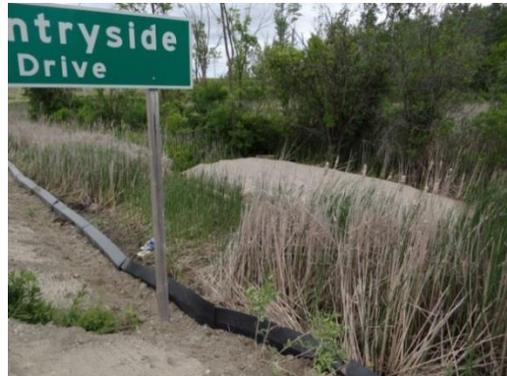
Figure 31 - TRCA installed turtle nesting beach on east side of Heart Lk Rd

Nesting mounds were designed and installed by the TRCA (Figure 30 and 31) on both sides of the mitigated areas on May 11 to 13, 2016, in time for the turtle-nesting season peaking in June. The mounds were positioned close to the road but inside the wildlife fencing and act as an alternative to roadside nesting.

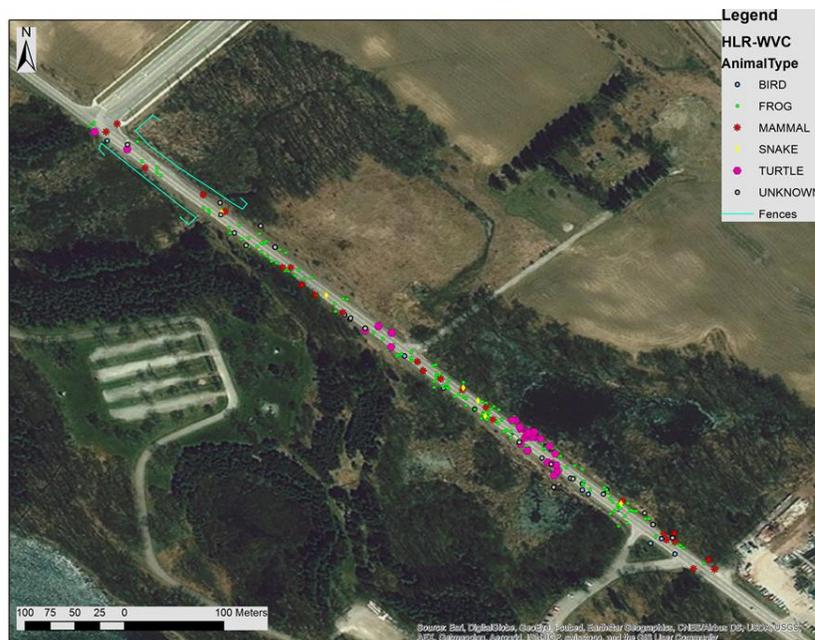
Figure 35 - Map of WVCs along Heart Lake Road 2016

In 2016, a total of 263 WVCs were recorded along the monitored stretch of HLR, including 28 turtles indicated in the map below (Figure 35). General road mortality was clumped along the identified unmitigated hot spot #2 near the wetland. This 2016 survey adds another year of data to a growing body of evidence that HLR is, and continues to have, high mortality rates for all herpetofauna.
