Don River Watershed Plan

Fluvial Geomorphology – Report on Current Conditions

2009

Prepared by: Toronto and Region Conservation

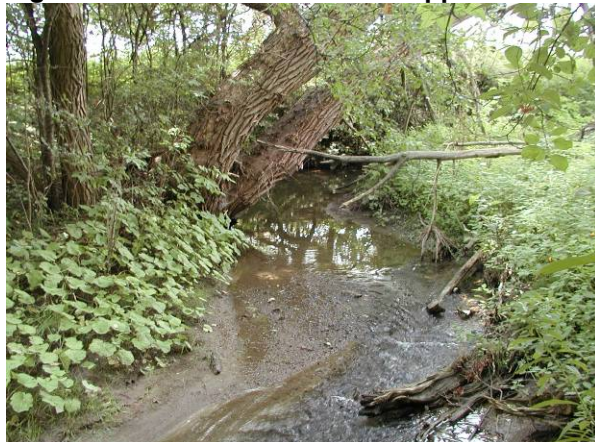
In the upper headwaters of the Don River watershed, small tributaries are generally underlain by thick sand deposits of the Oak Ridges Moraine and flows are largely ephemeral given that this is a zone of infiltration. Towards the transition zone at the southern end of the Moraine (south of Major MacKenzie Drive), it is possible to watch groundwater seeping to the surface of the bed and begin continuous flow. Further downstream, the headwater watercourses take on a low gradient, meandering channel form when permitted with deeper, narrower channels in the open field sections, and wider channel conditions in forested sections (Figure 3).

Figure 3: Headwater channel of upper East Don River.

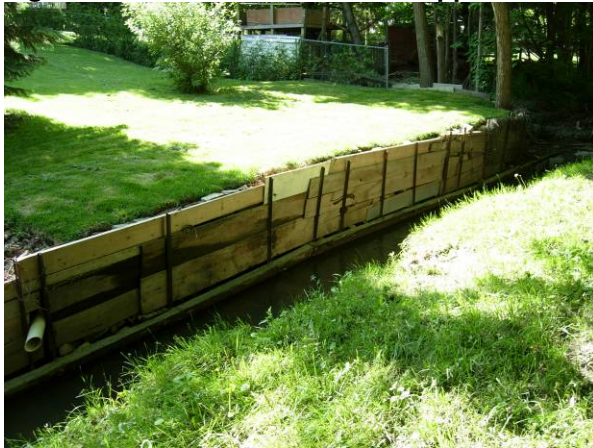
The direct and indirect impacts of urbanization are apparent in the headwater areas. Many streams located within or downstream of older urban development have been altered through channelization and installation of engineered bed and bank stabilization techniques to facilitate development or protect private property, altering or eliminating natural morphologic features (Figure 4). Field reconnaissance indicates that very little "natural" river channel remains except in some headwater sections of the Upper West Don River, Upper East Don River and German Mills Creek. In these areas, streams in or downstream of newer developments exhibit less direct physical impact but are beginning to exhibit widening and instability in response to an altered hydrologic regime. It appears that in the open sections of the floodplain, dense grassy rooting masses help maintain channel stability despite the changes in hydrology that have occurred. When the river flows through the more shady, vegetated wooded areas, undergrowth and surficial rooting mass becomes more limited, which seems to have contributed to the much more unstable channel conditions in these areas in response to the changes in hydrology.

Figure 4: Channelized section of upper German Mills Creek.

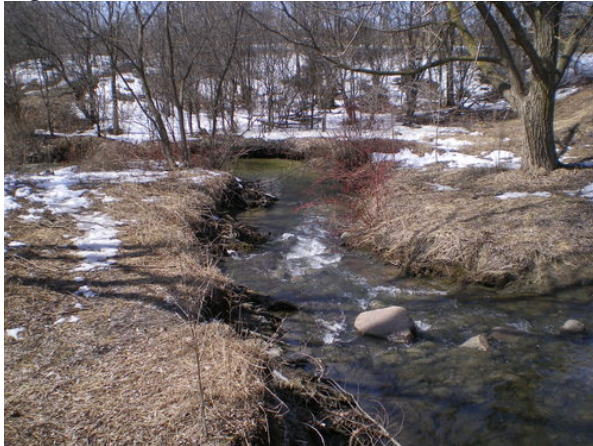
were realigned and engineered to facilitate development of infrastructure and housing, and to improve flood conveyance. A large proportion of the total stream length of the watershed from this point south has been straightened, hardened, buried, dammed, diverted and/or otherwise modified. Watercourses that have not been completely hardened show signs of instability including channel widening. This has resulted in the construction of stream bank protection works in many areas to prevent impacts to buildings and infrastructure constructed adjacent to watercourses. However, this effect is not as pronounced as it is further downstream in the City of Toronto, likely in part because of the relatively erosion resistant underlying glacial till in this area.

Figure 5: East Don River near Carrville Road, Richmond Hill.

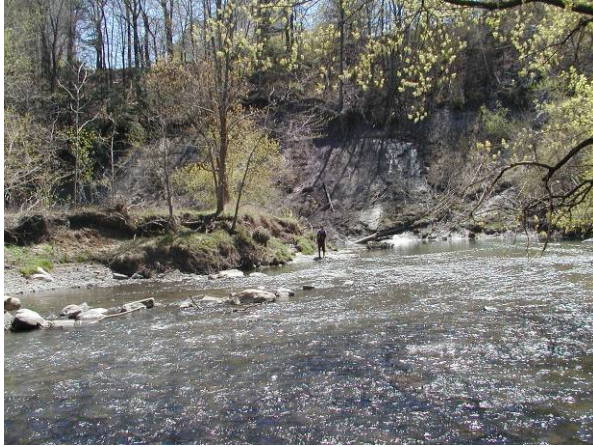
Approaching Steeles Avenue, the corridors of the East and West Don rivers become increasingly defined in the form of deep incised valleys (Figure 6). These are the remnants of glacial outwash rivers that cut valleys down to a lake level significantly lower than today's, after the draining of the glacial Lake Iroquois. The bottom substrate of these valleys consists largely of sand and gravel deposited in the remnant glacial outwash channels as the water level of Lake Ontario slowly rebounded and advanced into these deep valleys in the post-glacial period. This material is much less resistant to erosion than the glacial tills through which watercourses flow further north in the watershed, and the rate of movement of the East and West Don rivers, both natural and otherwise, is greater in this area. As a result, the impacts of upstream development and the associated hydrologic change are much more pronounced in the City of Toronto than they are further upstream.

Stream bank erosion and channel widening are widespread in the East and West Don river valleys, and without the control on bed level elevation created by glacial tills in upstream areas, the river channels have also downcut a significant degree. This tendency to downcut has resulted in the failure of many bank protection works that have been installed over the past century (Figure 7), resulting in the need for constant maintenance and replacement by the City of Toronto and TRCA. Increased lateral erosion rates within the river channels, caused by the urban hydrologic regime, and irregular patterns of channel migration, caused by bank protection works, have also increased erosion of valley walls, as seen in Figure 6, particularly on the East Don River where the river valley is narrower. While some erosion of valley walls is inevitable when modern rivers are confined within large, remnant glacial channels, the increased rate of erosion due to urbanization in the watershed is much larger than would be

expected in a natural system, resulting in loss of property on tableland above the unstable valley slopes, loss of forest cover on valley slopes, and safety risks.

Figure 6: East Don River south of Lawrence Ave.

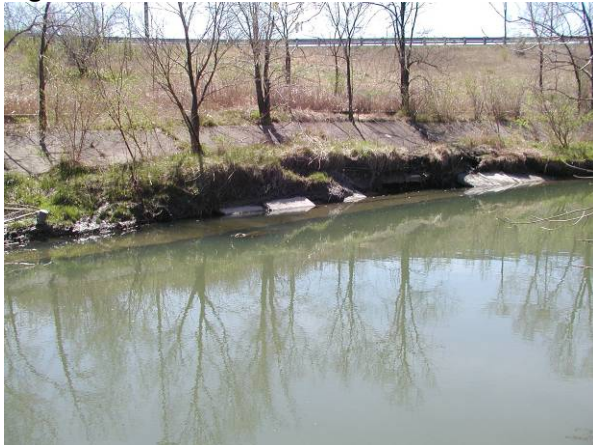
Figure 7: East Don River near Lawrence Avenue and Don Valley Parkway.

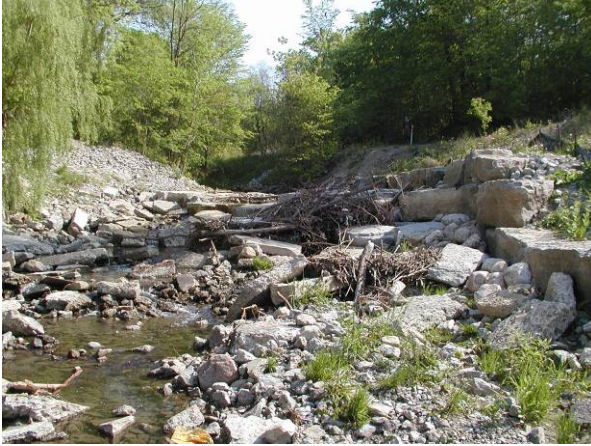
Despite the widespread historic elimination and enclosure of watercourses associated with development in the City of Toronto, there remain a number of significant tributary watercourses to the East and West Don rivers that originate within City boundaries, such as Taylor/Massey Creek, Wilket Creek, and Burke Brooke. These tributaries are the steepest watercourses in the Don River watershed, steeper even than those flowing over the southern slopes of the Oak Ridges Moraine, as they flow over a relatively short distance from the tableland of the City into the deep valleys of the East, West or Lower Don rivers. These watercourses have experienced perhaps the most dramatic and longest-lasting hydrologic changes from urbanization anywhere Southern Ontario, as their upstream catchment areas consist almost entirely of older, high-density development with virtually no stormwater management controls. In addition, the networks of small tributaries that regulate the rate of flow into the main watercourse channels have been largely replaced by pipes and engineered conduits in this older development that discharge stormwater runoff much more rapidly. These hydrologic impacts, combined with the high flow energy associated with steep gradients and the highly erodible substrates where these watercourses flow into the main valley systems, have resulted in some of the most extreme examples of channel degradation and resulting impacts to infrastructure and property found in TRCA jurisdiction. Extensive erosion protection works have been constructed over the

past half-century or more in response, which fail frequently due to the extreme conditions and require constant effort to maintain and replace (Figures 8 and 9).

Figure 8: Failed Erosion Protection Works on Taylor/Massey Creek near Warden Ave. and St. Clair Ave.

channel systems and offline wetlands in the large hydro corridors in the Ellesmere Road and Lawrence Avenue areas. For the remainder of Taylor/Massey Creek, regular monitoring and maintenance of bank protection works are recommended, as is the relocation or protection of some pathway currently at risk of erosion.

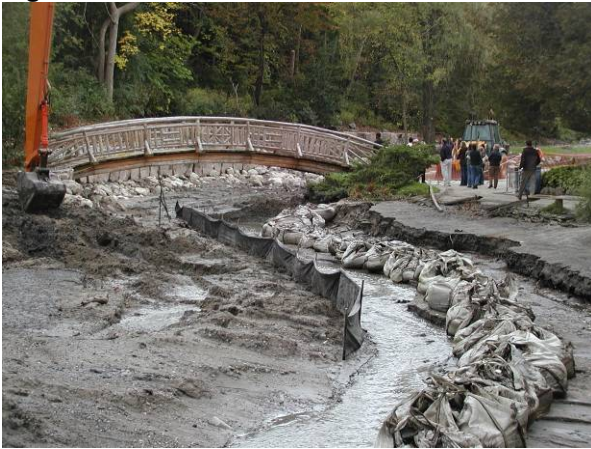
Figure 9: Channel reconstruction work on Wilket Creek near Lawrence Ave. and Leslie St.

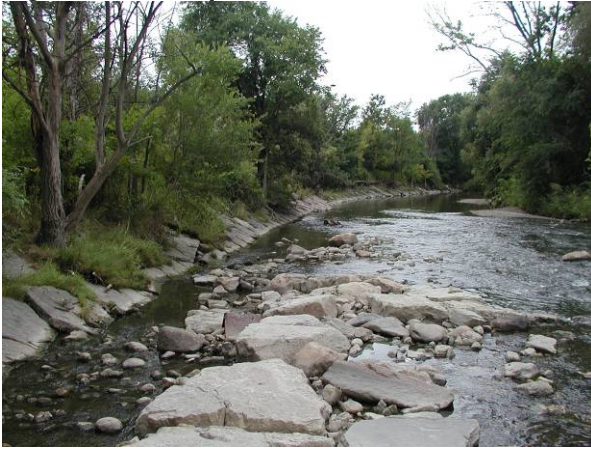
The Lower Don River originates at the confluence of the West and East Don River branches, near the Don Mills Road ramp to the Don Valley Parkway. For most of its length, the Lower Don is a low-gradient channel that conveys flow out of the remnant glacial valley over the historic Lake Iroquois shoreline deposits and into Lake Ontario. The Lower Don River has been entirely channelized and hardened over the last 150 years, to allow for and prevent undermining of critical infrastructure such as the Don Valley Parkway (DVP), railway tracks, Bayview Avenue, and various other utilities running parallel and adjacent to the river throughout its entire length. Between the confluence of the three tributaries (Lower East Don River, Lower West Don River and Taylor/Massey Creek) and the Don Narrows, the river has a moderately sinuous form that meanders across a deep, moderately vegetated floodplain. Superficially, the river channel appears to possess a relatively natural form, but a wide range of bank and channel works including concrete trapezoidal channels, boulder rip rap banks, armourstone revetments, erosion control weirs, sheet piles and wooden piles, have almost completely fixed the channel in place (Figure 10). As in other portions of the Lower East and West Don rivers, bank protection has caused downcutting of the river channel and irregular channel migration patterns, resulting in failure and need for reconstruction and new works elsewhere. Due to the

low gradient of this section of the river, sediment from ongoing degradation and erosion in the upstream watershed is deposited, creating irregular accumulation patterns in the channel.

Figure 10: Bank protection on Lower Don River north of Bloor Street.

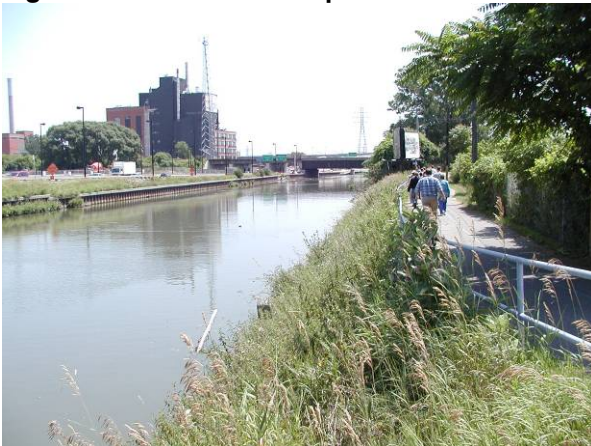
The Don Narrows is the nearly straight reach of the river from Riverdale Park to the CN Railway north of Keating Channel (Figure 11). The Narrows resulted from realignment of the river over a century ago, when the Port Lands industrial area was created and the wetlands at Ashbridge's Bay (the original mouth of the Don) were drained. At that time, the river was straightened and widened using vertical cedar piles placed side-by-side to form a sheer, hardened river bank. Later in the mid-1950s, the original cedar piles were replaced with steel sheetpiles to provide a foundation to construct the DVP on the east side of the river, and to reinforce the railway bed and Bayview extension on the west side of the river. The channel within the Don Narrows is relatively uniform with low-bed relief features and substrate consisting primarily of sand and coarse silt. There is essentially almost no hydraulic gradient to the channel, and water levels in low flow conditions are governed by the Lake Ontario backwater south of Gerrard Street.

Figure 11: Don Narrows upstream of CN rail line and Gardiner Expressway.
