## Archaeological Assessment Existing Conditions

**Stage 1 Archaeological Assessment — Existing Conditions**

**Don Mouth Naturalization and  
Port Lands Flood Protection Project  
City of Toronto, Ontario**

January 2007 (Revised November 2007)

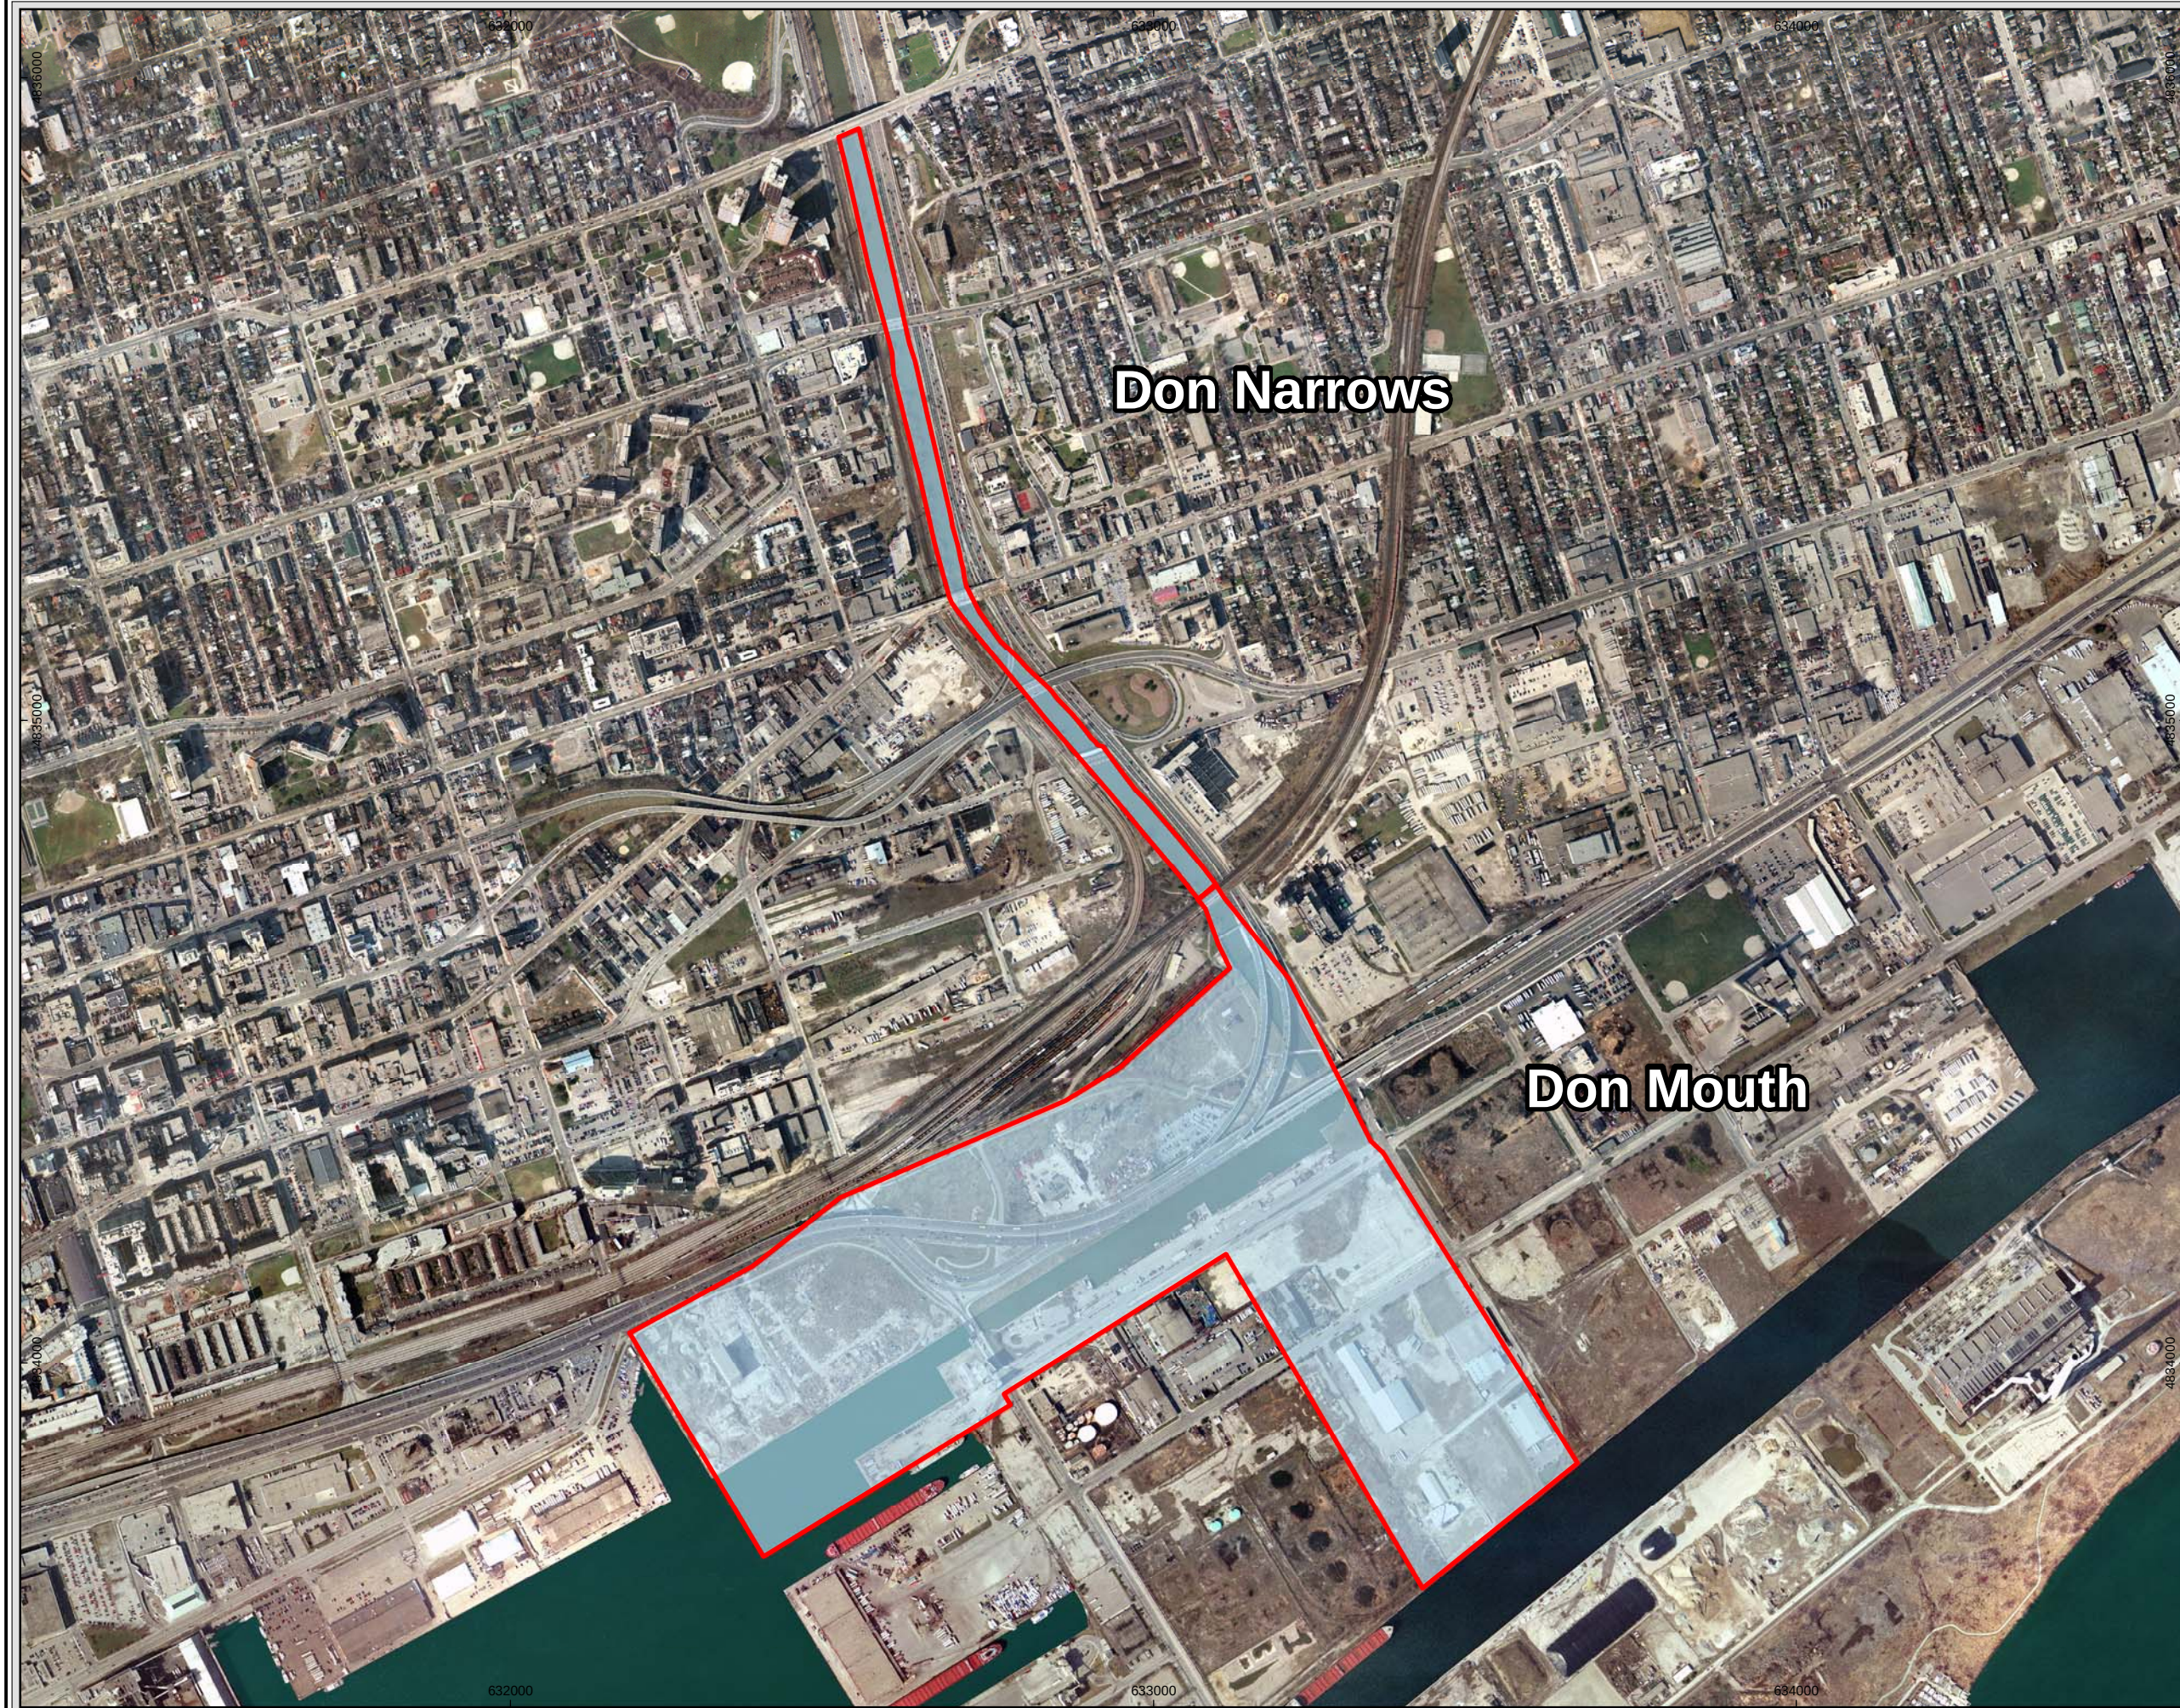
Legend  
Study Area

This Existing Conditions report identifies and describes the archaeological resources baseline conditions associated with the Don Mouth Naturalization and Port Lands Flood Protection Project Study Area (see Figure 1) in accordance with Appendix B (Archaeology Work Plan) of the approved Don Mouth Naturalization and Port Lands Flood Protection Project Environmental Assessment (EA) ToR.

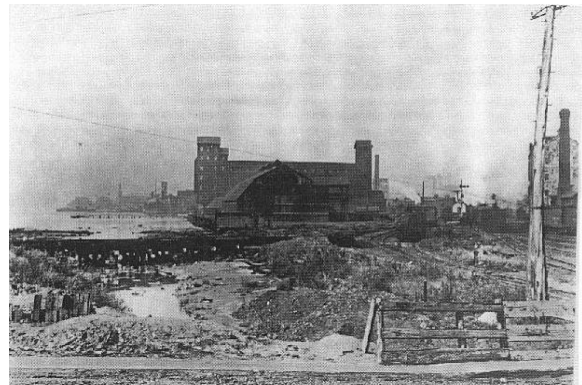
Figure 4: The silted up mouth of the Don River in an undated photograph. The Gooderham Wharf (Wharf 48) is in the middle background and also seems to have silted in.

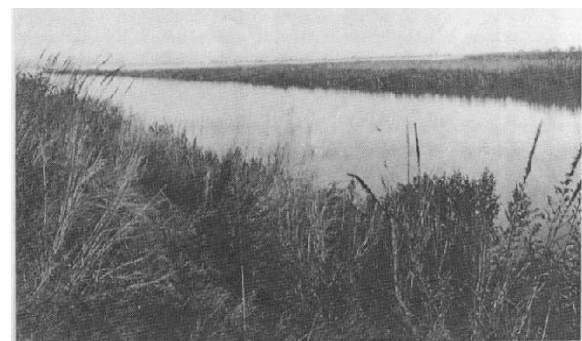
Figure 5: The Keating Channel in 1904.

The sewage problem finally drove the City’s engineering department, in 1893, to dredge a channel—later known as the Keating Channel—from Toronto harbour to Coatsworth’s Cut at the end of Ashbridge’s Bay, some 3 1/3

miles in length (Figure 5). Approximately four years later, the Don River was extended south to join this cut in a design intended to produce a current that would flush effluent out of the bay. In addition, land reclamation commenced to expand the small triangle of land between the old Don and the Keating Channel. This seems to have been driven, at least in part, by the dumping of municipal garbage, as the City Engineer's *Annual Report* of 1901 notes the expense of hauling street cleaning and garbage to the marsh due to lack of dumping grounds in the central city. This new land was seen as a good location for factory sites, and by 1913 two concerns—the National Iron Works on the west side of Cherry Street and the British American Oil Co. on the east—were established in the area. While the old mouth of the Don was not actively filled by these processes, it seems to have gradually silted in over time, although it did not disappear totally until the completion of the Harbour Commissions' land fill operations in 1912. In 1906, the connecting channel was replaced with an alignment to the east, creating a straighter route from the railway bridge.

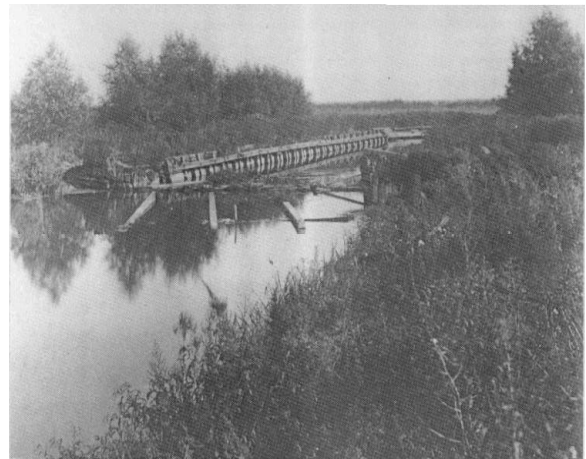
Figure 7: The Toronto Dry Dock looking south from the old Don River near Cherry Street in 1898. The structure appears to have been built of timber cribs.

The earliest industrial establishment in the Lower Donlands precinct appears to have been the Toronto Dry Dock Company (Figure 7). By the mid-1870s, shipping interests were promoting a dry dock for Toronto, since at that time the nearest repair facilities were at Port Dalhousie on the Welland Canal, or in Kingston. Therefore, in 1881, a company was formed and obtained a 21-year lease on a plot of land measuring 600 feet by 677 feet on the south side of the Don River, near the foot of Cherry Street. The intent was to construct a dry dock 60 feet wide and 280 feet long, which would have handled any vessel capable of using the Welland or St. Lawrence River canals. Although the dock was to have been completed in 1882, newspaper accounts in 1884 indicated that the works had already been abandoned, as it became apparent that frequent silt deposition made dock operations unfeasible. The company had spent a total of \$26,600.00 on the dry dock; in 1901, the City contemplated buying the property for \$5,000.

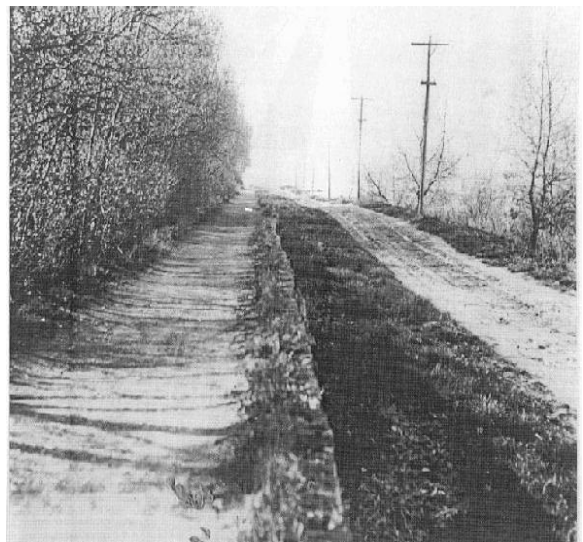
Figure 8: The Government Breakwater in 1909. The double rows of sheet piling are indicated by the line of trees on the left and the line between the light and dark ground in the middle.

| Table 2: Don Mouth Naturalization and Port Lands Flood Protection Project Archaeological Inventory: Summary of Features and Significance Evaluations | | | | | | | | | | | | |
|---|---|---|---|---|---|---|---|---|---|---|---|--|
| LDP-2 | Government Breakwater | <p>Built by the Dominion government in 1882 to prevent the movement of Ashbridge’s Bay into the harbour. The structure consisted of a double row of sheet piling, which served as retaining walls for rock fill. Heavy storms in the spring of 1882 caused such severe damage that the length of the piling had to be considerably increased. The work was completed in 1882-1883.</p> <p>The feature followed a curving line from the Don breakwater to Fisherman’s Island, bending west to the edge of the East Gap. The breakwater did not follow the natural line of the spit, though the top formed a dirt pathway that later supported the horse-drawn wagons, automobiles and the hydro lines of the local cottagers. The breakwater regularized a path system that had probably existed since earliest times.</p> <p>Under pressure to improve the sanitary conditions in Ashbridge’s Bay, the breakwater was breached in 1893, beginning implementation of a new plan for the whole marsh area put forward by City Engineer, E.H. Keating (Stinson 1990:9). The result was the Keating Channel.</p> <p>In areas, deeply buried remains of the structure may survive within the later fill deposits.</p> | 3 | 3 | 3 | 2 | 0 | — | 11 | Grade 2: Documentation during construction monitoring. | Deeply buried remains may survive, although not as a continuous feature. | |

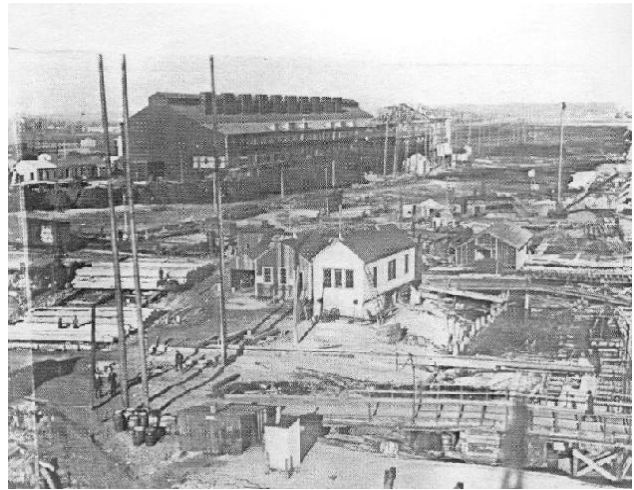
Figure 11: 1917 view of the British Forgings Plant.

The largest industrial complex to be developed within the Portlands area was that of British Forgings Limited, although it was a short-lived operation (Figure 11). It was the first large plant built on the land newly reclaimed from Ashbridge's Bay. It housed the largest electric steel plant in the world, and was constructed in the remarkably short time of six months. Work began in February 1917 on a 127-acre site to build the steel mill to produce forgings from scrap steel for the war effort. Steel production commenced in August, and the company produced 9,000 tons per month until the end of the war. The plant closed at the end of the war, but was reopened by Welsh steel company Baldwins Ltd. in 1919. Although Baldwins added

| Table 2: Don Mouth Naturalization and Port Lands Flood Protection Project Archaeological Inventory: Summary of Features and Significance Evaluations | | | | | | | | | | | | |
|---|---|---|---|---|---|---|---|---|---|---|---|--|
| LDP-8 | British Forgings | <p>Construction of the plant required that 10 feet of fill be added to the site to raise the grade above the height achieved during the pre-war filling program. Thousands of foundation piles for the structures were driven eight feet below the finished grade to support the concrete foundations of the buildings. There is an extensive photographic record of the site (Stinson 1990), which vividly conveys the massive size of the steel works, however, mapping of the layout of the complex was not located during this study. A few “ruins” are depicted on the 1931 <i>Goad’s Atlas</i> maps of the area.</p> <p>Stinson (1990) noted that the foundations of many of the buildings remain buried on the site and recommended that these remains be exposed and preserved for interpretation. This recommendation was reiterated in the 2003 <i>Stage 1 Archaeological Assessment of East Bayfront, West Donlands and Portlands Areas</i> (ASI and HRL 2004), wherein it was noted that such work need not be accompanied by archaeological investigation.</p> | 2 | 2 | 3 | 3 | 0 | — | 10 | Grade 3: No archaeological action required. | Foundations may remain. Previous studies have recommended that these be exposed for interpretation. Such work need not be accompanied by archaeological investigation. | |
