Toronto Islands Flood Characterization and Risk Assessment Project

Flood Risk Assessment Report

30 April 2019 | 13017.101.R2.Rev0_FloodRisk

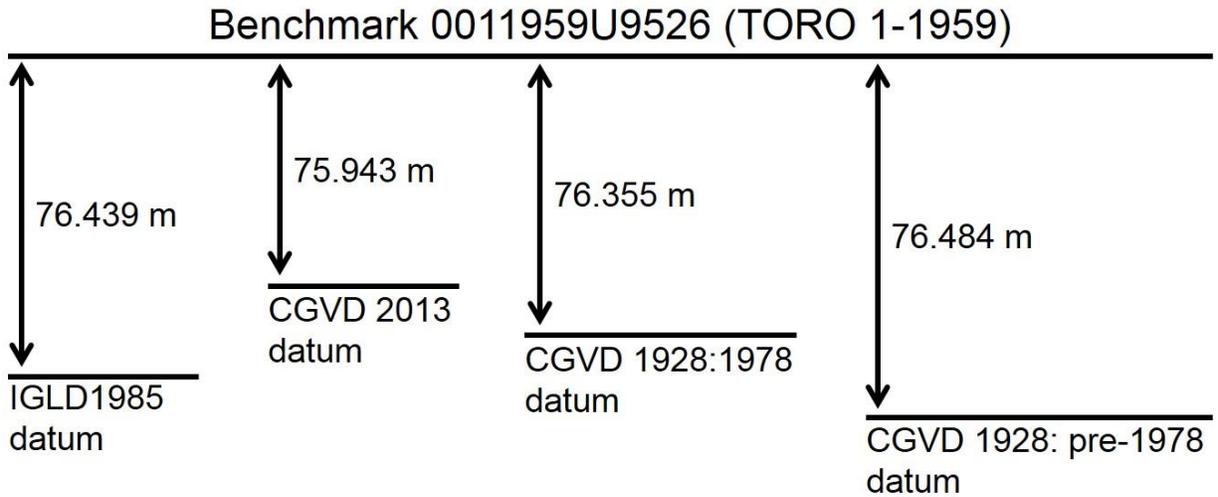
Figure 1.1: Elevation of the Toronto Harbour Gaugehouse Benchmark

Unless otherwise noted, all water levels are reported in International Great Lakes Datum 1985 (IGLD85). IGLD85 is 8.4 cm below Canadian Geodetic Vertical Datum 1928-1978 Ontario Adjusted Version (CGVD 1928:1978), and 49.6 cm below Canadian Geodetic Vertical Datum 2013 (CGVD 2013) at the Canadian Hydrographic Service benchmark 0011959U9526 (also known as 00159U9526, 59U9526, and TORO 1-1959). The benchmark is located at the Toronto Harbour Gaugehouse at the south side of Queen's Quay. The elevation of the benchmark relative to the different datums is shown in Figure 1.1.

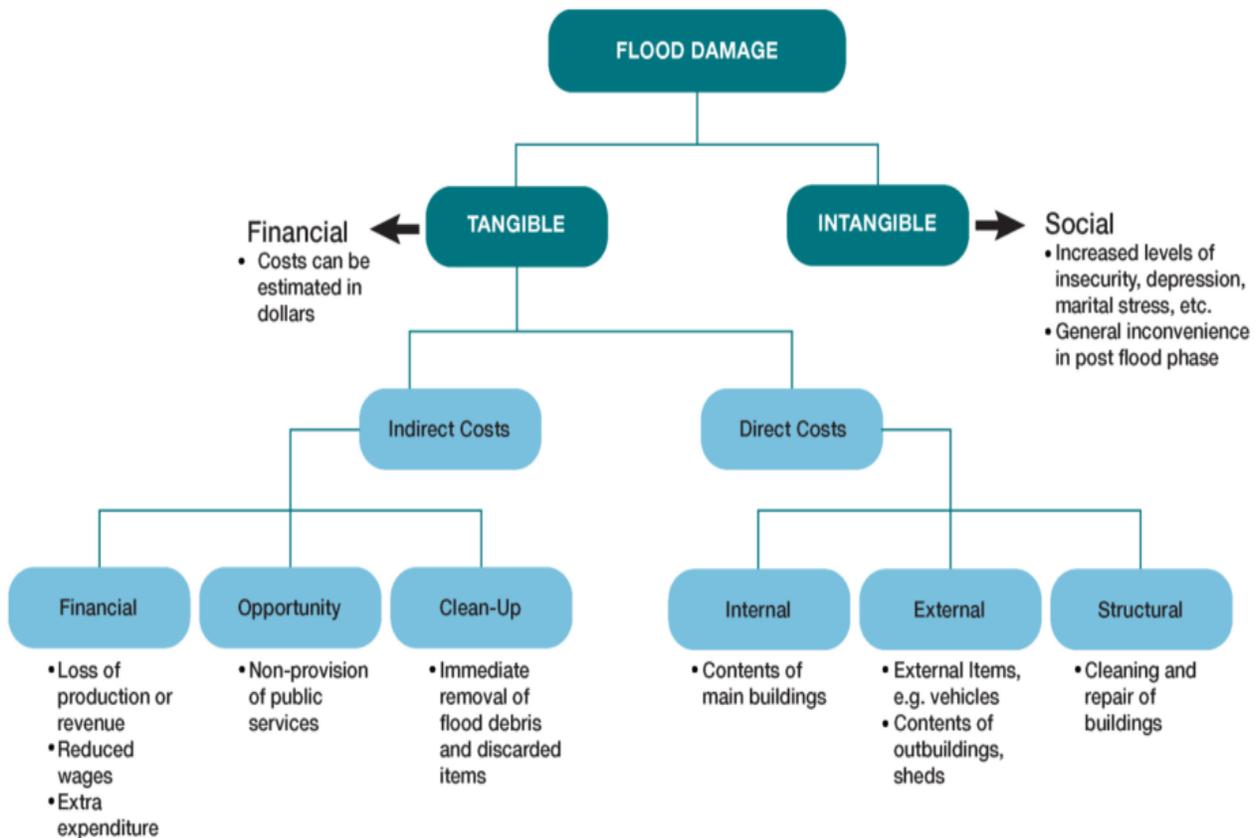
Figure 2.1: Classification of Flood Damages (from NRCAN, 2017)

The types of damages resulting from a flood can be categorized as either tangible or intangible. Tangible damages are financial damages that result from damages to property and other costs that were incurred because of the flood. Intangible damages are non-financial damages and include social, environmental and health impacts. The different types of flood damages, and terminology used in this report, are outlined in Figure 2.1.

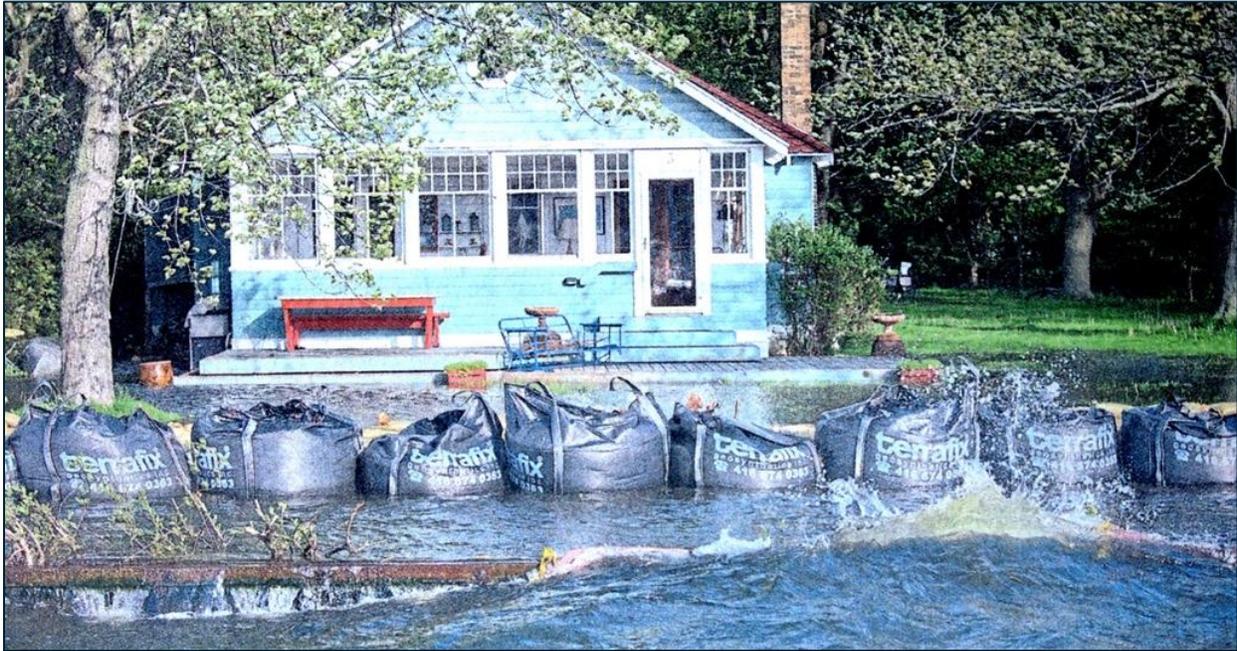
Figure 3.1: Photograph of Wave Overtopping of Algonquin Island Seawall in 2017

Toronto Island Park was closed between May 4 and July 30, 2017 as a result of the high water levels in Lake Ontario (City of Toronto, 2018a). Flooding on Toronto Islands was due to a high water table, which resulted in flooding of crawlspaces and basements in many homes. Wave overtopping at Algonquin Island and heavy rainfall contributed to localized flooding and ponding of water (see Figure 3.1).

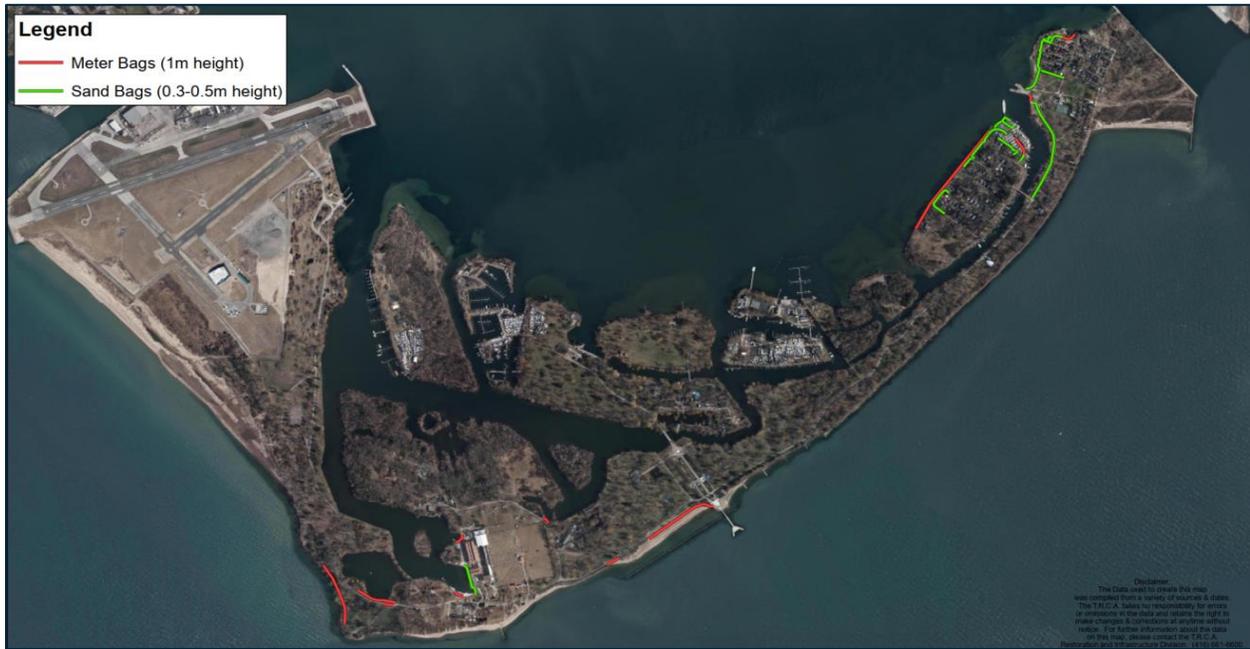
Figure 3.2: Map of Sandbag Locations during 2017 Flood

The City also deployed over 15 high-discharge trash pumps at key locations on the islands (mostly on Algonquin and Ward's Islands) to lower surface water levels from high precipitation and saturated ground conditions. Municipal assets such as sewage pumping stations and electrical transformers were also sandbagged for protection and were under constant surveillance by City personnel. A map showing the locations of sandbags across Toronto Islands and a photograph showing typical conditions are provided in Figure 3.2 and Figure 3.3.

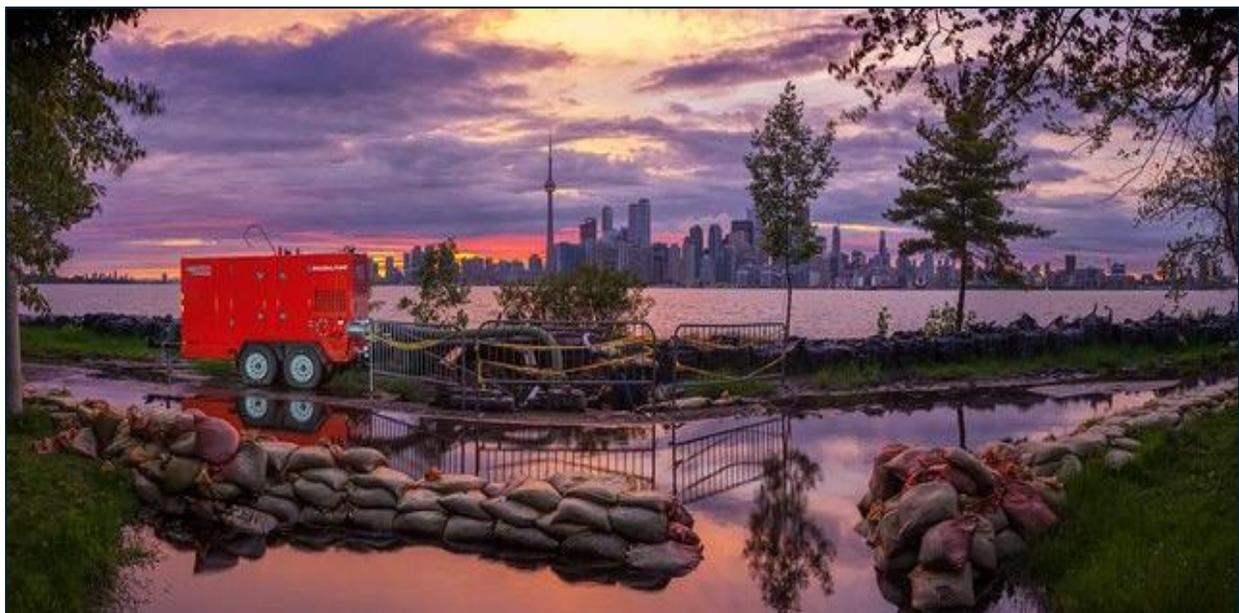
Figure 3.3: Photograph of Sandbags and High-Discharge Pump on Algonquin Island

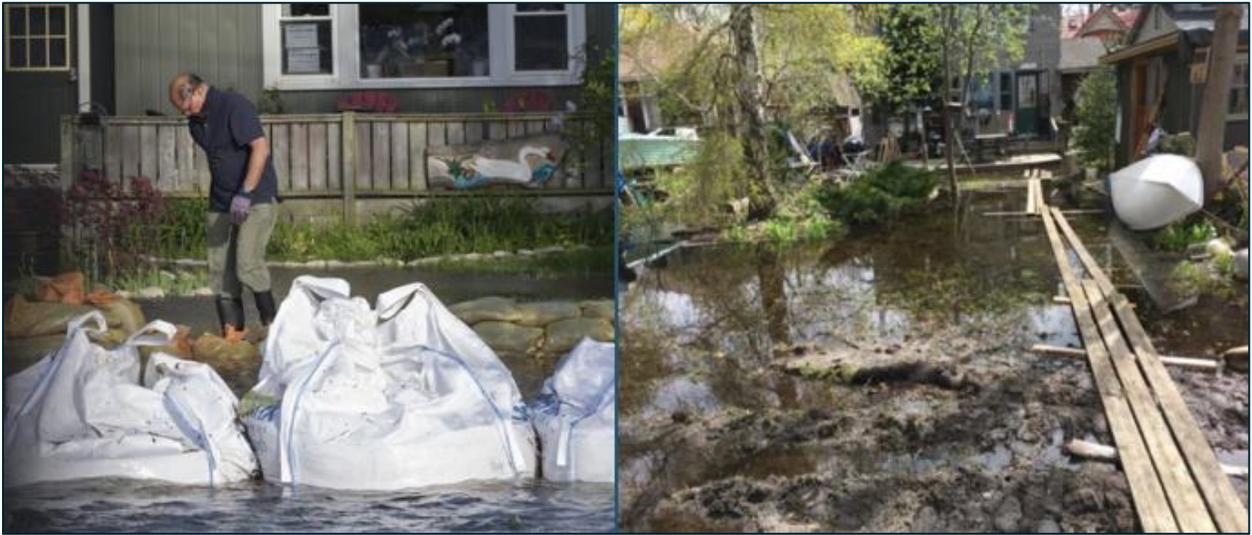
Figure 3.4: Photographs of Flooded Yards in 2017 (from Toronto Star, 2017; and French, 2017)

Residents and business owners also took actions to mitigate the flooding effects on their properties and businesses. Many installed sandbags around their properties or along the streets. Many people purchased small pumps to drain their yards and crawlspaces or basements. Some dug trenches or swales on their property to direct surface water to smaller pumps, or along streets to municipal pumps. Many homes and businesses had saturated or flooded yards and placed wood planks, soil, or wood chips to raise the local grade and to maintain access to their homes. These conditions and mitigation efforts are shown in Figure 3.4.

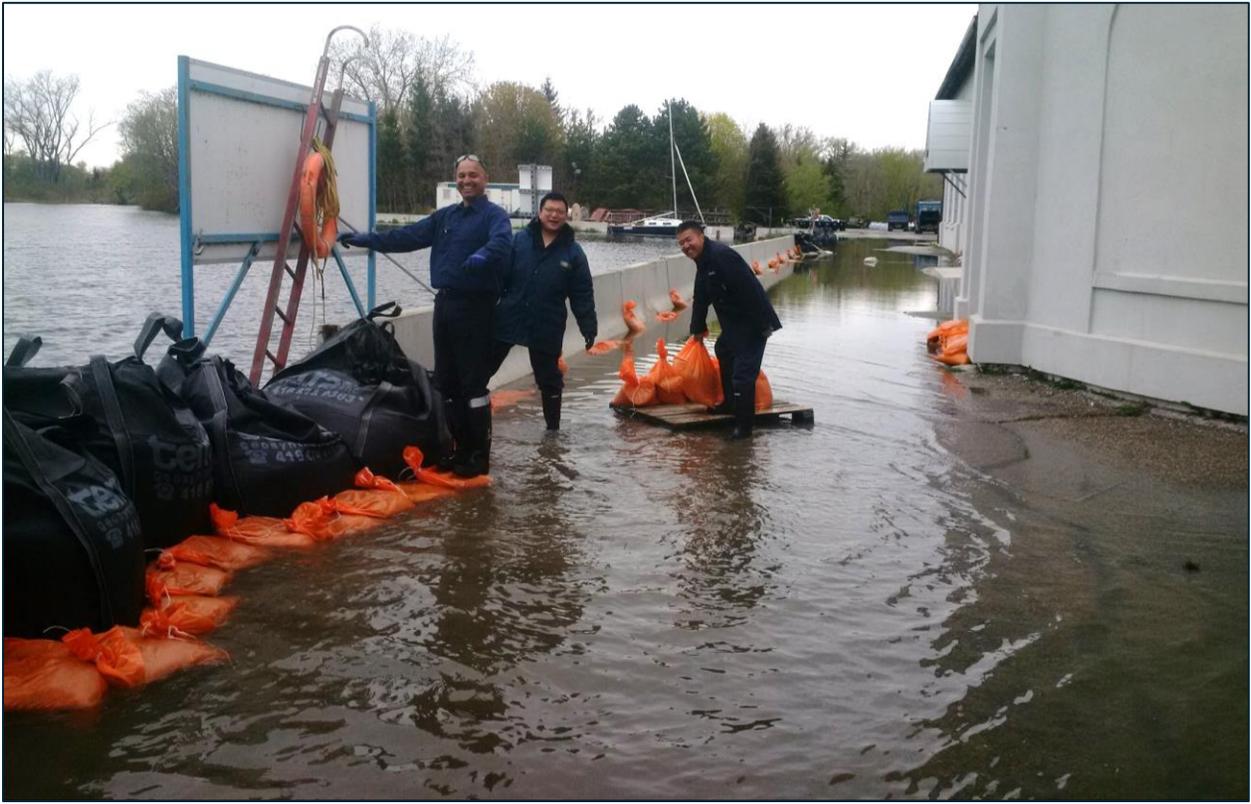
Figure 3.14: Photograph of Toronto Island Water Treatment Plant (May 19, 2017 by Niall Robertson)

Baird discussed the impacts of the flooding with Niall Robertson (Manager of the Island Water Treatment Plant). When the flooding occurred, the access road was scheduled to be resurfaced and the works were delayed until water levels subsided. The water treatment plant buildings suffered no damage, however staff were not able to access the facility by road due to flooding. This required the treatment plant to hire a water taxi to transport staff (and other persons) between the facility and Ward's Island Ferry dock. The costs for the water taxi were approximately \$10,000. A photo of the loading dock at the Island Water Treatment Plant taken on May 19, 2017 is shown in Figure 3.14.

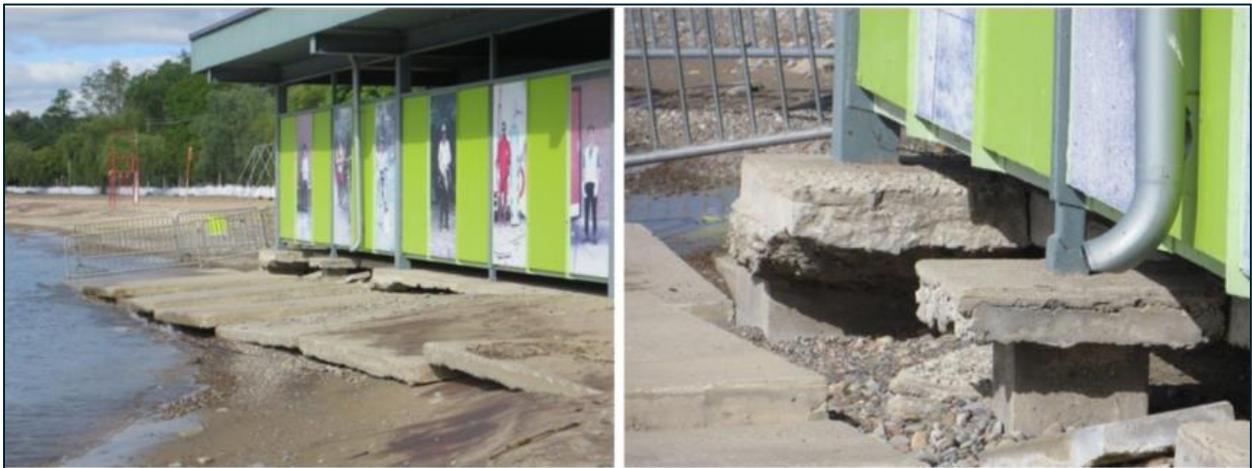
Figure 3.15: Photograph of Damage to Centre Island Washroom & Bathing Station (from City of Toronto, 2018a)

The City and TRCA assessed the damages caused by the flood. The review identified 74 instances of damage across the Toronto waterfront (e.g. structural damage, flooding, and erosion). Examples of the damages at Toronto Islands include damage to the Centre Island Washroom & Bathing Station and Grandstand (see Figure 3.15 and Figure 3.16). The City projected that \$7.4M will be required to repair and protect damaged infrastructure across the Toronto waterfront (e.g. install permanent pumping facilities on the islands, install beach curbs at select locations to prevent shoreline degradation, etc.)

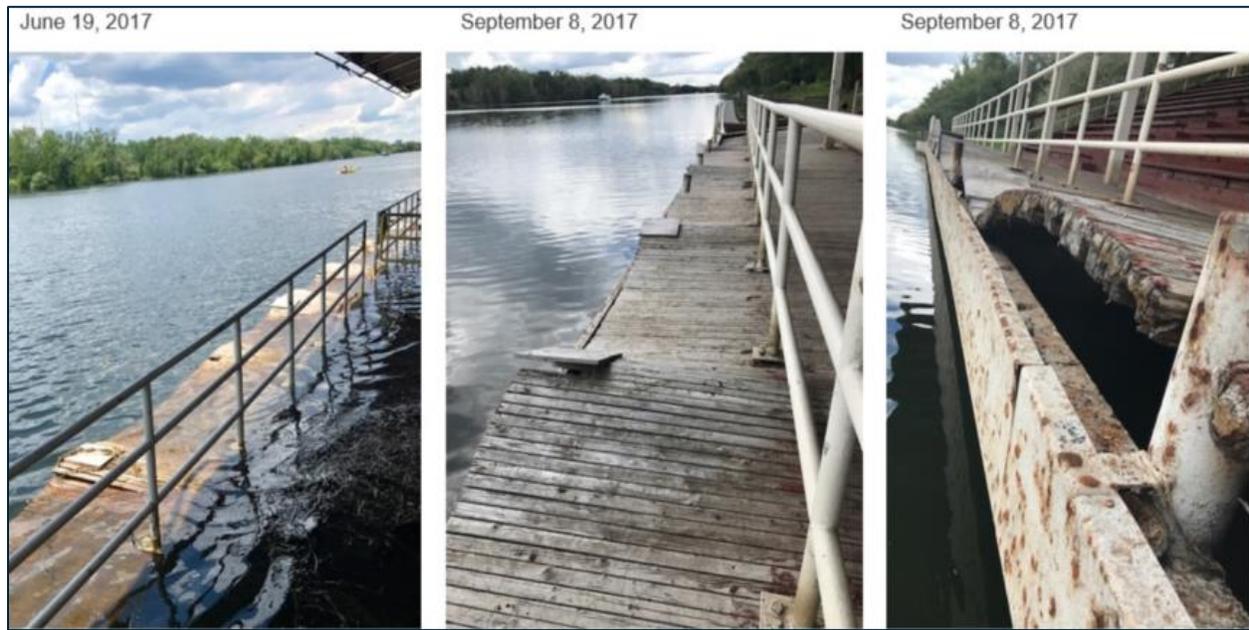
Figure 3.16: Photograph of Damage to Centre Island Grandstand (from City of Toronto, 2018a)

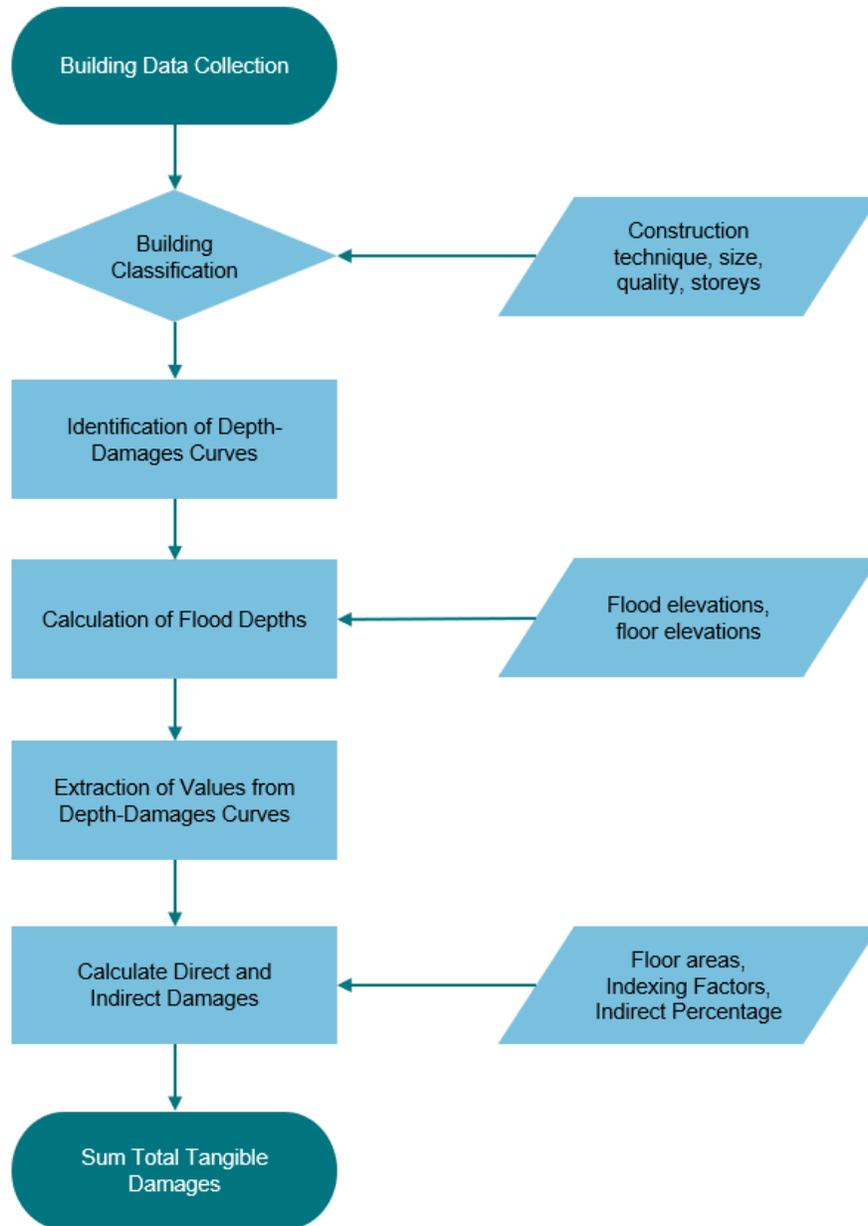
Figure 4.3: Generalized Procedure for Calculation of Residential Total Tangible Damages

damage cost per square metre of floor area is determined. The direct damage unit rate is multiplied by the total floor area to estimate the total direct damages to the building. Indirect damages and indexing (region and year) are then applied as markups to arrive at total tangible damages.

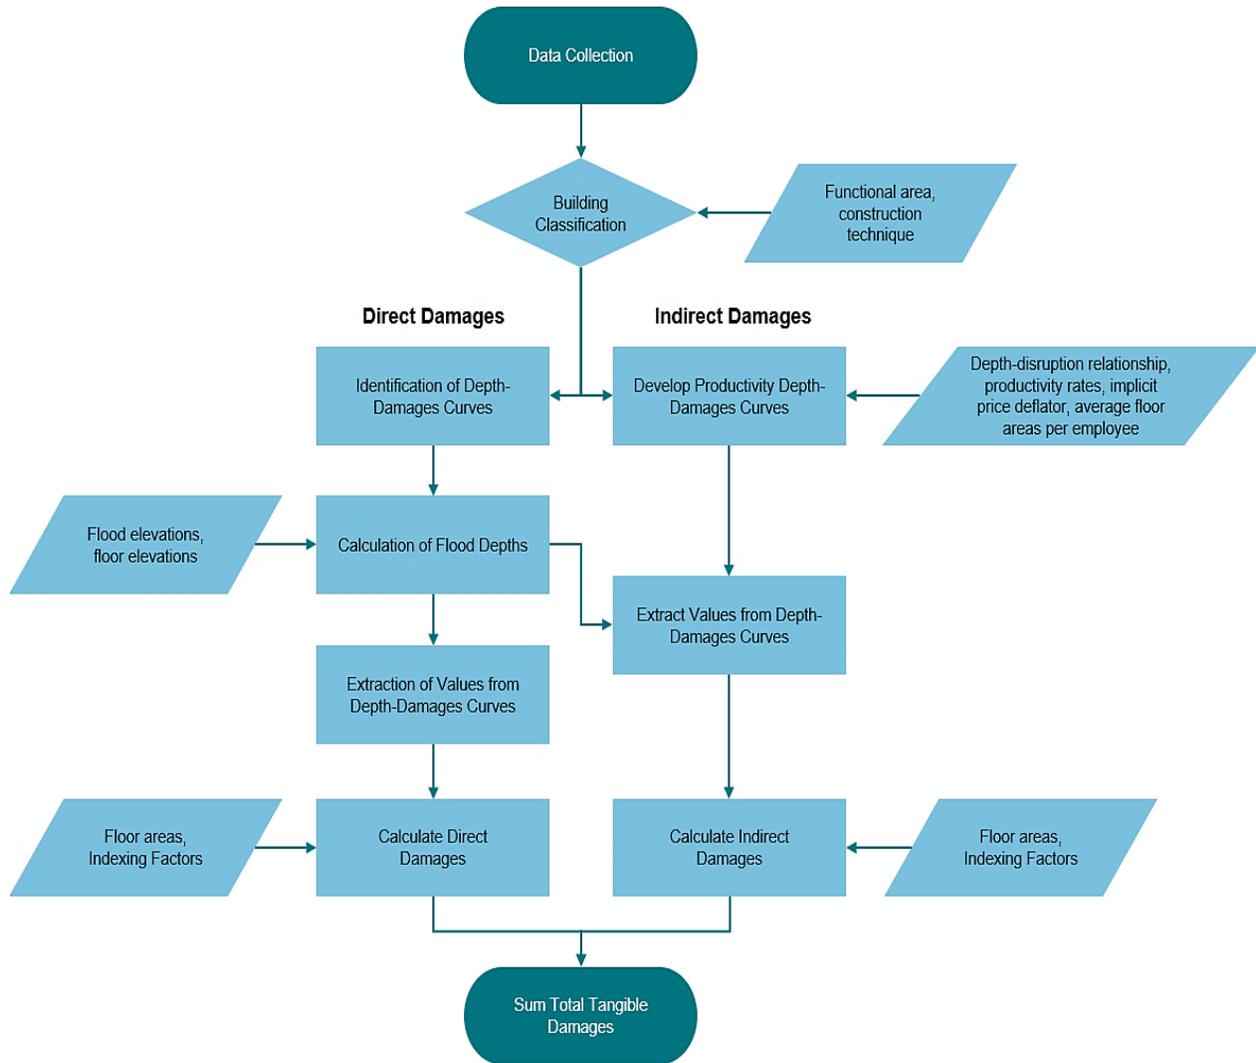
Figure 4.4: Generalized Procedure for Calculation of Non-residential Total Tangible Damages

using productivity depth-damage curves which must be developed using the methodology in NRCAN (2017). These can then be applied in a similar manner using flood elevations, floor elevations, floor areas and indexing factors.

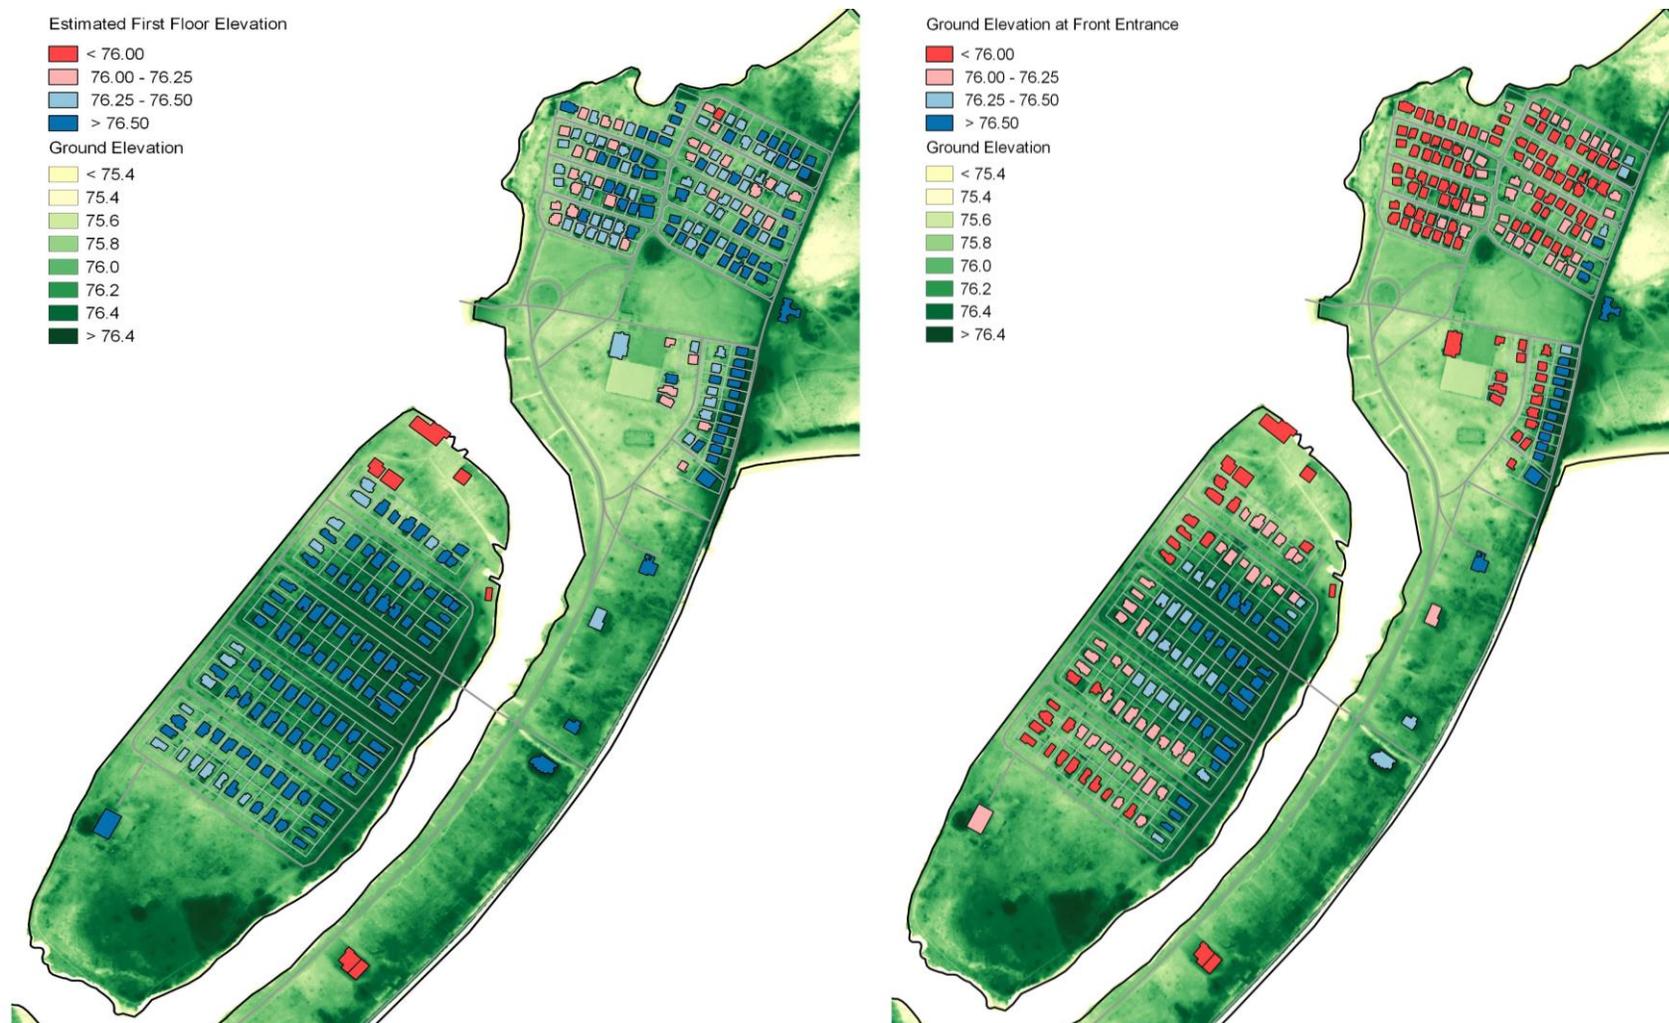
Figure 5.15: Estimated First Floor Elevation (left) and Ground Elevation at Front Entrance (right) on Algonquin and Ward's Island

¹ The minimum floodproofing standard elevation as required by provincial policy for development and site alternation within the flooding hazard limit is the 100 year monthly mean lake level plus the 100 year wind setup plus a flood allowance for wave uprush and other water related hazards.

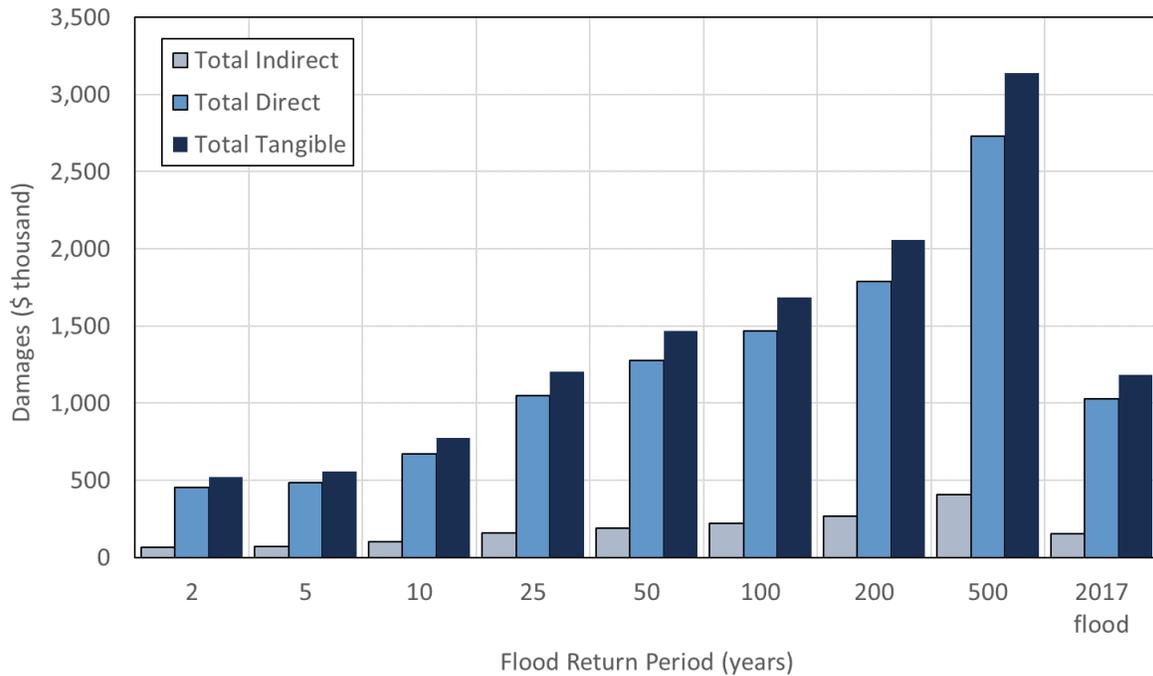
Figure 6.1: Calculated Direct, Indirect and Total Tangible Damages for Different Flood Return Periods

Figure 6.1 shows the calculated total direct, total indirect, and total tangible damages for all residential buildings for all flood return periods, as well as the 2017 flood level. Total residential damages range from \$0.5M at the 2-year flood to \$3.1M at the 500-year flood.

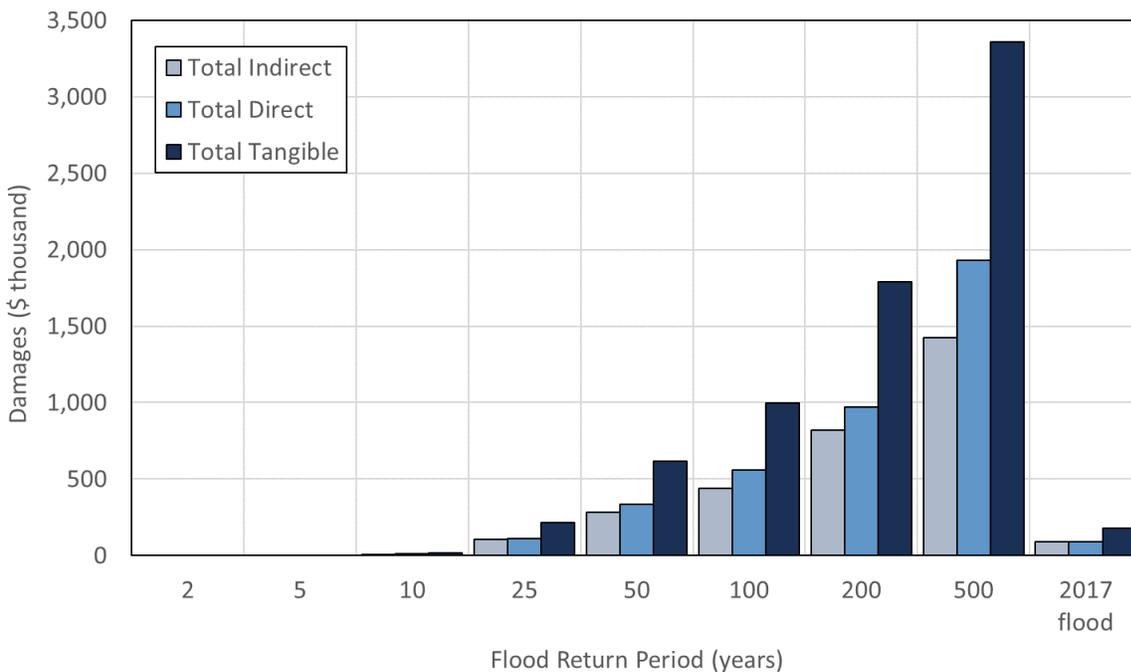
Figure 6.5: Calculated Non-residential Direct, Indirect and Total Tangible Damages

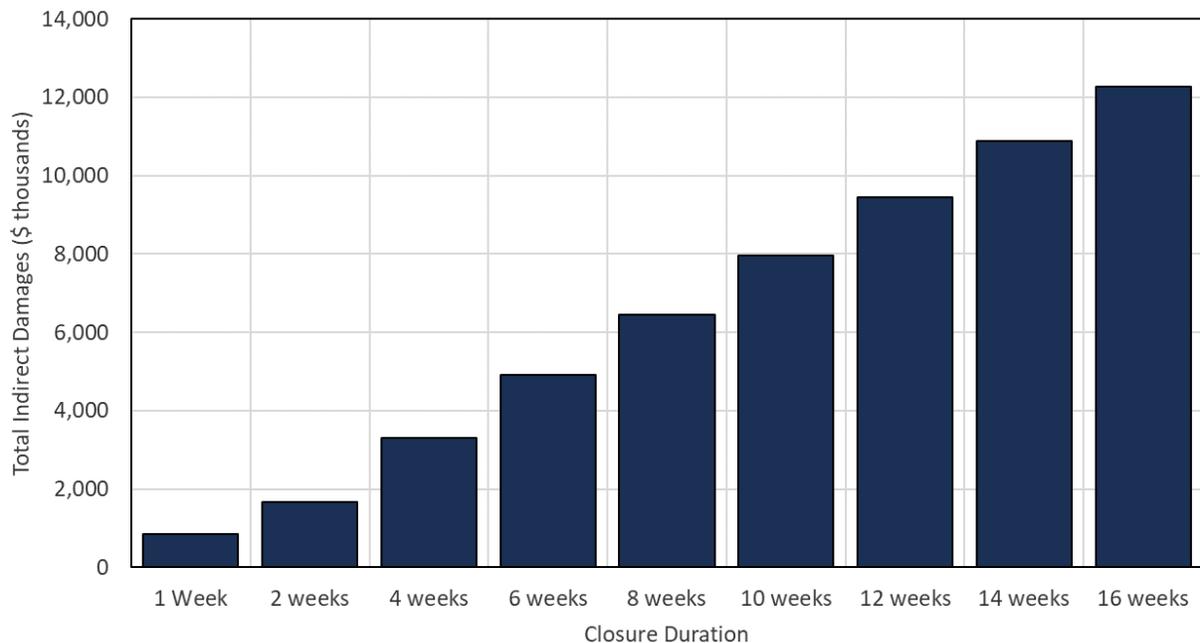
Figure 6.6: Estimated Non-Residential Indirect Damages Resulting from Closure of Toronto Island Park

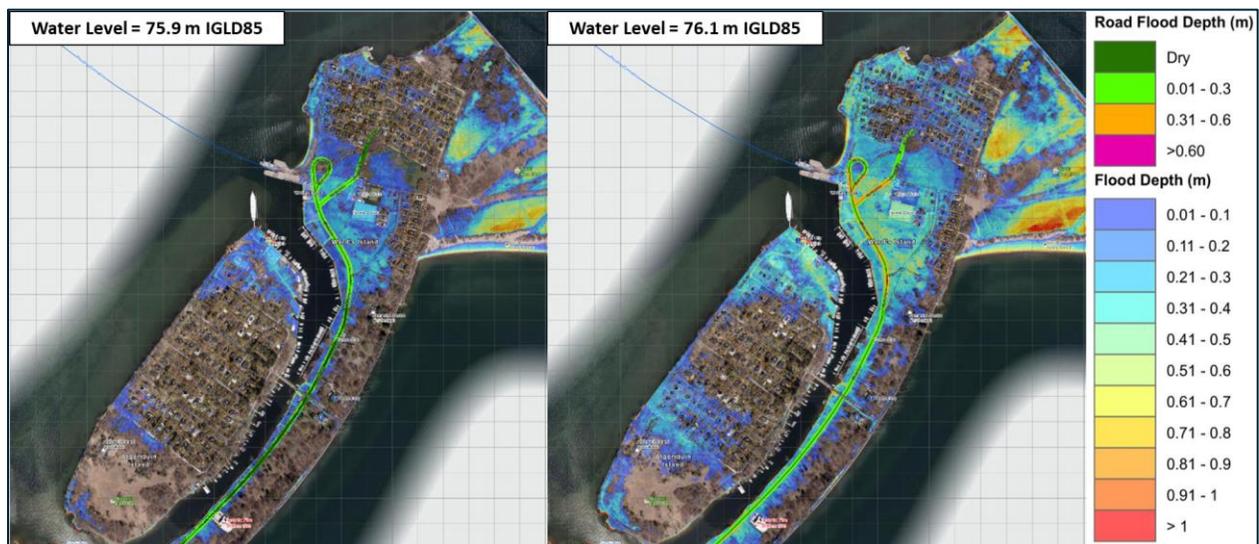
Figure 6.7: Floodwater Depths in Residential Areas at 75.9 m (left) and 76.1 m (right)

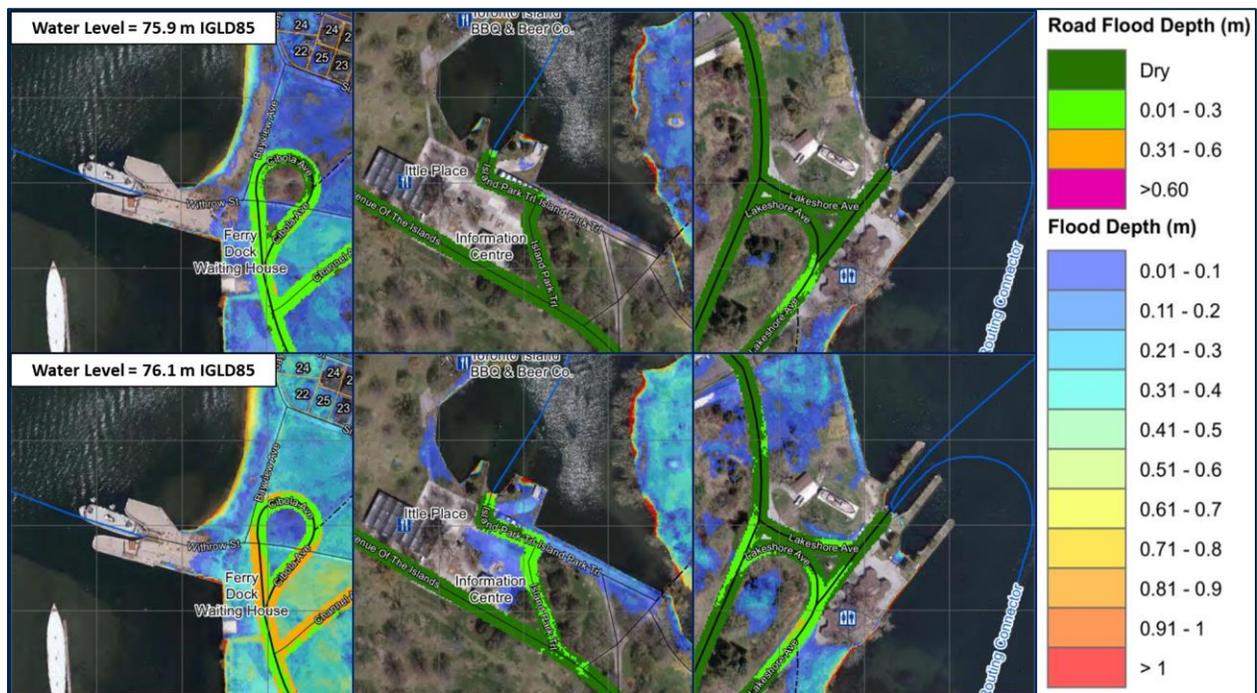
Figure 6.8: Floodwater Depths at Ward’s Island Ferry Dock (left), Centre Island Ferry Dock (middle) and Hanlan’s Point Ferry Dock (right) at 75.9 m (top) and 76.1 m (bottom)

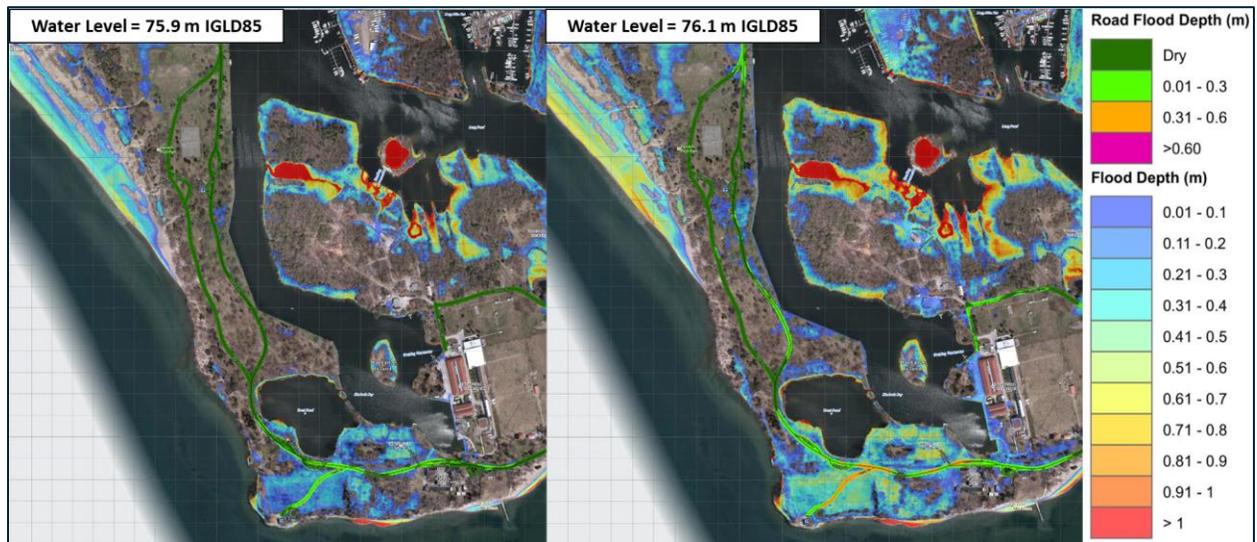
Figure 6.10: Floodwater Depths at Gibraltar Point at 75.9 m (left) and 76.1 m (right)

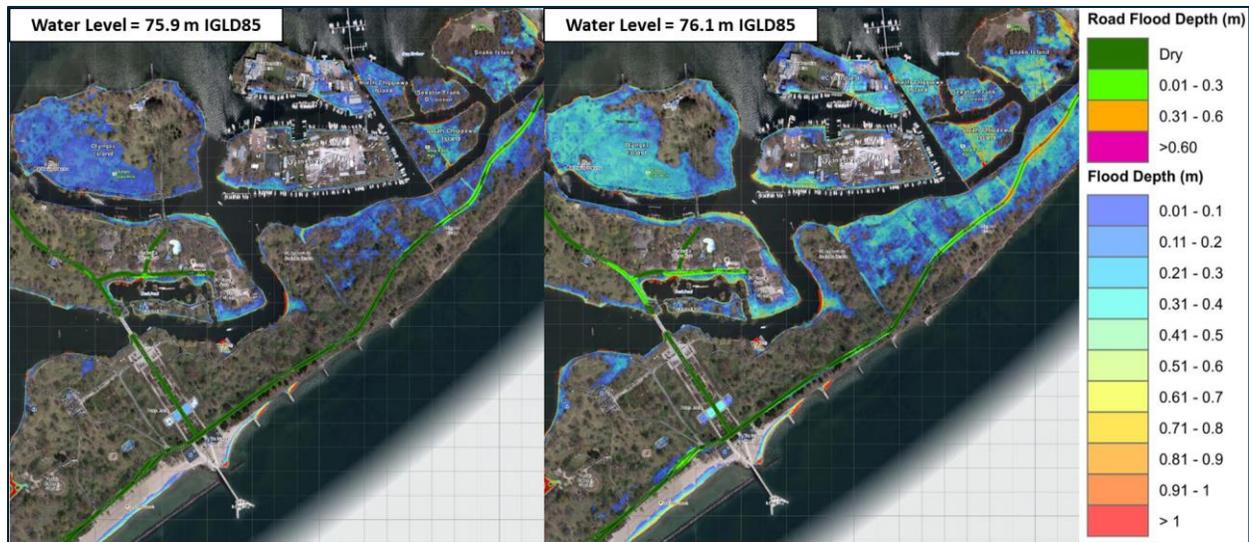
Figure 6.11: Flooding in Central Area of Toronto Islands at 75.9 m (left) and 76.1 m (right)

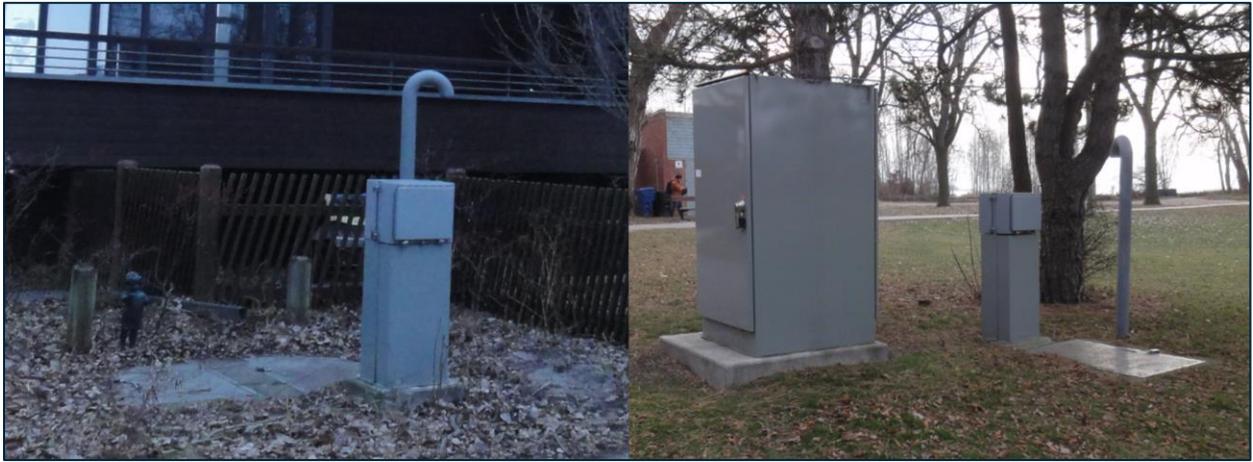
Figure 6.12: Examples of a Sewage Pump Station and an Electrical Transformer on Ward's Island

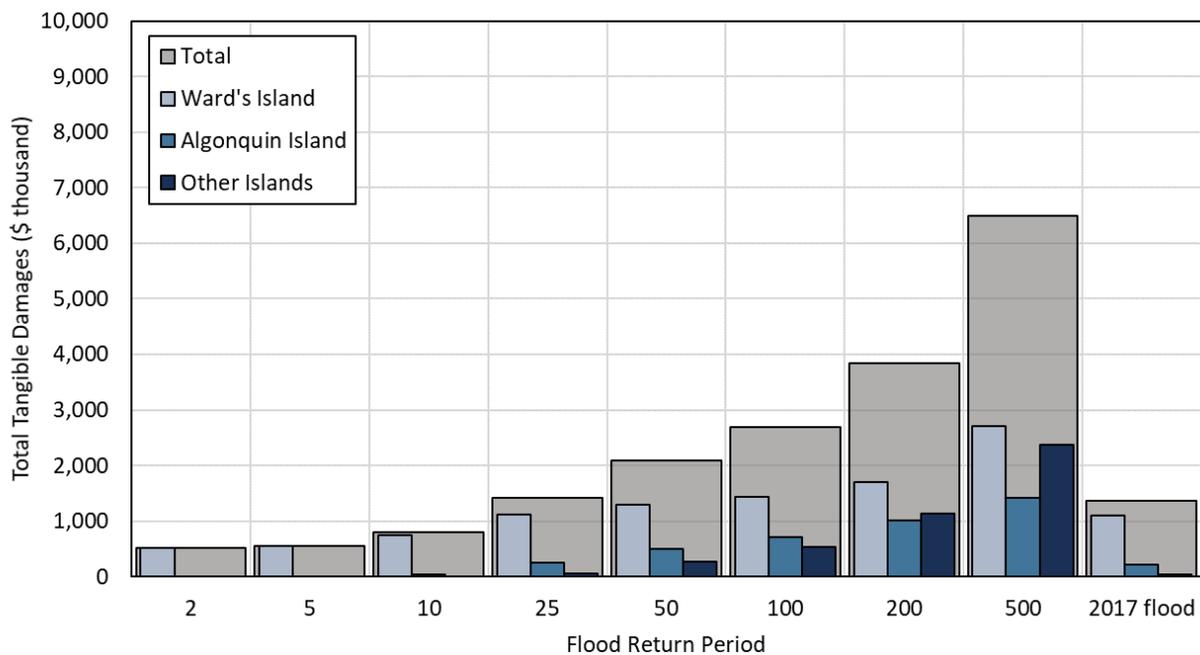
Figure 6.13: Total Tangible Damages for Different Flood Return Periods

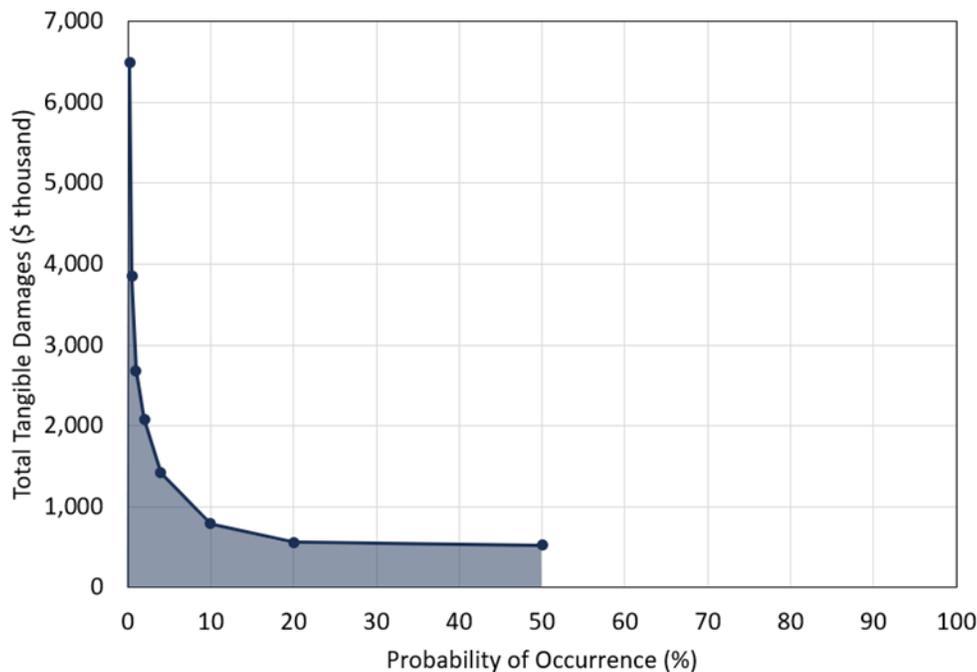
Figure 6.14: Total Tangible Damages vs. Probability Curve for Different Return Periods

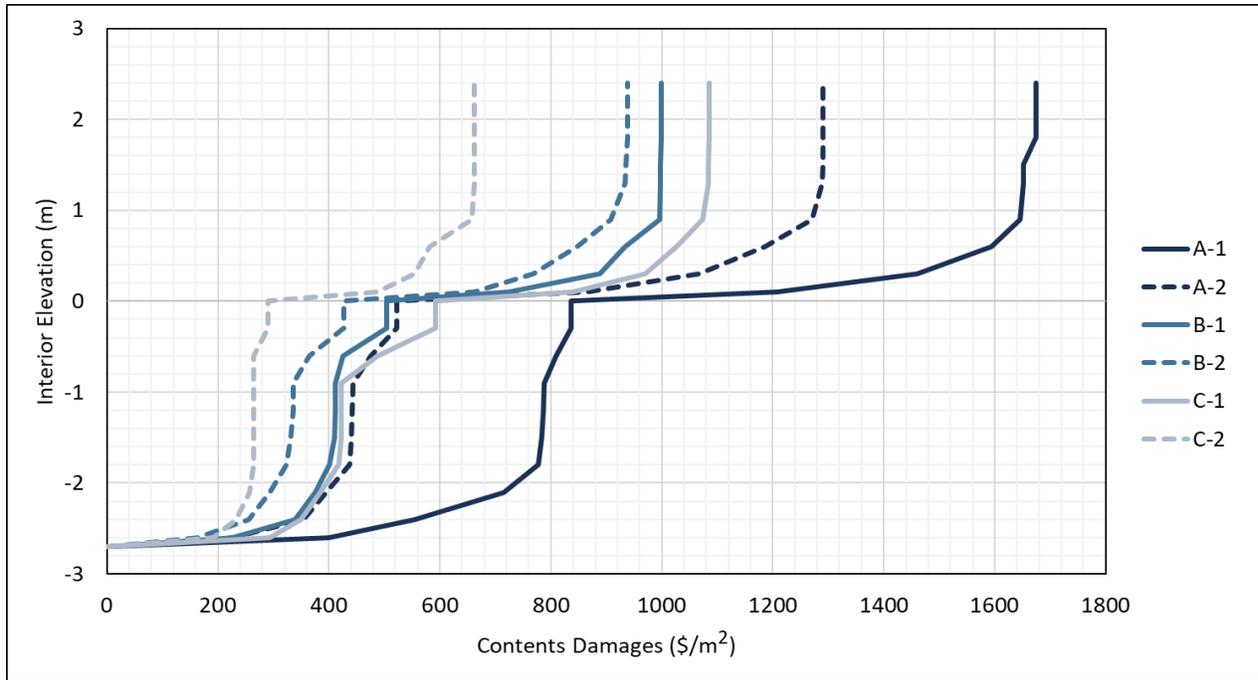
Figure C.1: Residential Contents Depth-Damages Curves (adapted from IBI Group, 2015)

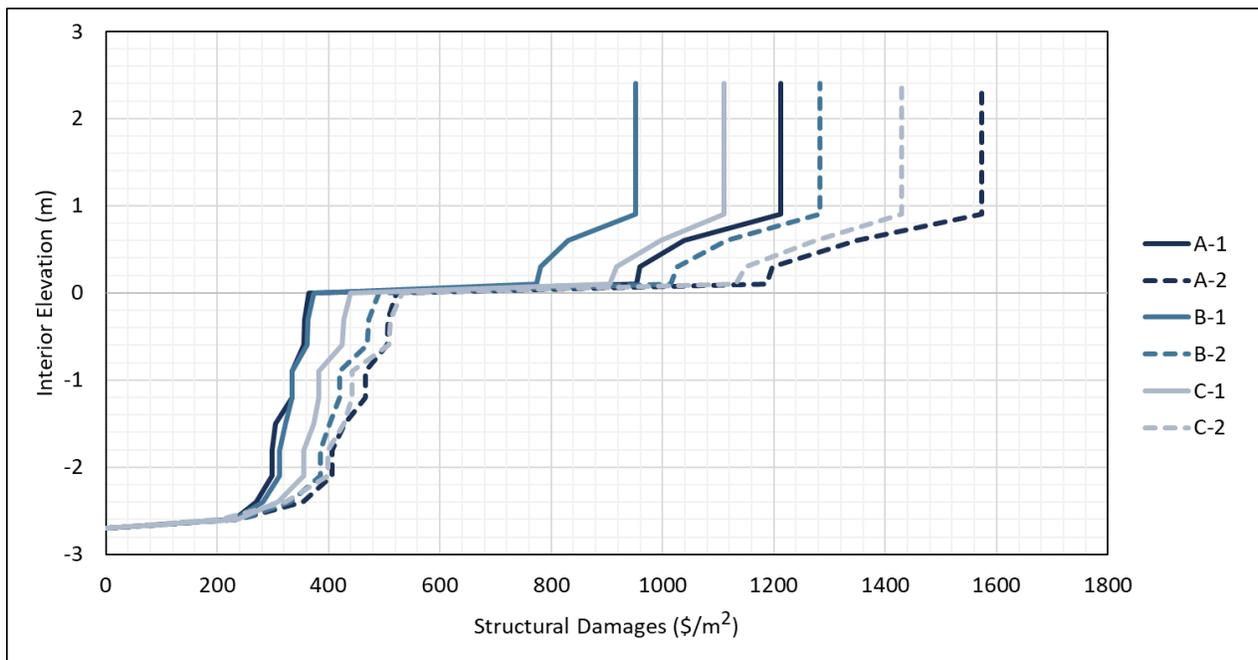
Figure C.2: Residential Structural Depth-Damages Curves (adapted from IBI Group, 2015)

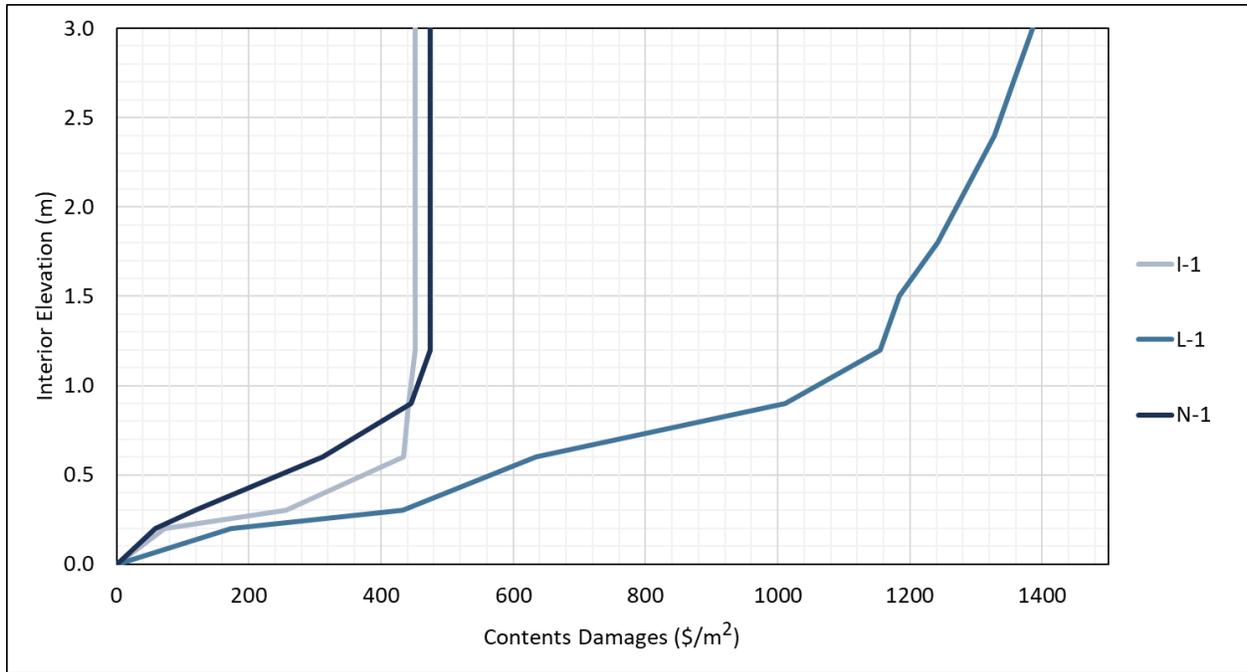
Figure C.3: Non-residential Contents Depth-Damages Curve (adapted from IBI Group, 2015)
