Toronto Islands Flood Characterization and Risk Assessment Project

Flood Risk Assessment Report

30 April 2019 | 13017.101.R2.Rev0_FloodRisk

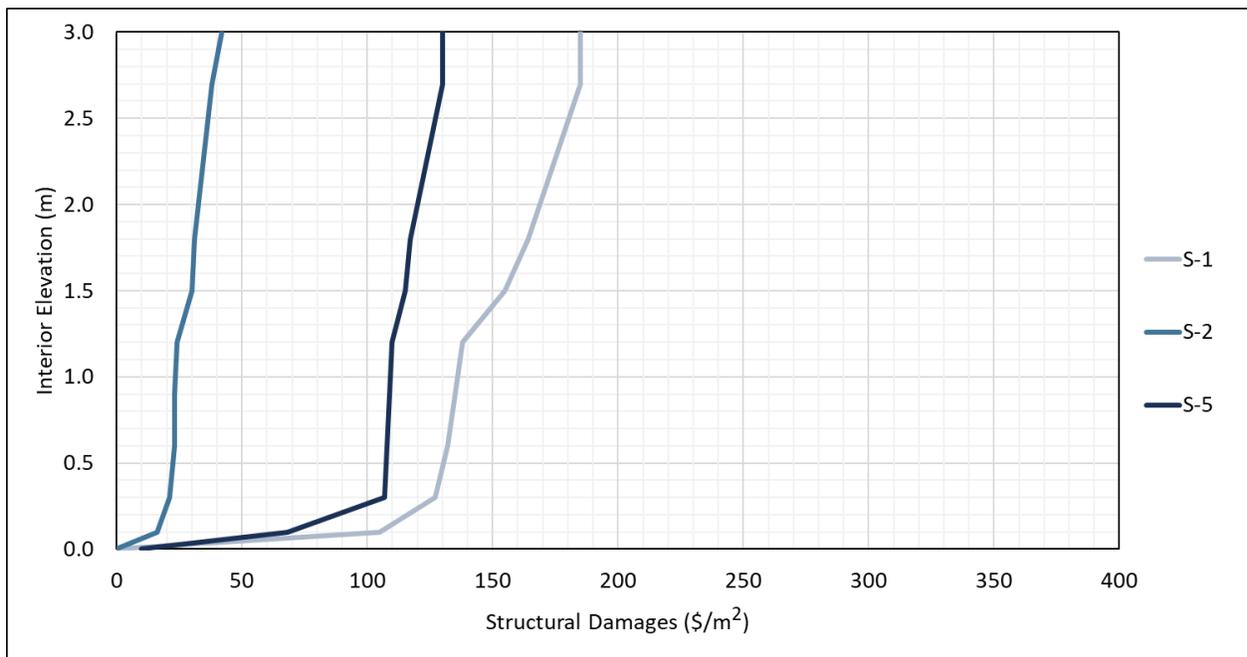
Figure C.4: Non-residential Structural Depth-Damages Curves (adapted from IBI Group, 2015)

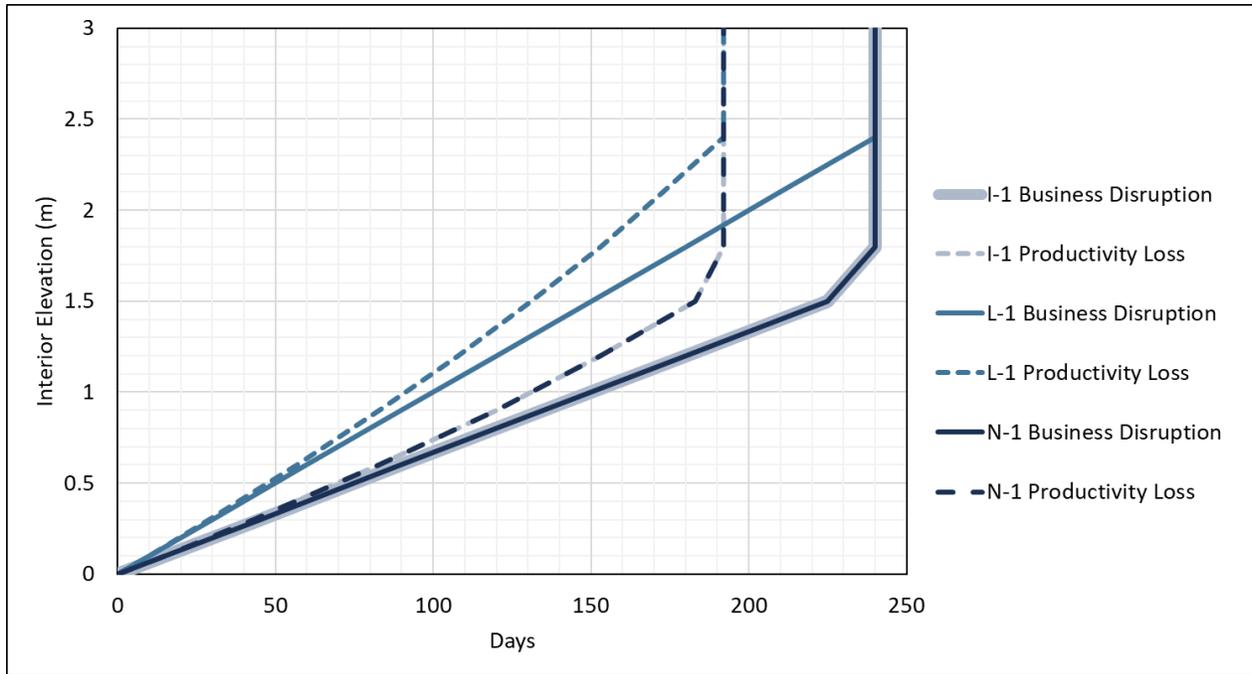
Figure C.5: Non-Residential Days of Business Disruption and Productivity Loss

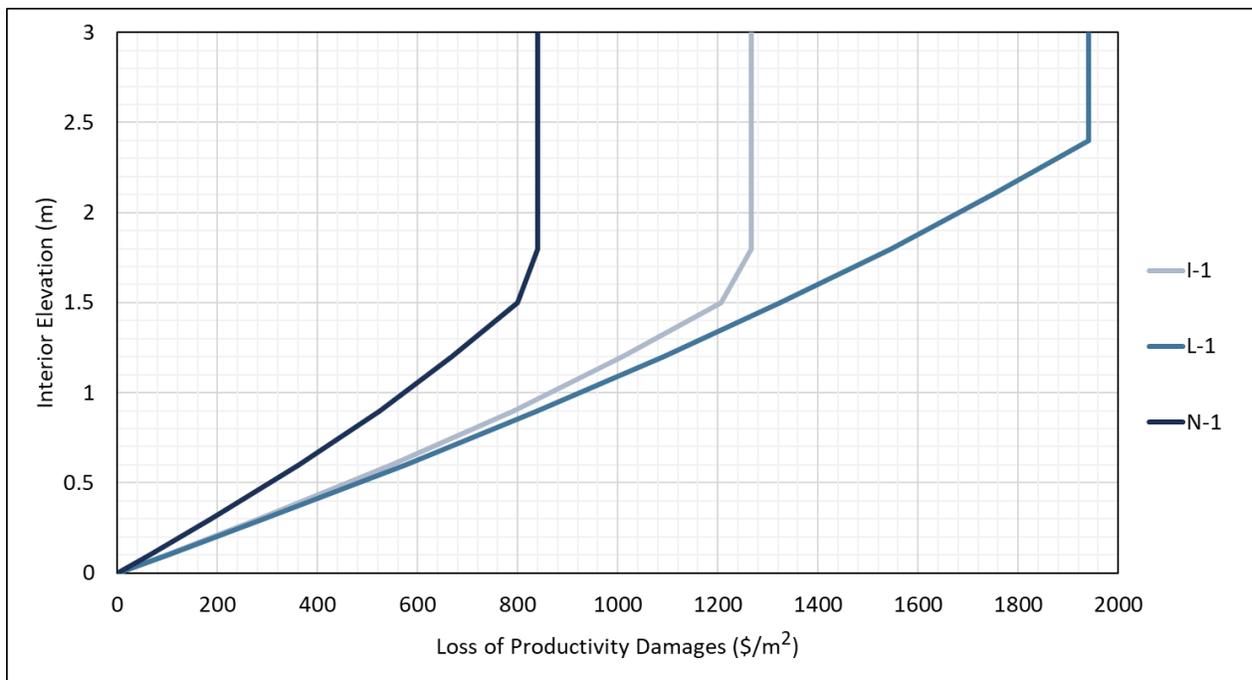
Figure C.6: Non-Residential Productivity Loss Depth-Damages Curves
