**TORONTO AND REGION CONSERVATION
AUTHORITY**

**Conservation Ontario Class
Environmental Assessment for the
Rehabilitation of the Pickering and Ajax
Flood Control Dykes**

Environmental Study Report

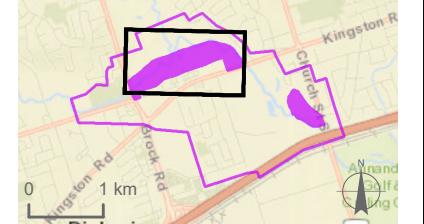
Dyke Erosion Risk: Pickering Dyke

NOTES:
 (1) 1981 and 2002 channel delineation were excluded from figure for ease of interpretation.
 (2) Base imagery (2018) provided by TRCA web map service.

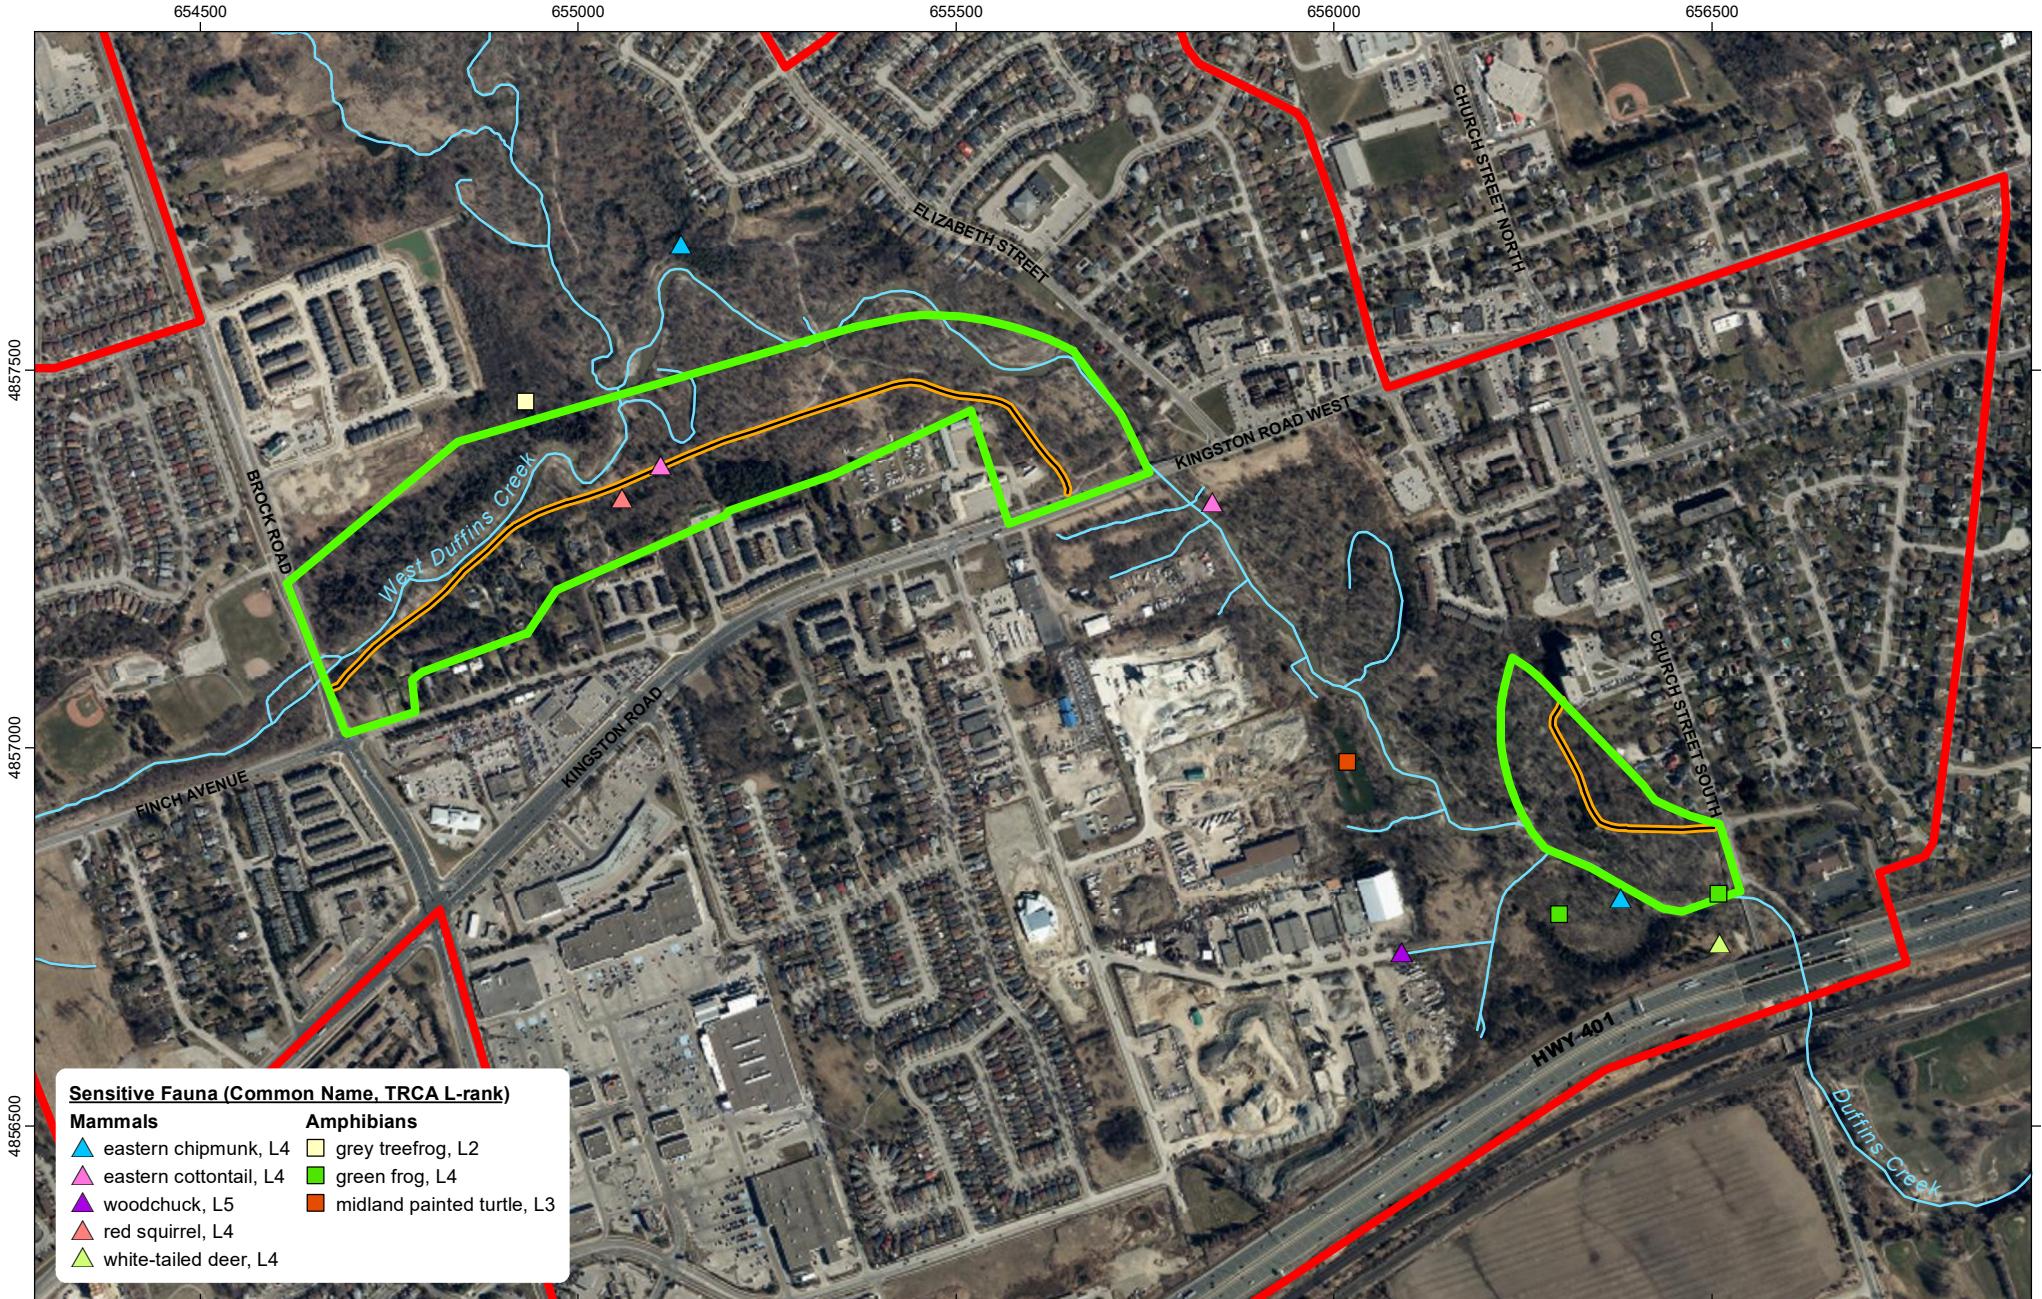
Figure 3-12

**Terrestrial Resources
– Breeding Birds**

The West Duffins and Duffins Creeks are considered Urban River Valleys that connect the Greenbelt Plan area north of Pickering/Ajax to Lake Ontario. Due to the presence of water and a variety of treed habitats, these areas provide a wildlife corridor for a variety of species moving between these two areas (Figures 3-12 and 3-13).

The TRCA recorded 37 bird species during their 2019 field visits in the Project Study Area. Of the 38 species, three (3) were considered exotic species (L+) and 19 were considered ‘not of concern’ (L5). The L3 and L4 species are listed in Table 3-9. Bird species with a breeding status of ‘probable’ or ‘confirmed’ are shown on Figure 3-12.

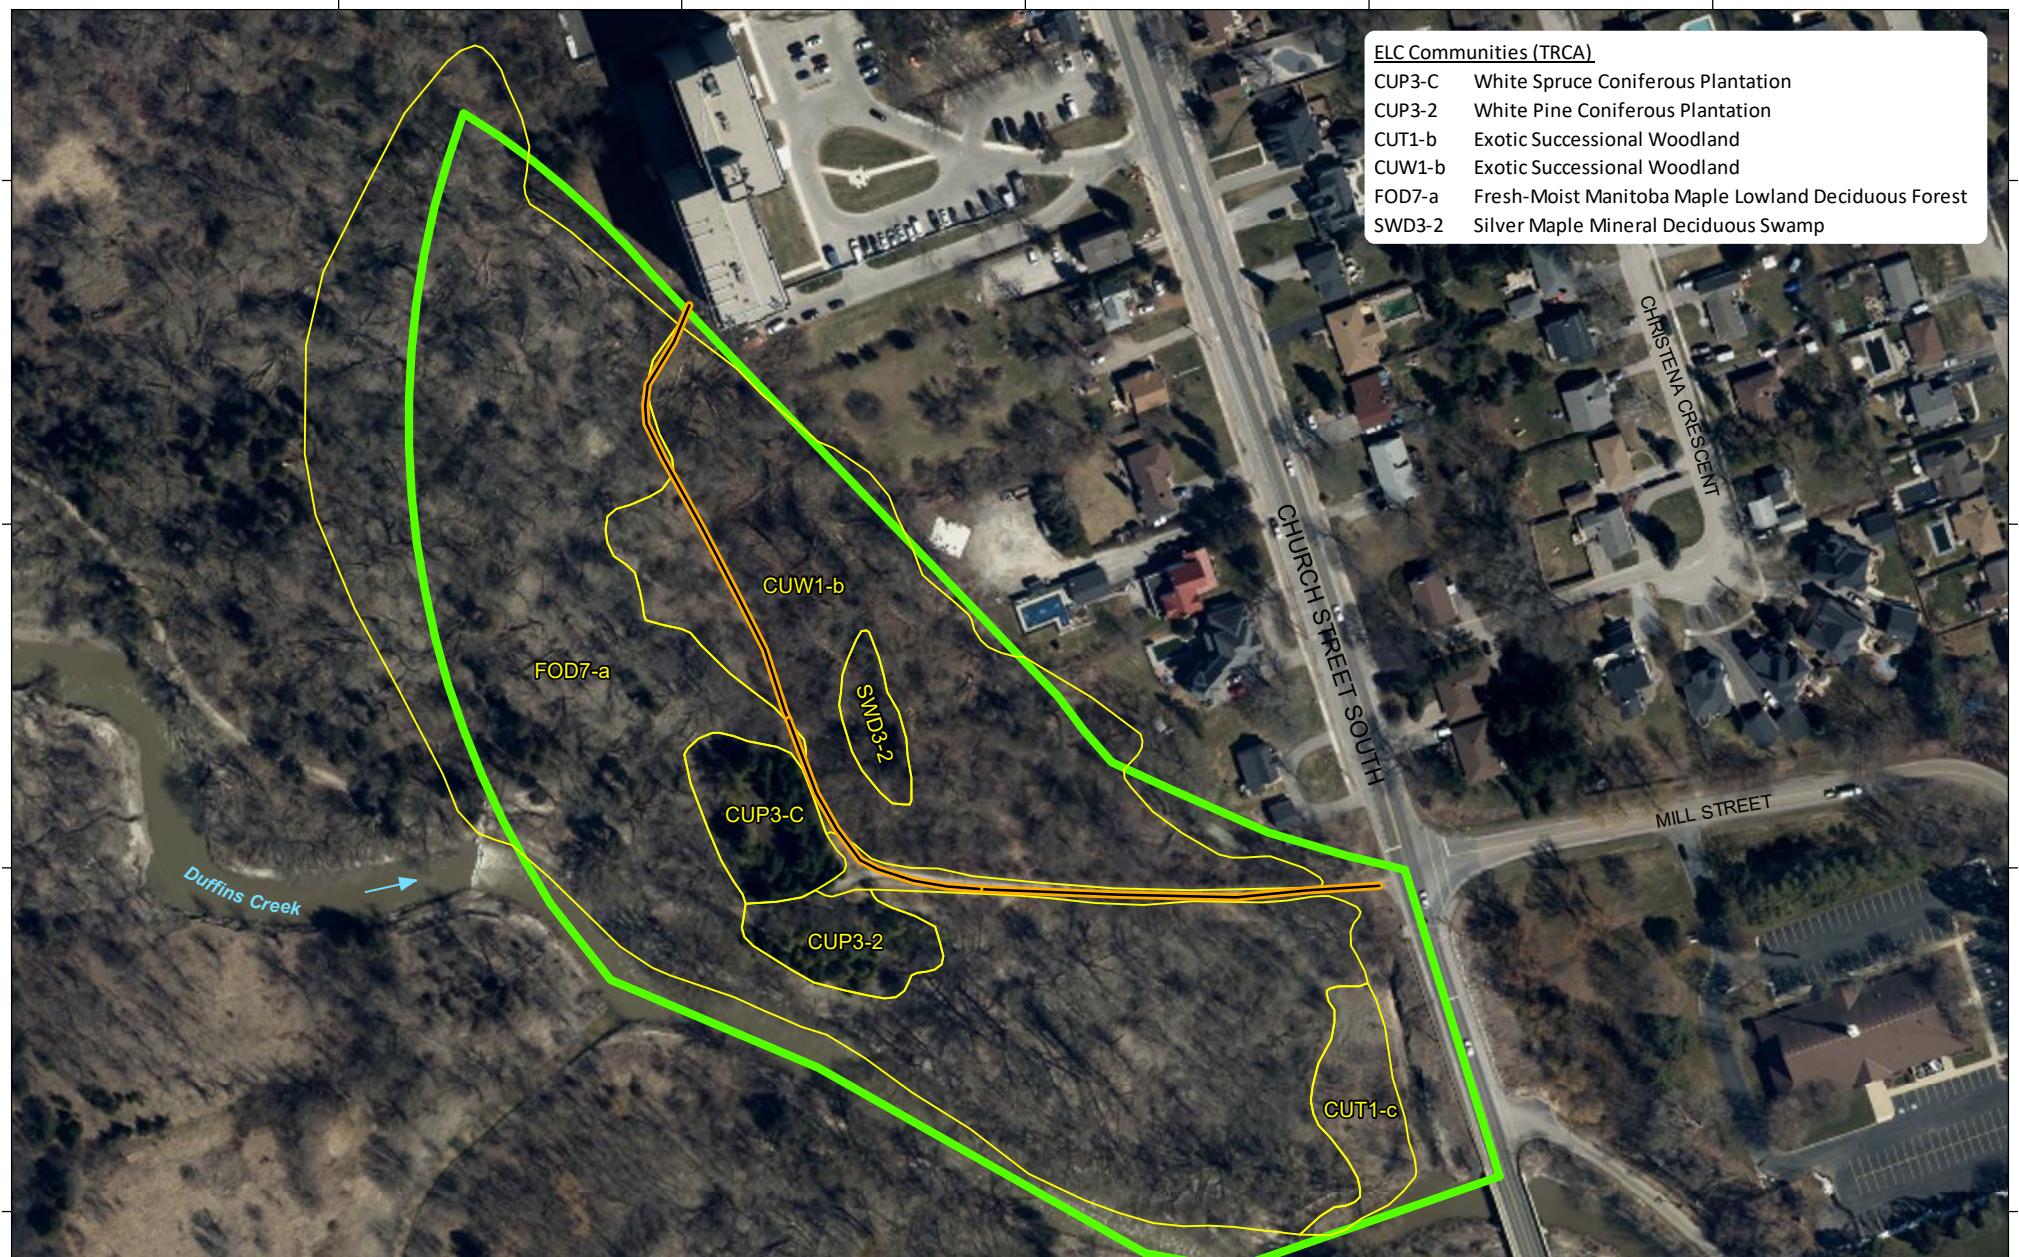
Figure 3-14

Environmental Land Classification

Ecological Land Classification (ELC) mapping provided by TRCA has been compiled and mapped for the Direct Environmental Study Area and is presented in Figures 3-14 and 3-15. The ELC classification is based on the *Ecological Land Classification for Southern Ontario* (Lee, et al., 1998); however, some codes have been altered to describe site-specific conditions (e.g. CUT1-c, refer to Figures 3-14 and 3-15 for the definition of each code noted herein).

The woodlands in the Direct Environmental Study Area are large and diverse (Figures 3-14 and 3-15). The buffering and protection they provide the West Duffins and Duffins Creeks and the potential wildlife habitats and movement corridor opportunities are important functions of these woodlands. Therefore, these woodlands areas would likely meet the Ministry of Natural Resources and Forestry definitions of Significant Woodlands and are mapped as part of the Natural Heritage System and Environmental Protection lands within the Pickering and Ajax Official Plans.

Rehabilitation of the dykes would have a low negative effect within the Direct Environmental Study Area as vegetation will be removed from the construction area. Approximately 2.7 ha of forest/woodland and thicket will be removed from the Pickering Dyke area and 1.4 ha of forest/woodland would be removed from the Ajax Dyke area. Significant vegetation communities adjacent to the Dykes will be impacted. These communities are shown on Figures 3-14 and 3-15 for the Pickering and Ajax Dykes respectively.
