TOPCLIFF AVENUE EROSION CONTROL AND SLOPE STABILIZATION PROJECT

CITY OF TORONTO

Class Environmental Assessment
for Remedial Flood and Erosion Control Projects

PROJECT PLAN
JANUARY 8, 2021

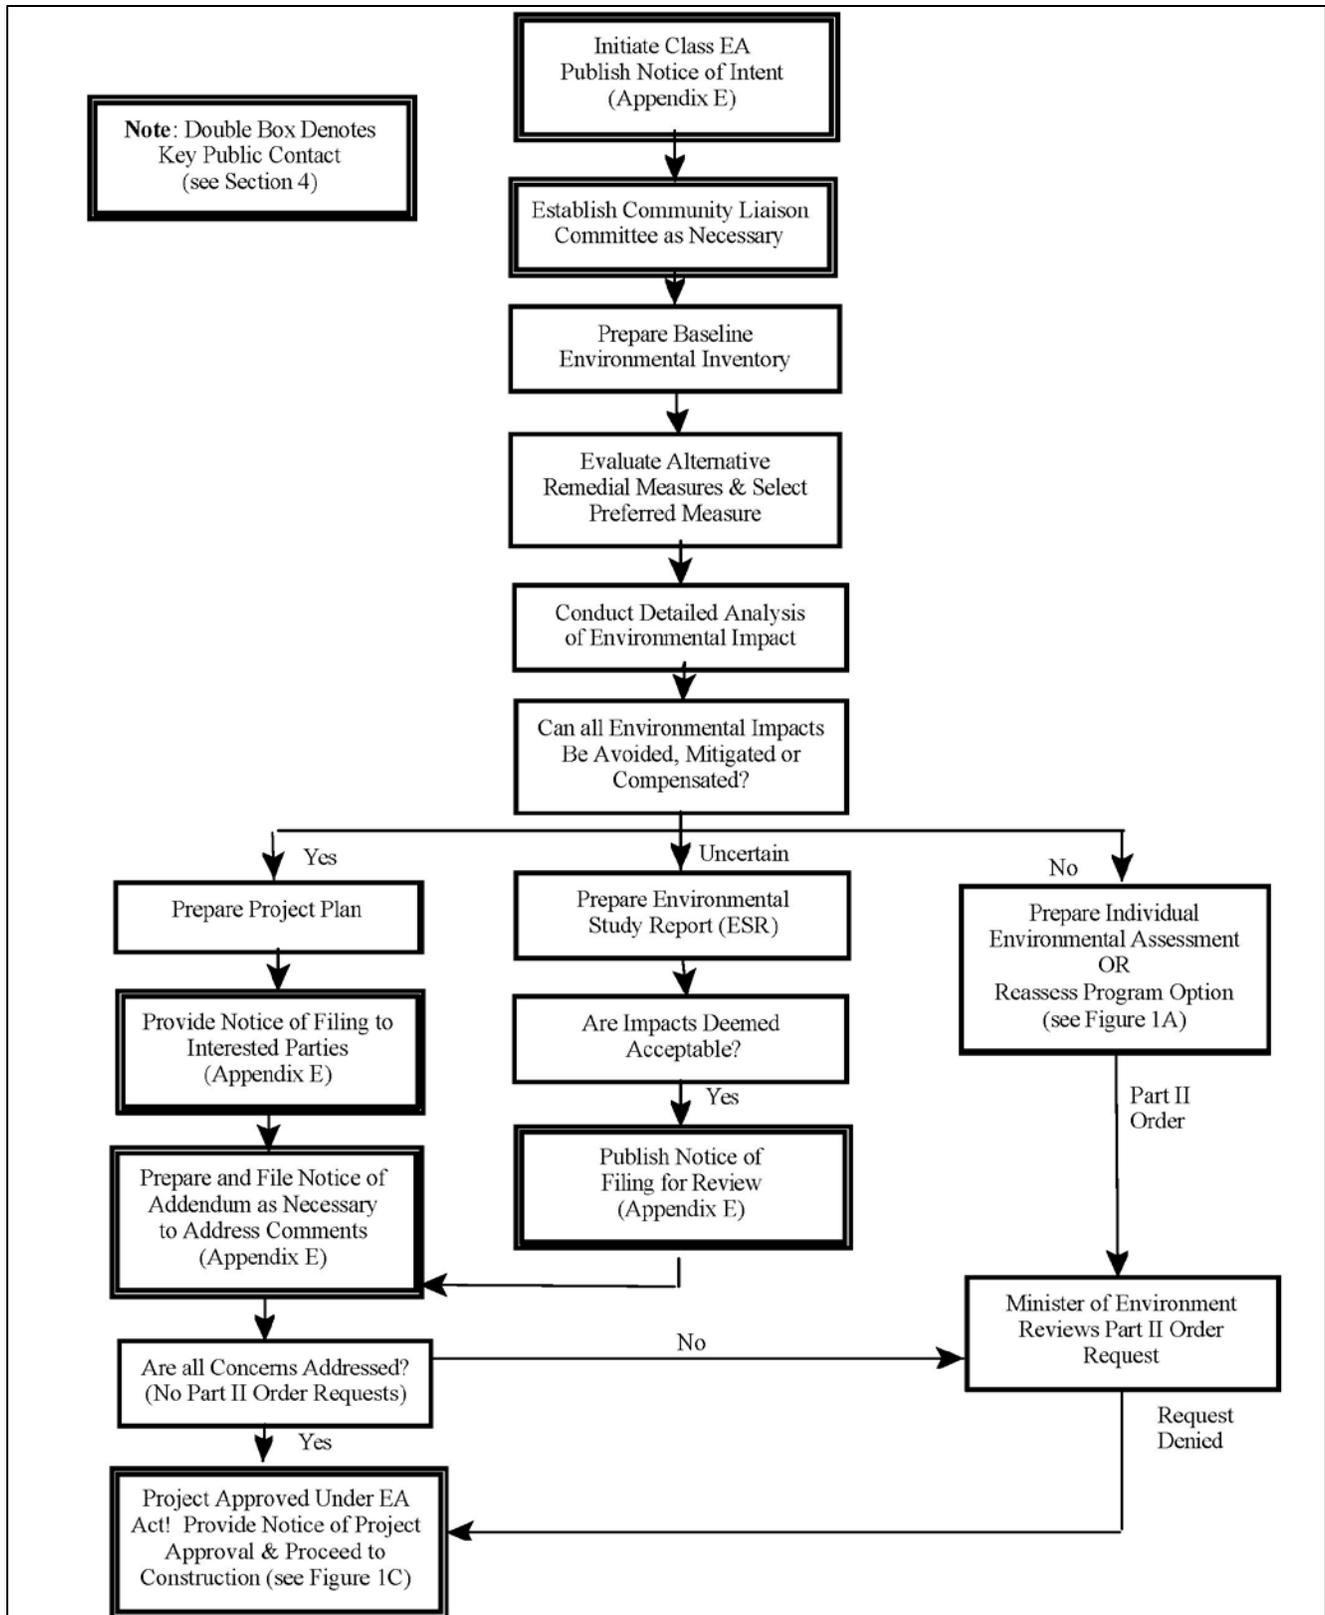
Figure 2: Class EA planning and design process. Source: Conservation Ontario, 2013.

Over twenty years of experience have demonstrated that using the Class EA approach is an effective way of complying with the EA Act’s requirements. Approval of the Class EA allows CAs to carry out these types of projects without applying for formal approval under the EA Act on the condition that all other necessary federal and provincial approvals are obtained (CO, 2013). A chart illustrating the key steps of the Class EA planning and design process is shown in **Figure 2**.

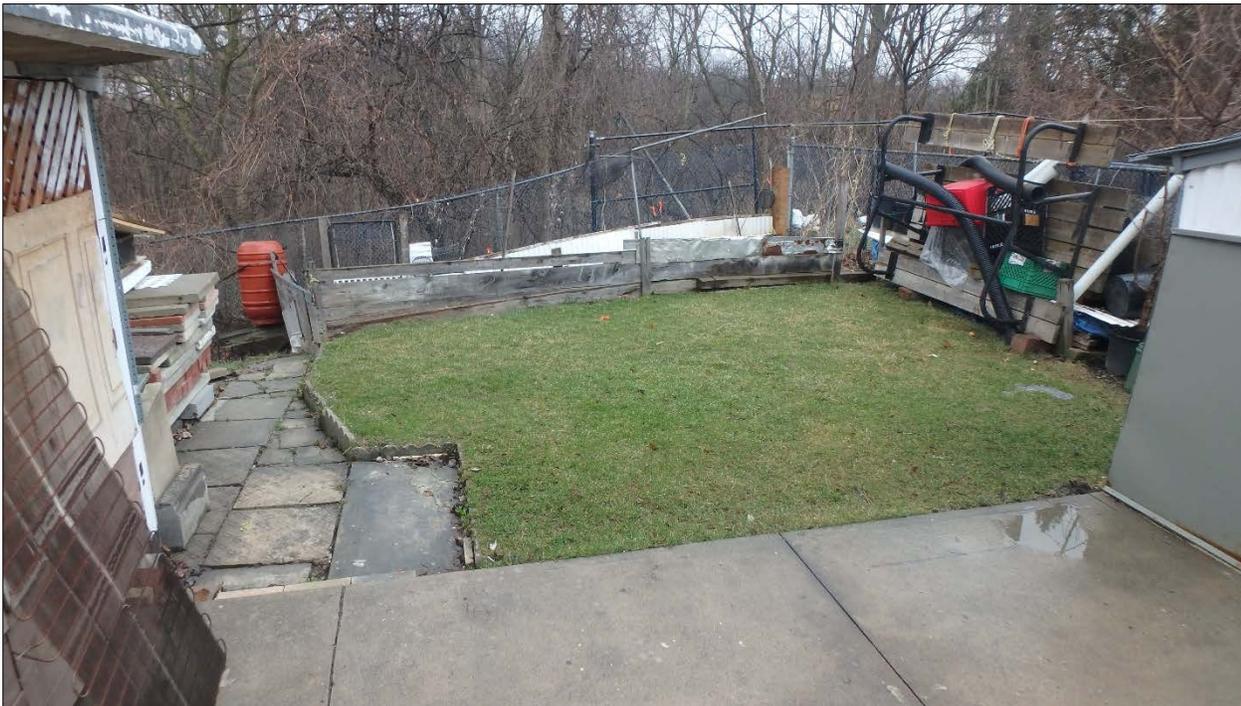
Figure 4: Rear tableland behind 39 Topcliff Avenue, facing west. *Source: TRCA, 2020.*

Tableland structures at these private properties include various property fences along the rear and side property lines, sheds, gardens, landscaping, patios, and a shared detached garage located at 37 and 39 Topcliff Avenue (see **Figure 4** to **Figure 10**). Makeshift and un-engineered retaining walls are located at the slope crest behind 31 to 39 Topcliff Avenue. The makeshift retaining walls from 33 to 41 Topcliff Avenue are approximately 1 metre high and are constructed of various materials including wood railway ties, wood logs, cinderblocks, and other rubble (Central Earth Engineering, 2020).

Drainage on the tableland typically occurs as sheet drainage toward the slope crest as the backyards grade toward the slope. Downspouts from the dwellings and other structures outlet onto the tableland and create additional surficial runoff over the slope.

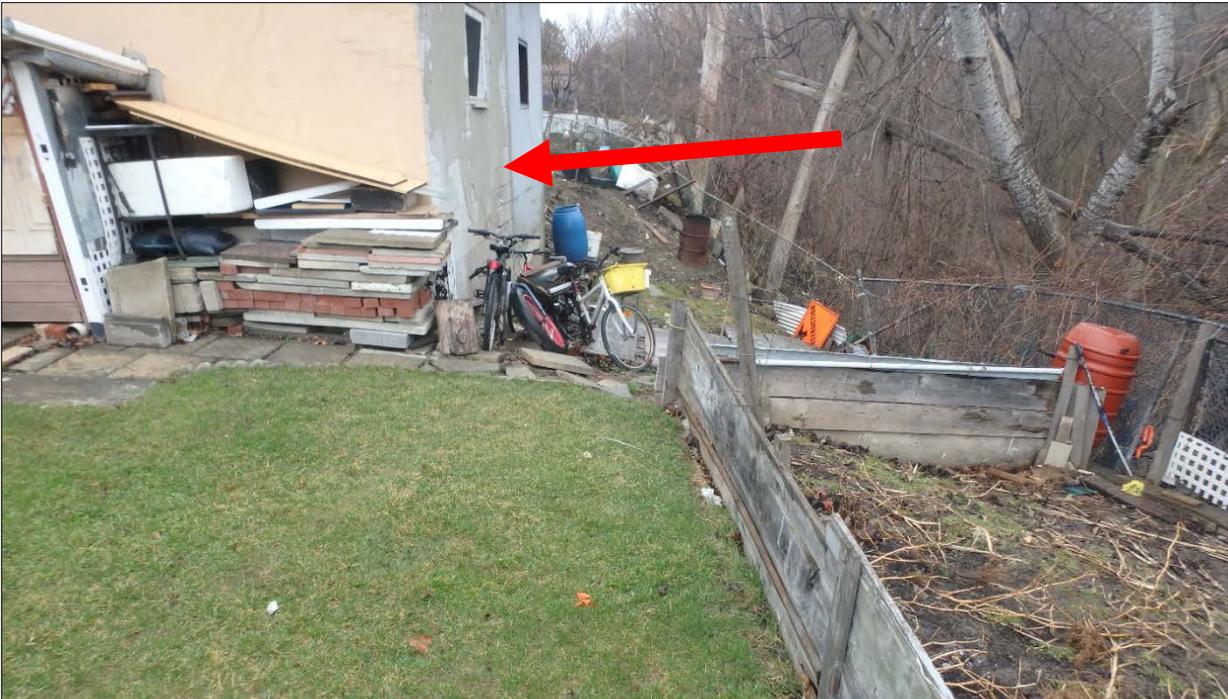
Figure 5: Shared detached garage located at 37 and 39 Topcliff Avenue. *Source: TRCA, 2019.*

In their 2020 geotechnical investigation, Central Earth Engineering (CEE) noted significant slumping in the area directly behind the shared garage located behind 37 and 39 Topcliff Avenue. This area has a lower topographic elevation which concentrates drainage over the slope behind the garage.

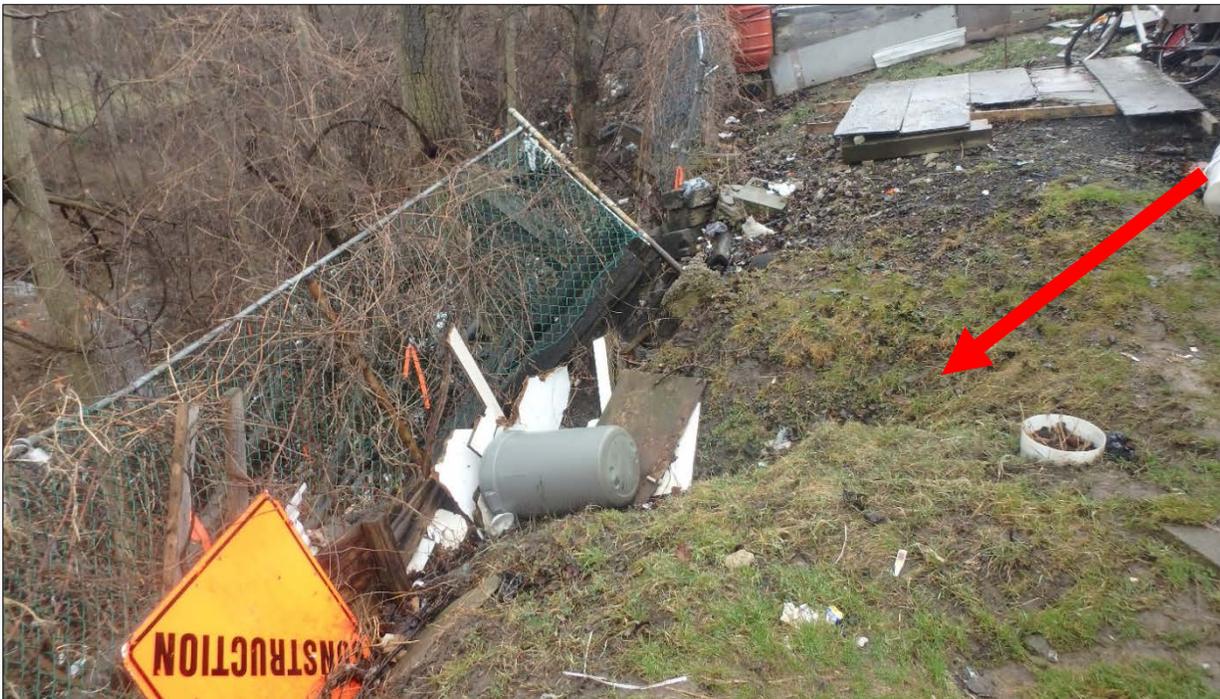
Figure 6: Red arrow highlights the concentrated overland drainage behind the shared garage at 37 and 39 Topcliff Avenue. *Source: TRCA 2020.*

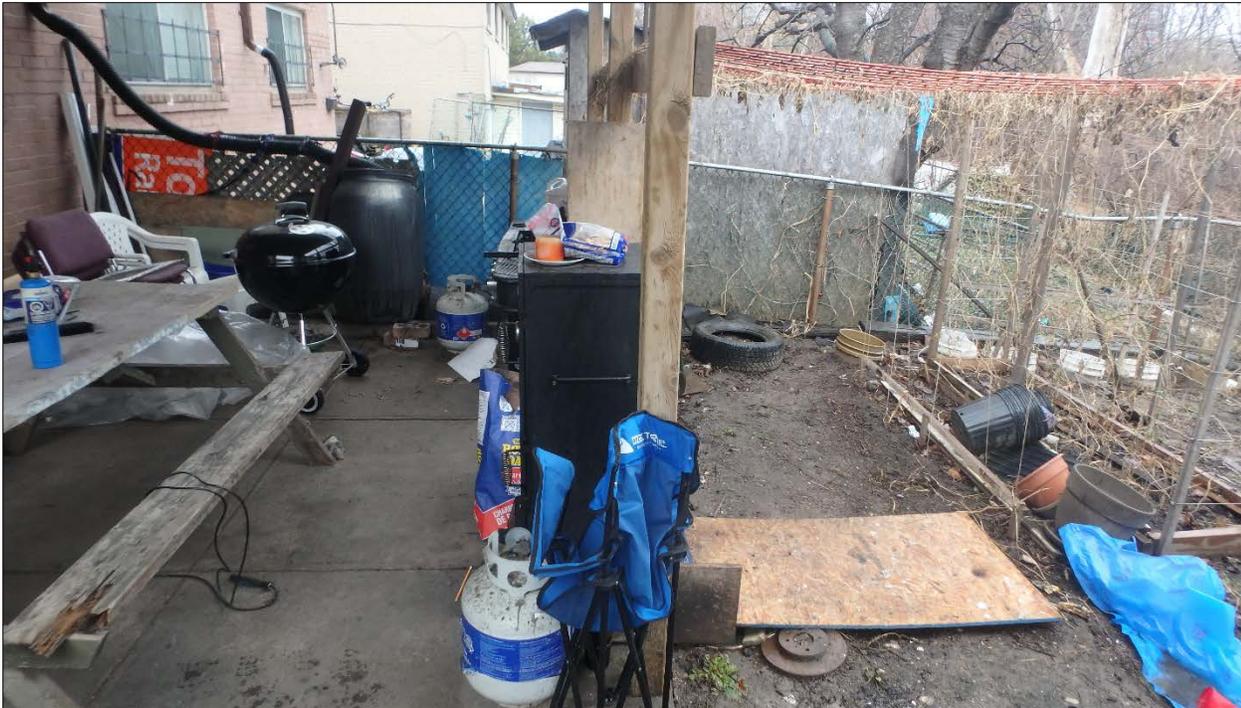
Figure 7: Patio area behind 37 Topcliff Avenue, facing northwest. *Source: TRCA, 2020*

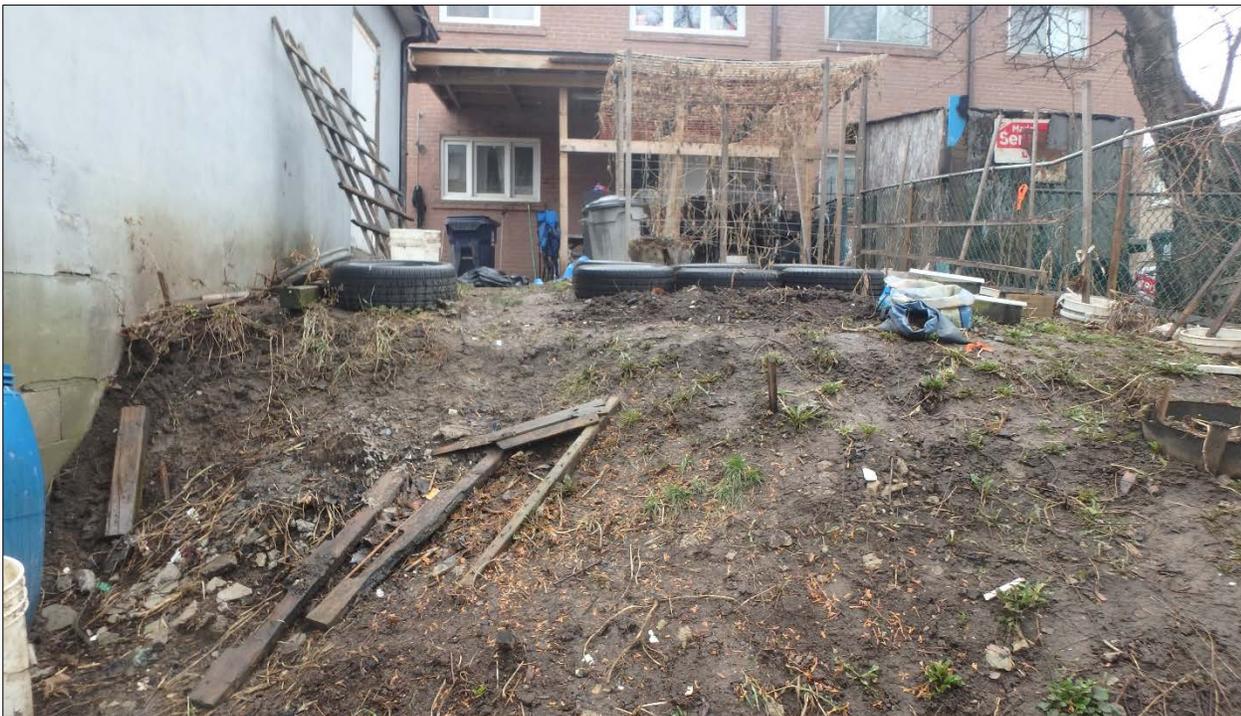
Figure 8: Rear tableland area behind 37 Topcliff Avenue, facing west. *Source: TRCA, 2020*

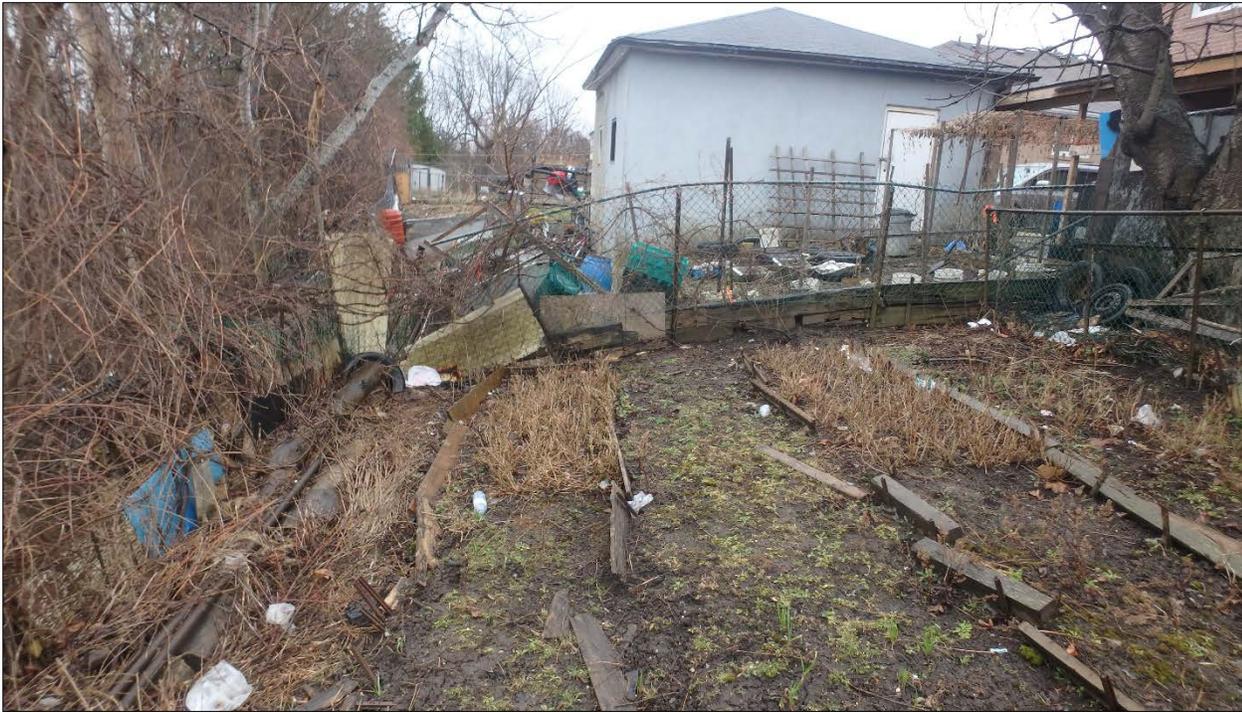
Figure 9: Facing southeast across 35 Topcliff Avenue towards 37 Topcliff Avenue. *Source: TRCA, 2020*

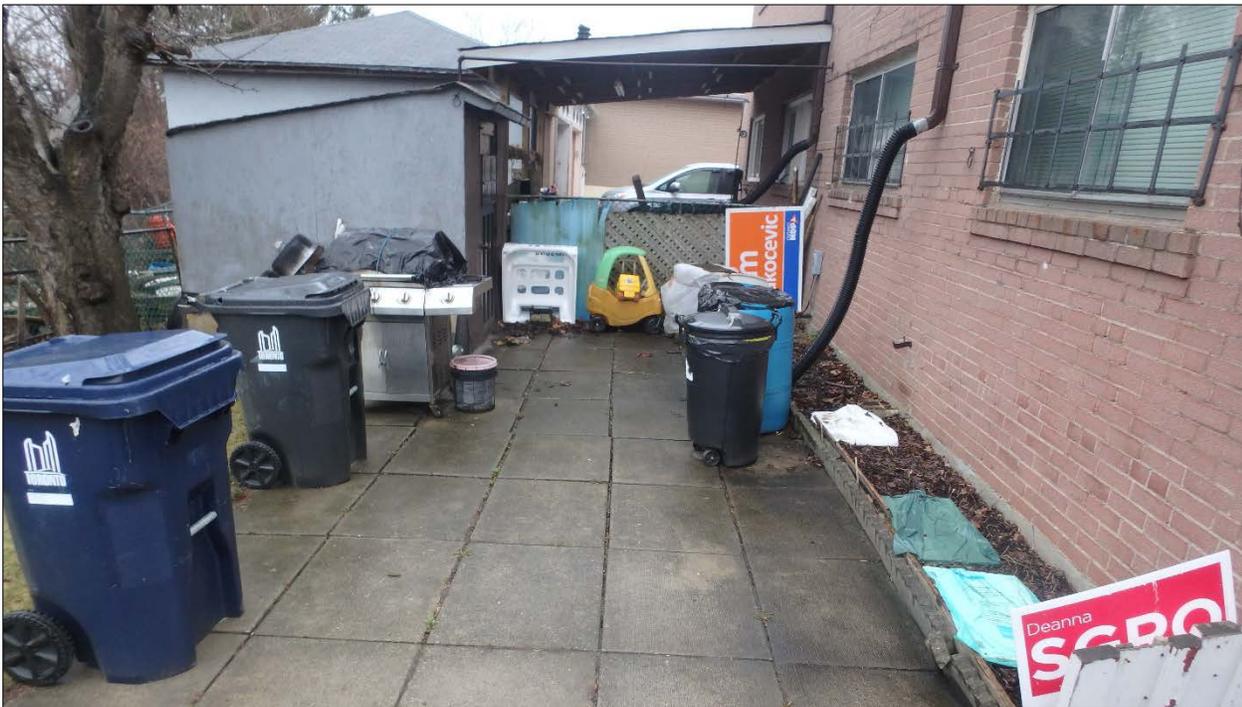
Figure 10: Patio area behind 35 Topcliff Avenue. *Source: TRCA, 2020.*

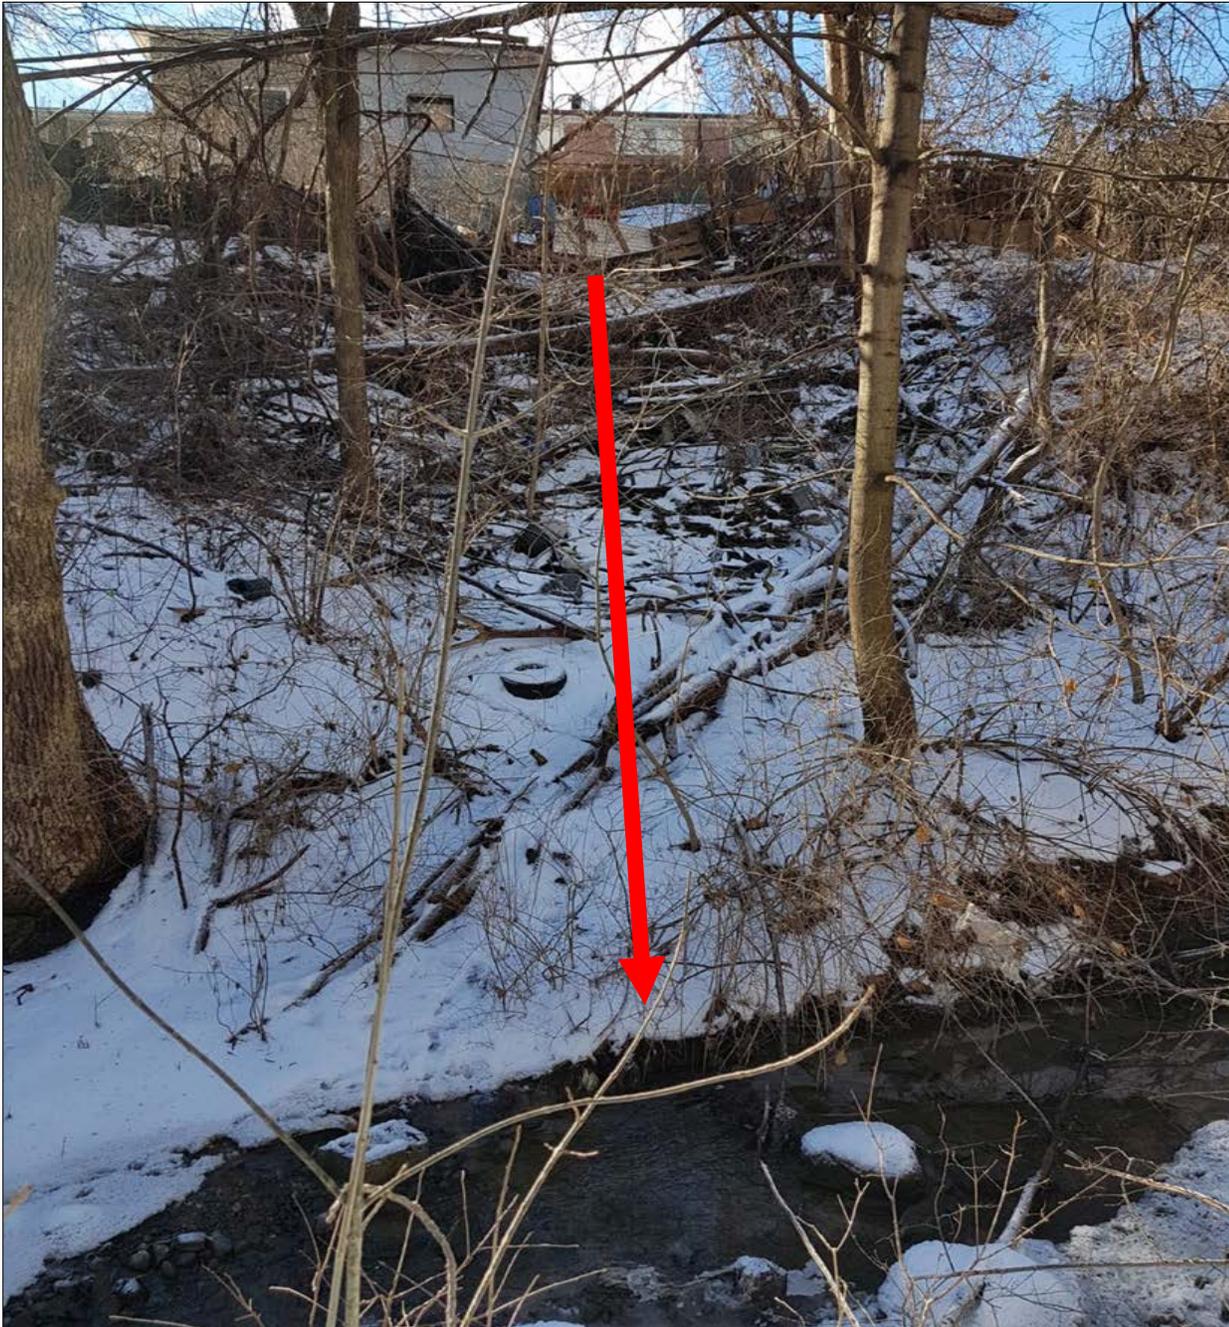
Figure 11: Valley slope and gully behind 37 and 39 Topcliff Avenue. *Source: TRCA, 2020*

The slope is approximately 9 to 11 metres in height, and inclinations range from near-vertical in over-steepened areas to 2.1H:1V in flatter areas. Bare areas are associated with the slope failure between 37 and 39 Topcliff Avenue behind the shared detached garage. A gully, caused by concentrated runoff from the tableland, extends down the slope face. The red arrow shown in **Figure 11** depicts the location of this gully.

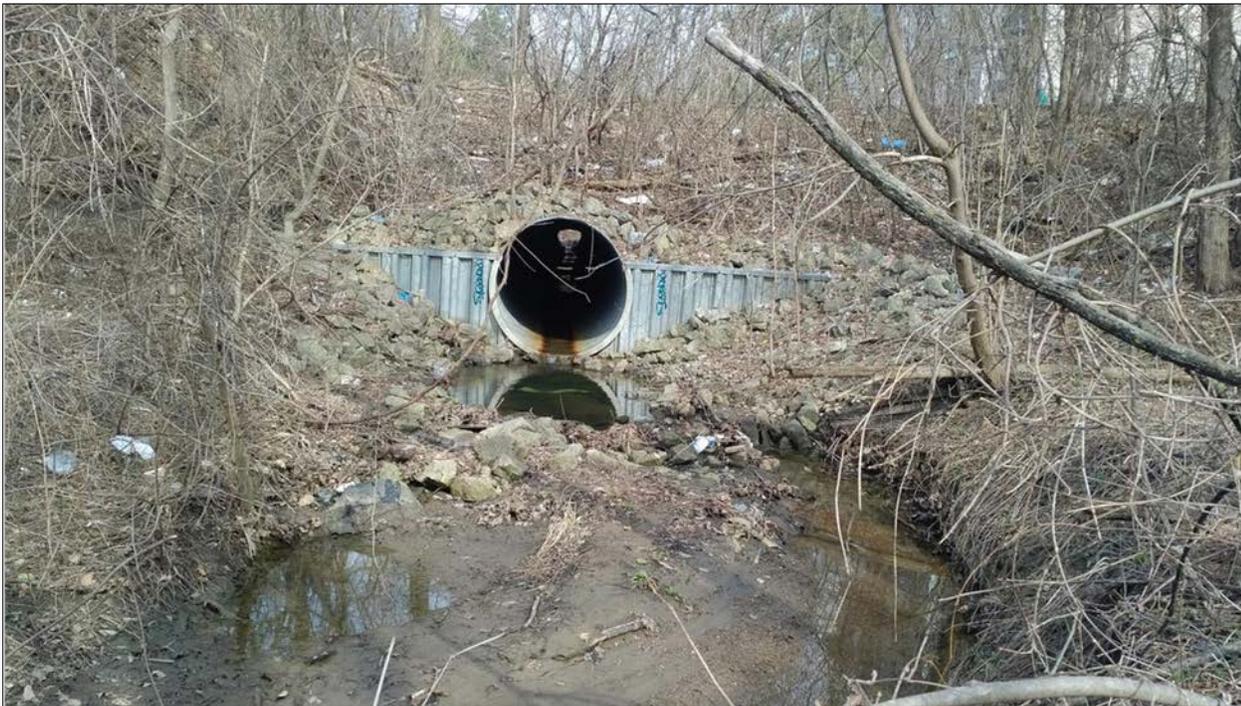
Figure 12: Black Creek tributary crosses Finch Avenue West through an 80-metre-long corrugated steel pipe culvert. *Source: TRCA, 2020*

The Black Creek tributary culvert located below the northern limit of Topcliff Avenue (**Figure 12**) has been identified as needing replacement under the Major Rehabilitation Category in the Ontario Structure Inspection Manual report completed by the City of Toronto in May 2013. As part of Finch West Light Rail Transit (LRT)

Project, this culvert will be replaced in 2021 to allow for the construction of Light Rail Transit along Finch Avenue West.

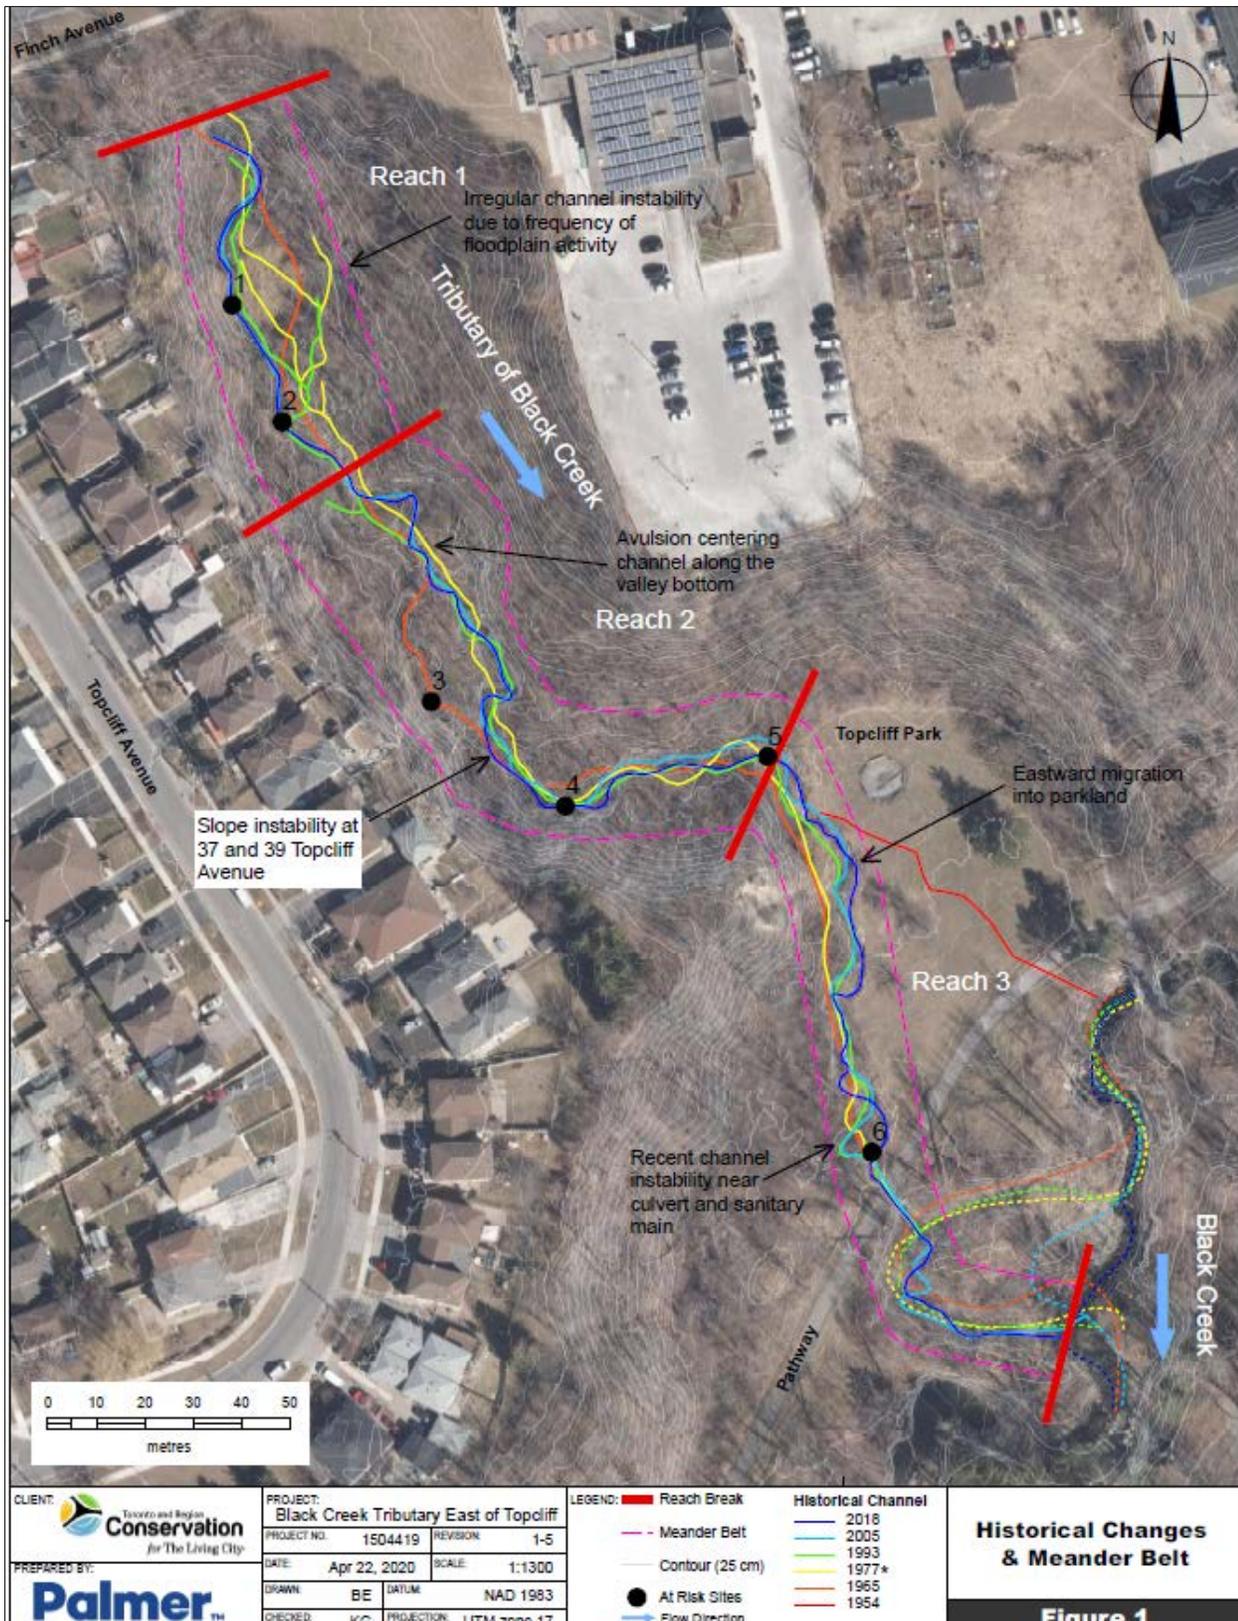
Figure 13: Map delineating the general location of reaches 1 – 3 behind Topcliff Avenue. Source: Palmer, 2020.

- **Reach 1** originates at the outfall south of Finch Avenue and extends approximately 100 metres downstream
- **Reach 2** spans for approximately 170 metres to the edge of Topcliffe Park
- **Reach 3** extends for approximately 150 metres along the western edge of Topcliffe Park before discharging into Black Creek

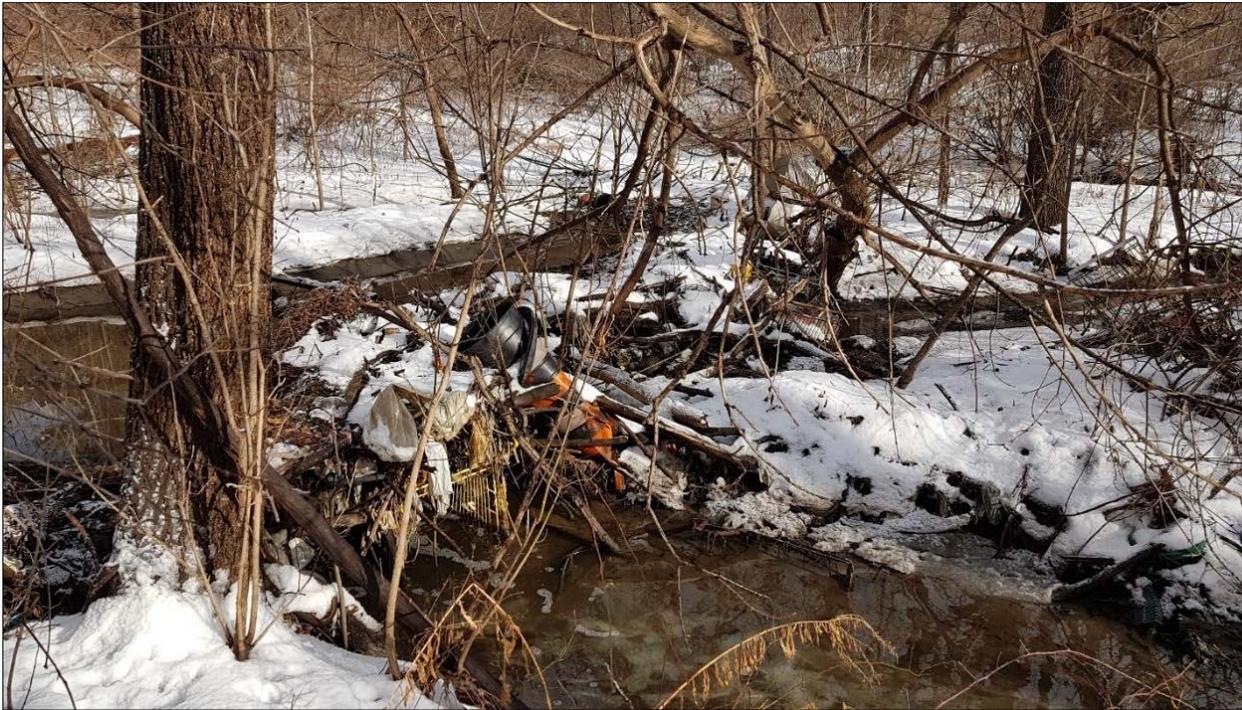
Figure 14: Large debris jam within the watercourse, looking North. *Source: TRCA, 2019.*

Where the creek tributary flows behind Topcliff Avenue, a significant amount of garbage debris and tree jams have accumulated. This is influencing the stability of the creek, negatively affecting aquatic habitat, and changing the trajectory of flows within the watercourse (Palmer Environmental Consulting Group, Inc., 2020).

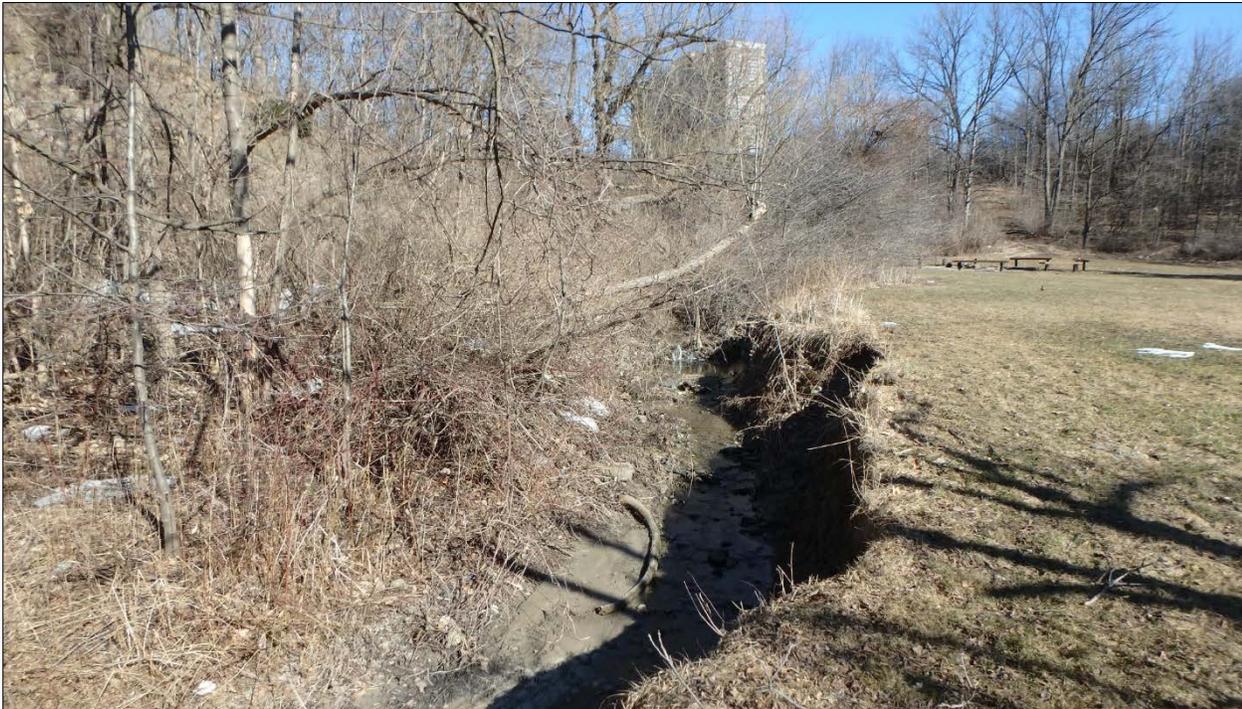
Figure 15: Black Creek tributary adjacent to Derrydowns Park, facing north. *Source: TRCA, 2020*

In the downstream section of the Project area, the floodplain to the east opens into manicured parkland and crosses beneath a multi-use public recreational trail before reaching Black Creek (**Figure 15**).

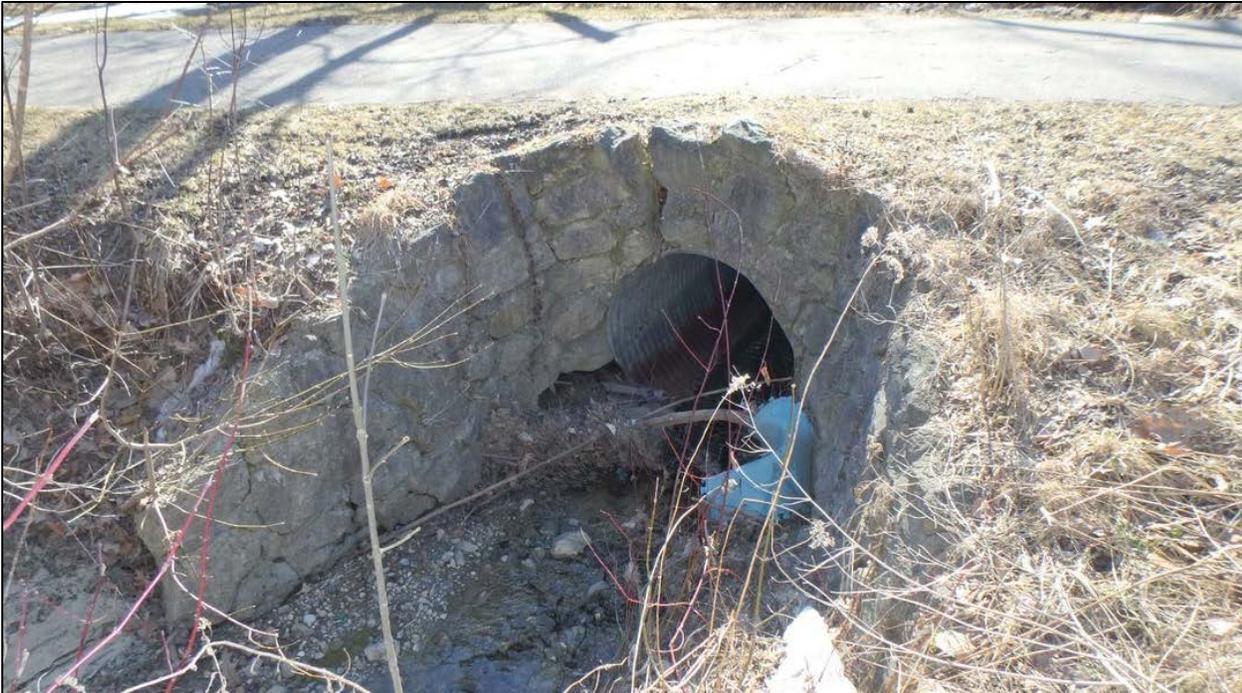
Figure 16: Constructed crossing located in Derrydowns Park near the southern limit of the Project area. *Source: TRCA, 2019.*

There is one constructed crossing overtop the Black Creek tributary located downstream of TRCA's intended work area (**Figure 16**). The closed-bottom culvert crossing runs underneath the pedestrian trail located in Derrydowns Park. TRCA does not anticipate any impacts to this constructed crossing as a result of the proposed remedial works as the crossing lies beyond the limits of TRCA's work area.

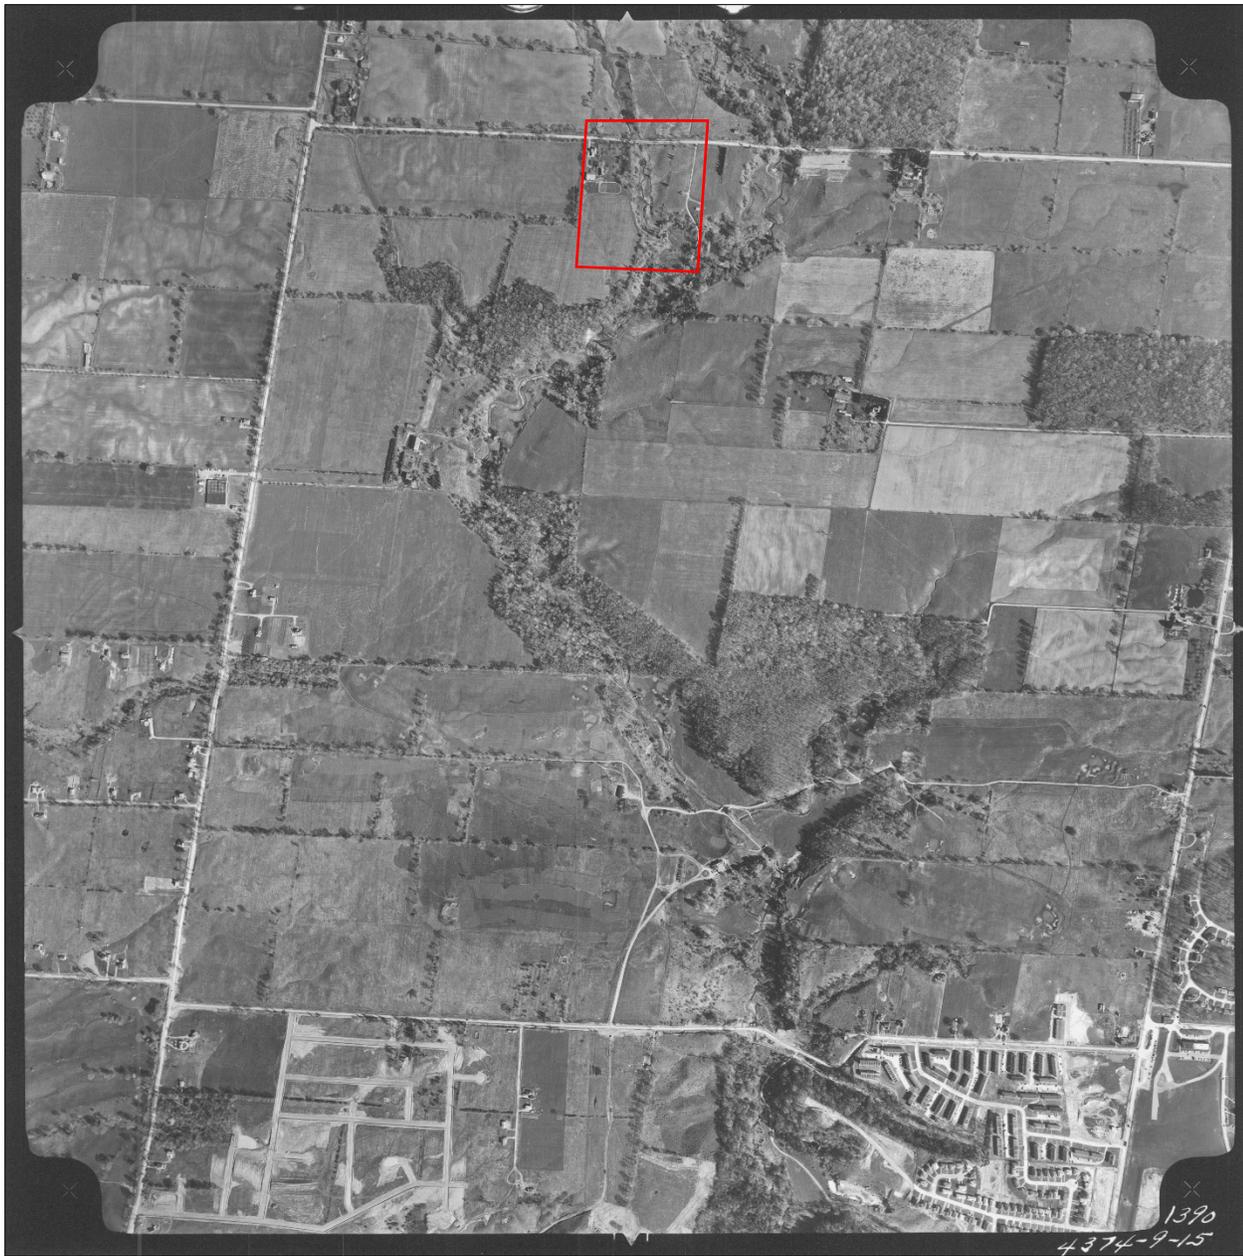
Figure 19: 1954 historical aerial photograph of area surrounding the Topcliff Avenue Project (red polygon). *Source: TRCA, 2018.*

Situated in the City of Toronto, the Project site is subject to significant pressures resulting from urbanization of surrounding areas. As can be observed in historical aerial photographs shown in **Figure 18** to **Figure 21** below, the region surrounding the Project has been subject to significant urbanization since the 1960s. Urbanization changes the composition of the Earth’s natural surface and typically results in the severe limitation or complete eradication of natural areas, causing increased stresses on remaining natural areas and features and negatively impacts the health and wellbeing of local ecosystems.

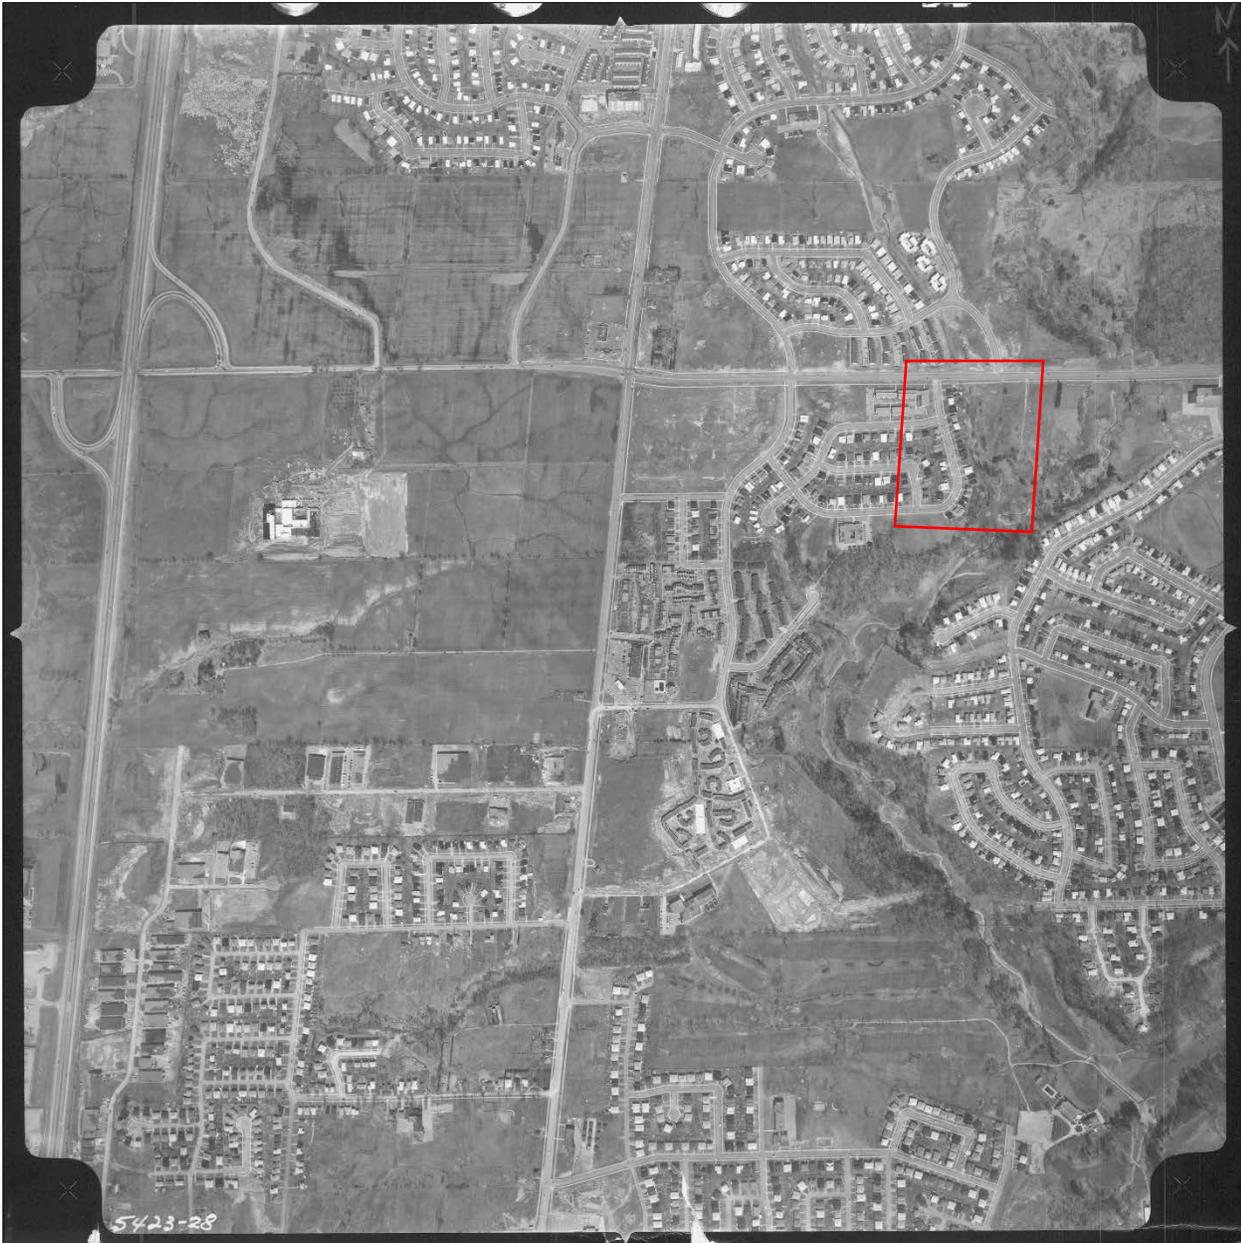
Figure 19: 1967 historical aerial photograph of area surrounding the Topcliff Avenue Project area (red polygon).
Source: TRCA, 2018

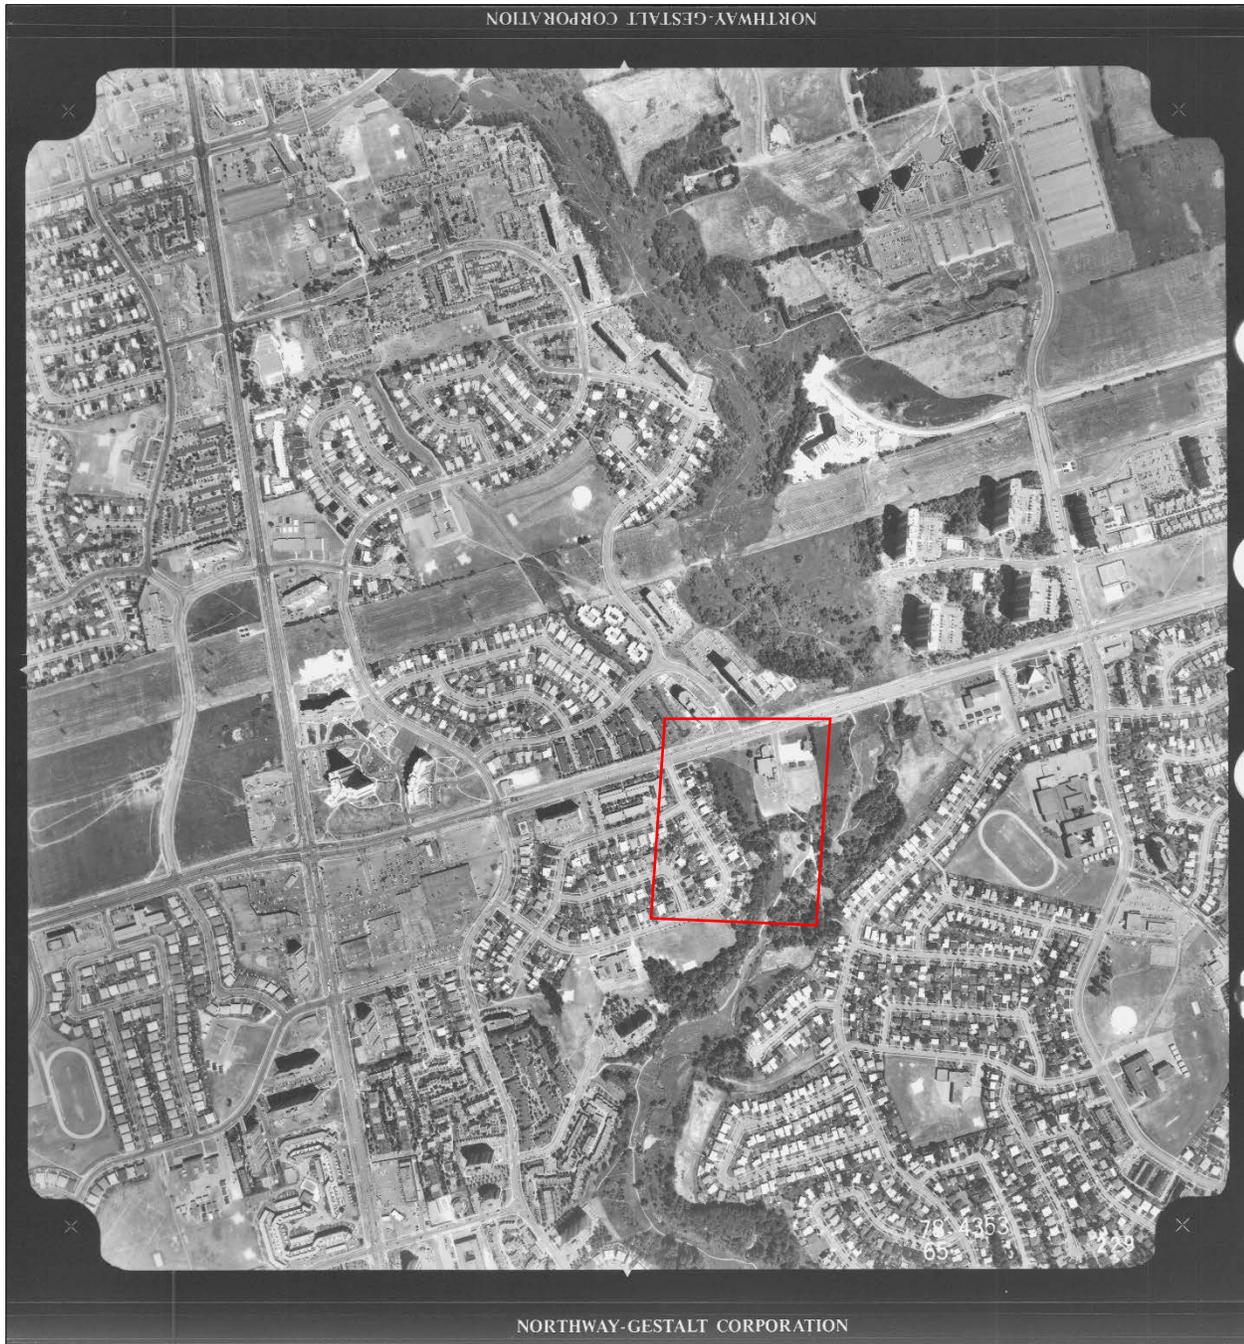
Figure 20: 1978 historical aerial photograph of area surrounding the Topcliff Avenue Project area (red polygon).
Source: TRCA, 2018.
