TOPCLIFF AVENUE EROSION CONTROL AND SLOPE STABILIZATION PROJECT

CITY OF TORONTO

Class Environmental Assessment
for Remedial Flood and Erosion Control Projects

PROJECT PLAN
JANUARY 8, 2021

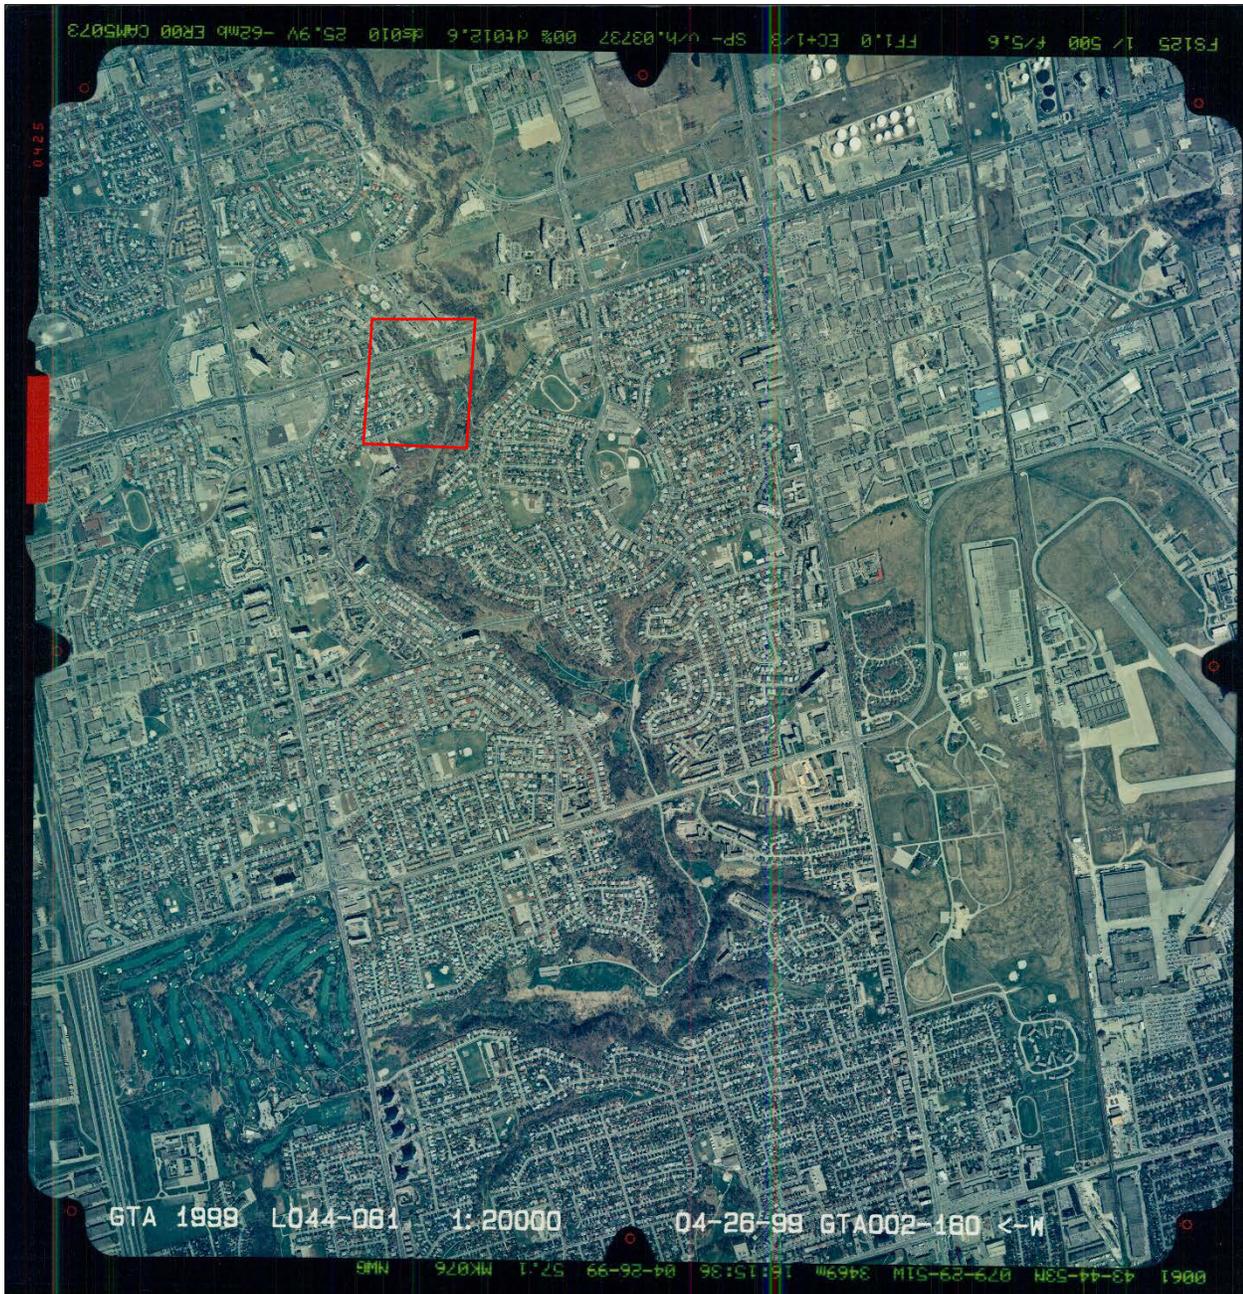
Figure 21: 1978 historical aerial photograph of area surrounding the Topcliff Avenue Project (red polygon). *Source: TRCA, 2018.*

Situated in the City of Toronto, the Project site is subject to significant pressures resulting from urbanization of surrounding areas. As can be observed in historical aerial photographs shown in **Figure 18** to **Figure 21** below, the region surrounding the Project has been subject to significant urbanization since the 1960s. Urbanization changes the composition of the Earth’s natural surface and typically results in the severe limitation or complete eradication of natural areas, causing increased stresses on remaining natural areas and features and negatively impacts the health and wellbeing of local ecosystems.

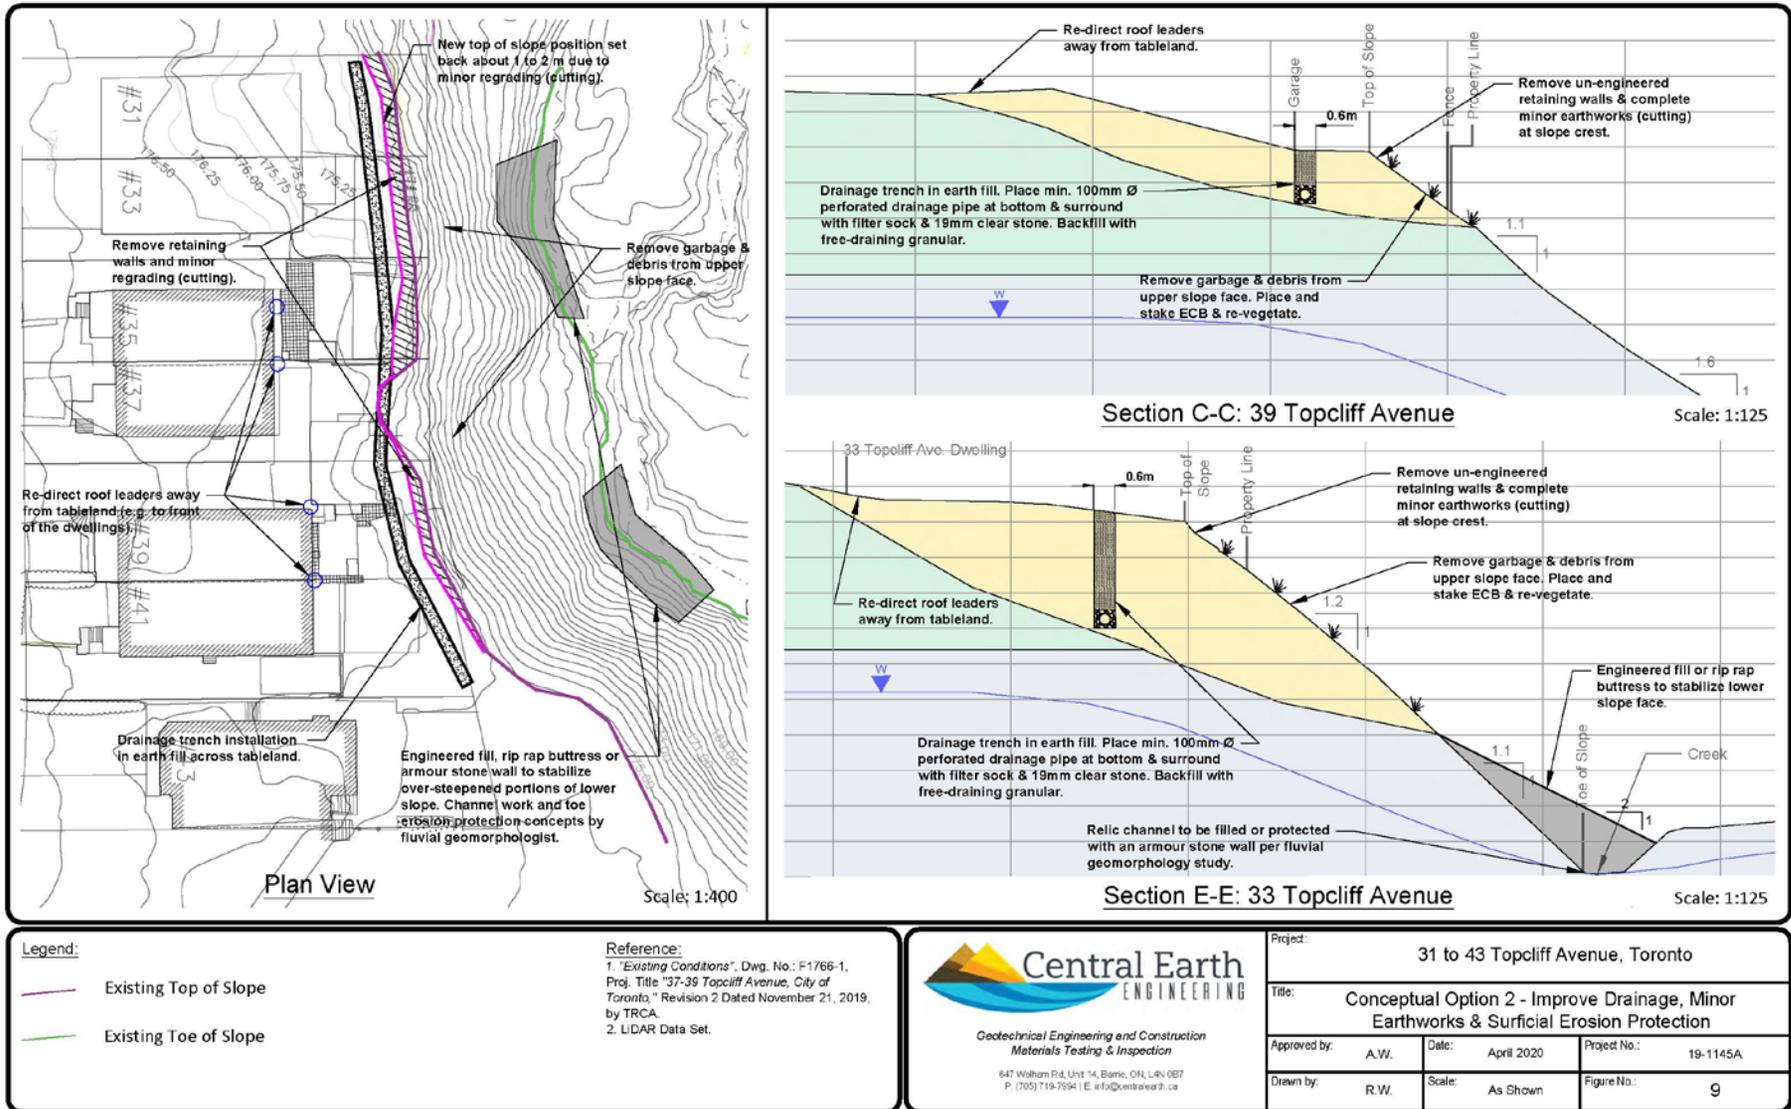
Figure 22: Concept 2 - Improvements for drainage with minor works and surface erosion protection. Source: (Central Earth Engineering, 2020)

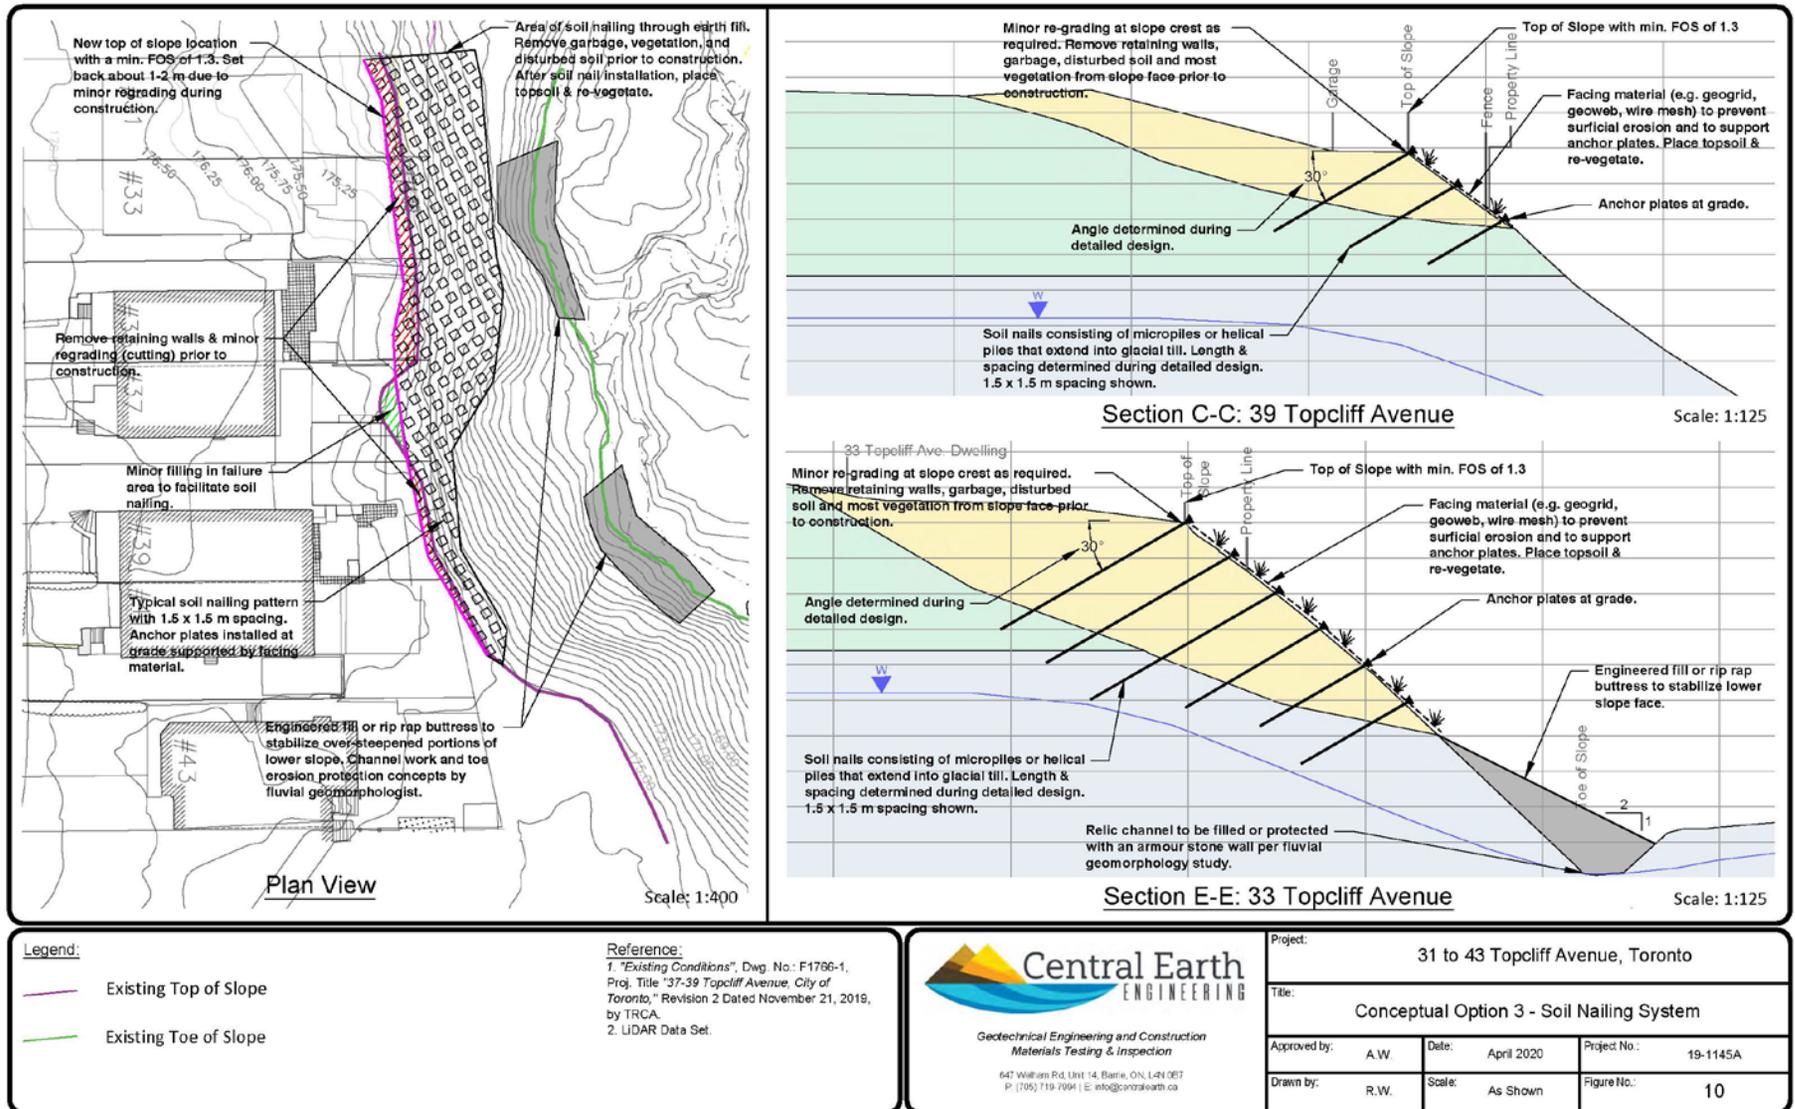
Figure 23: Concept 3 – Soil nailing, requires additional erosion control works in channel. Source: (Central Earth Engineering, 2020)

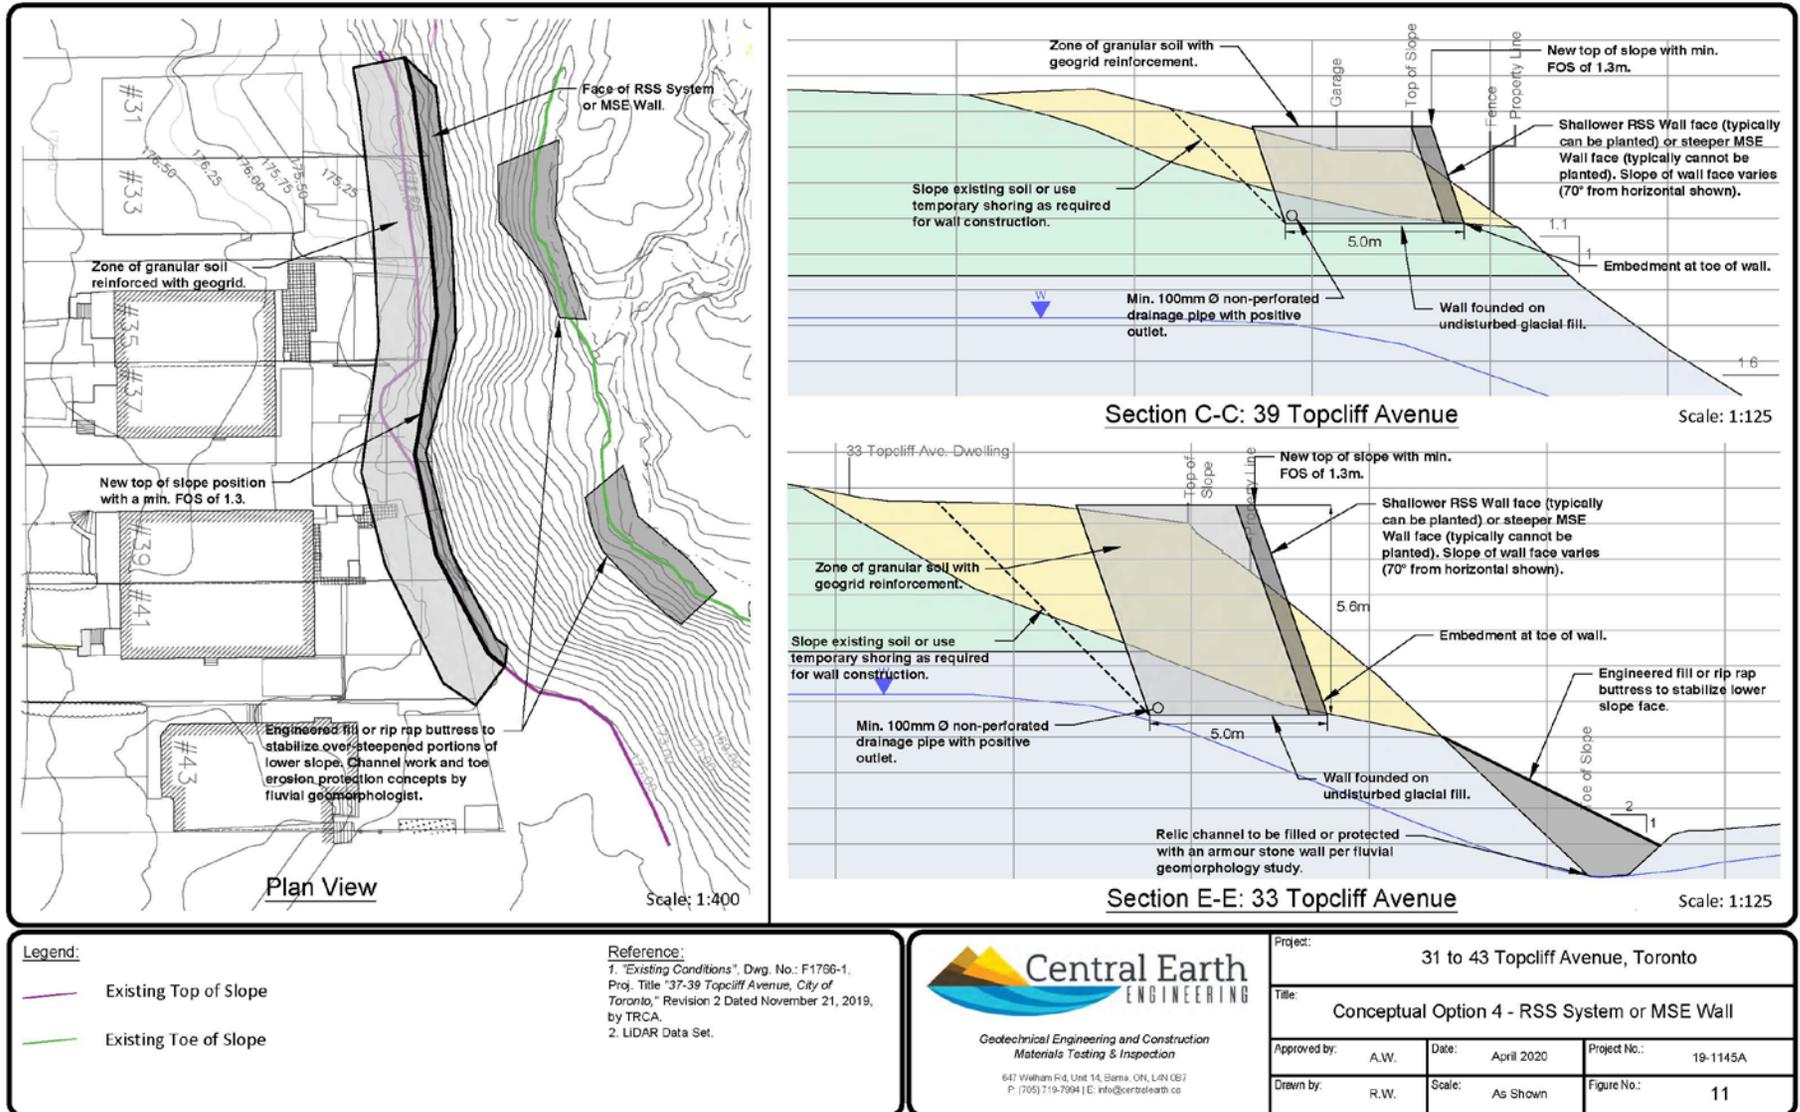
Figure 24: Concept 4 – RSS system or MSE wall, requires additional erosion control works in channel. Source: (Central Earth Engineering, 2020)

This alternative relies on channel works (described in **Section 4.2**) providing long-term toe erosion protection at the bottom of slope to stabilize the over-steepened lower slope face (Central Earth Engineering, 2020).

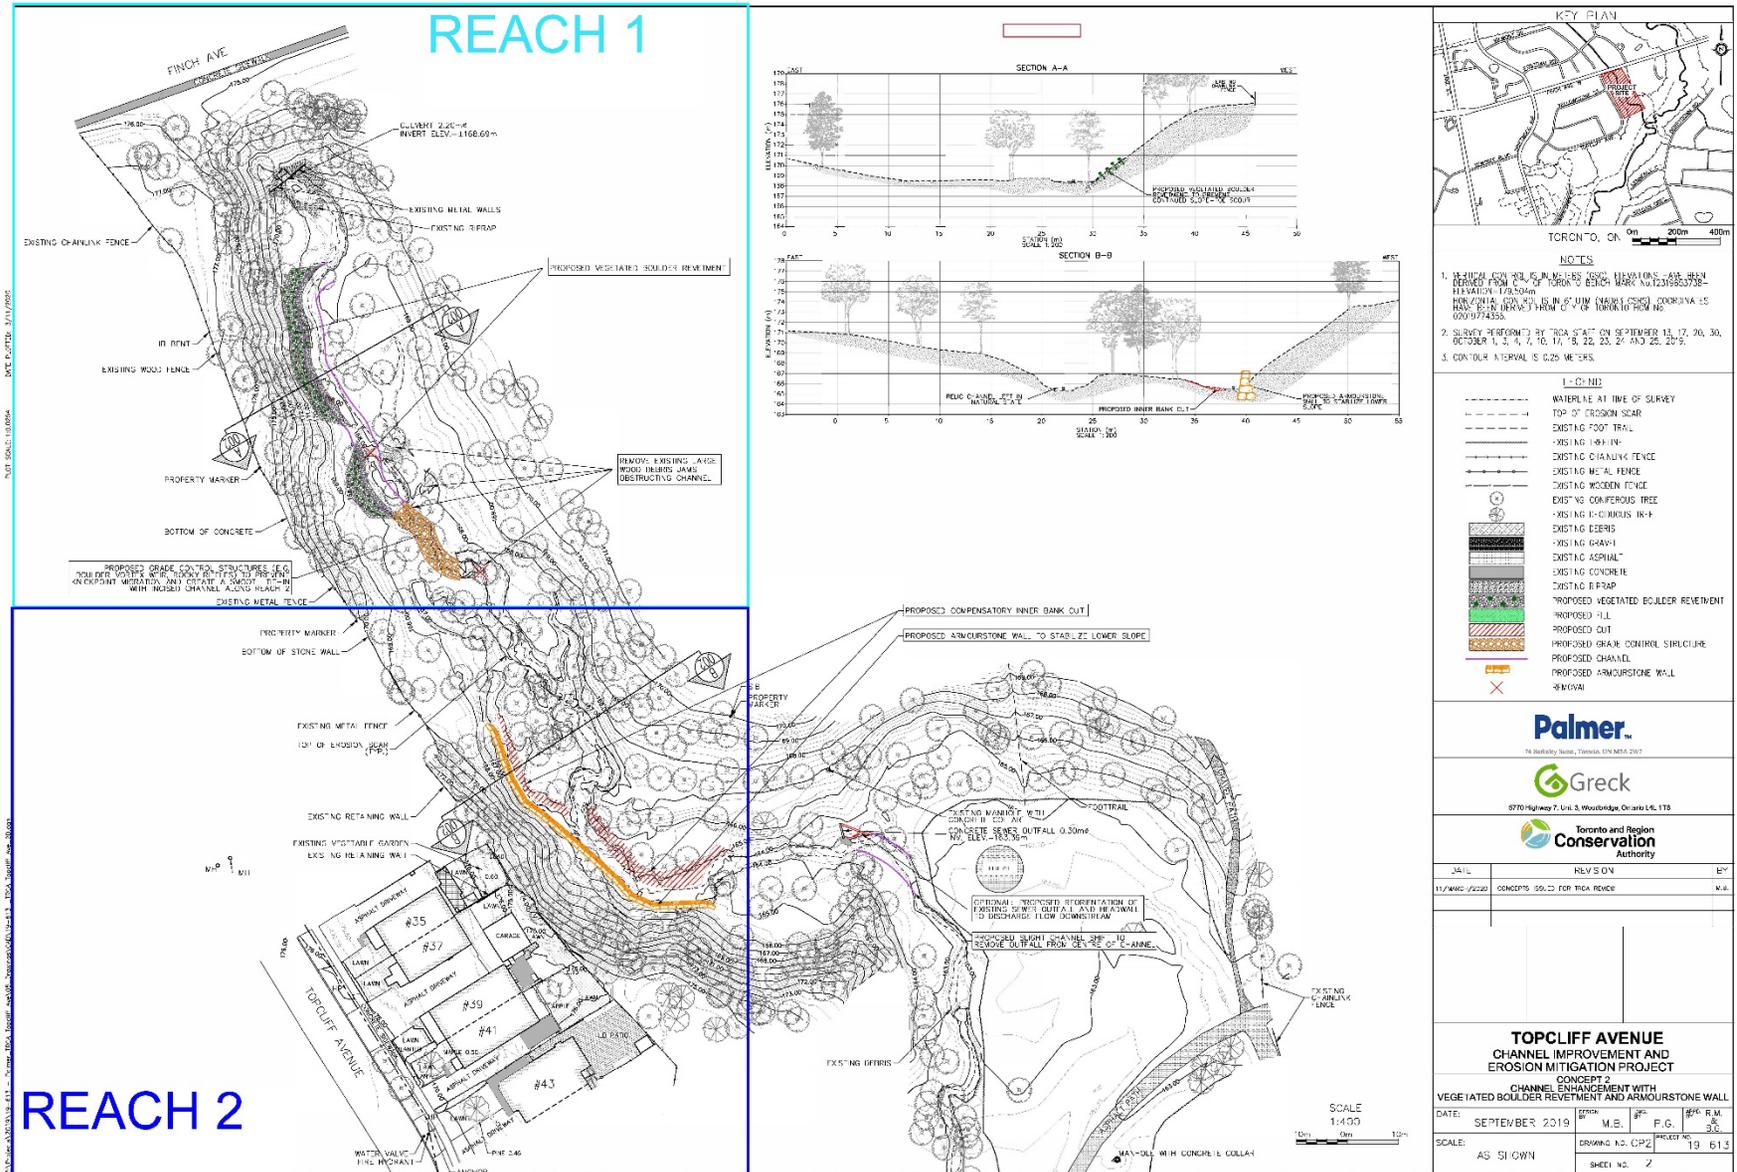
Figure 26: Concept 2 - Reach 1 (denoted by light blue square) and Reach 2 (denoted by dark blue square). Source: (Palmer Environmental Consulting Group, Inc., 2020)

The channel would be widened and deepened for both Reach 1 and Reach 2 to support the increase in flow volume and reduce the likelihood of debris build up within the channel (Palmer Environmental Consulting Group, Inc., 2020).

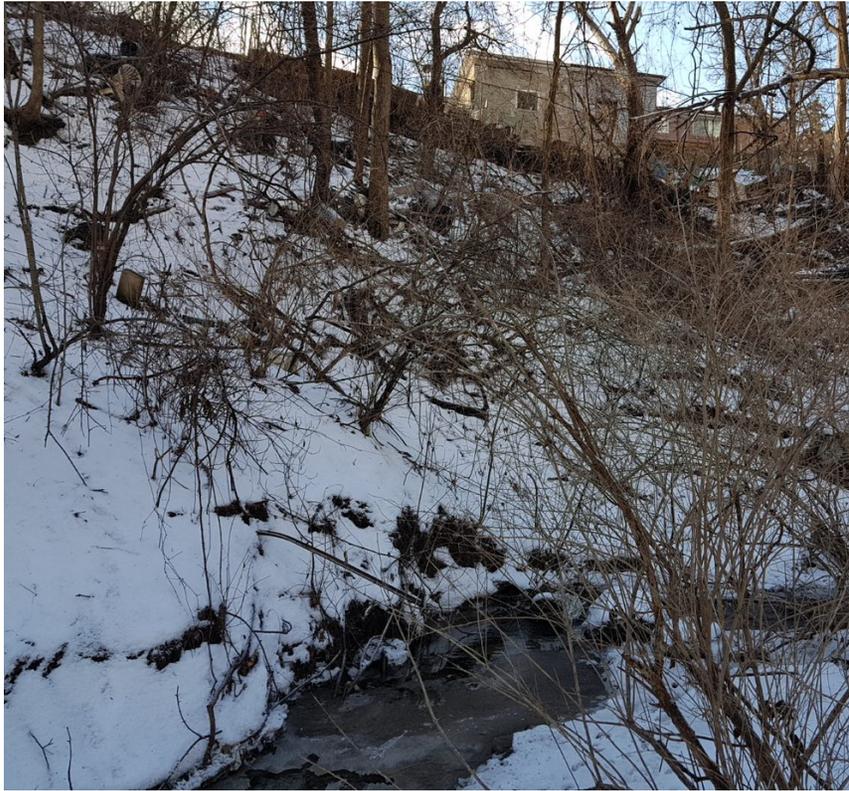
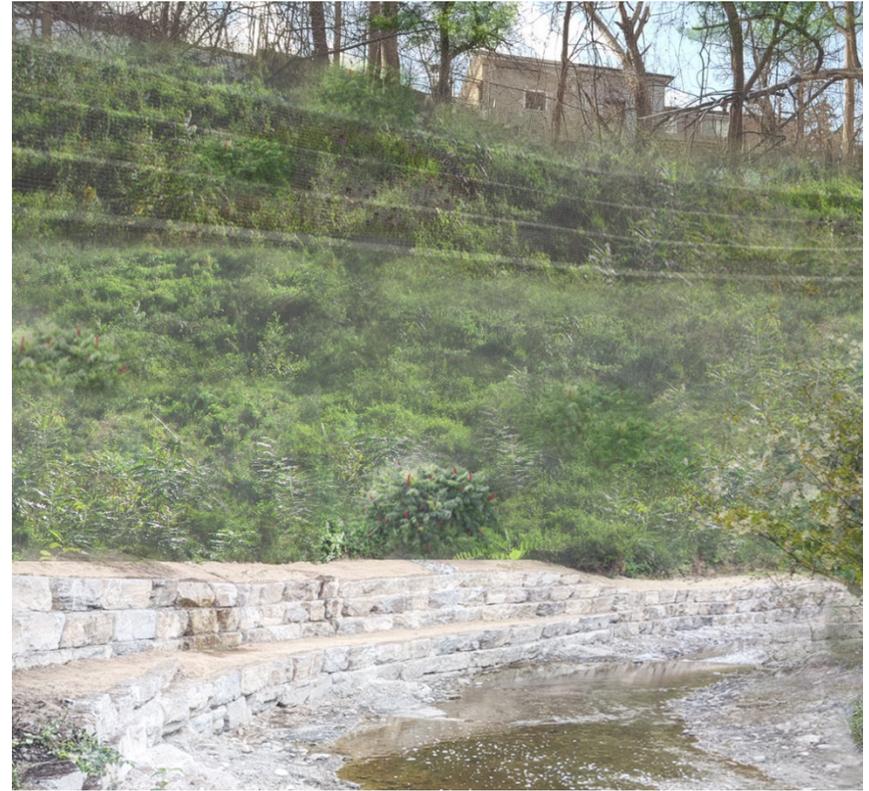
Figure 27: Existing slope behind affected properties on Topcliff Ave (left) and rendered photo of what the preferred alternative of an implemented RSS system with armourstone toe protection may look like (right). *Source: TRCA, 2020.*
