Technical Report

Humber River Watershed within the City of Toronto Floodplain Mapping Update

Toronto and Region Conservation Authority
101 Exchange Avenue, Vaughan, Ontario, L4K 5R6

September 14, 2018

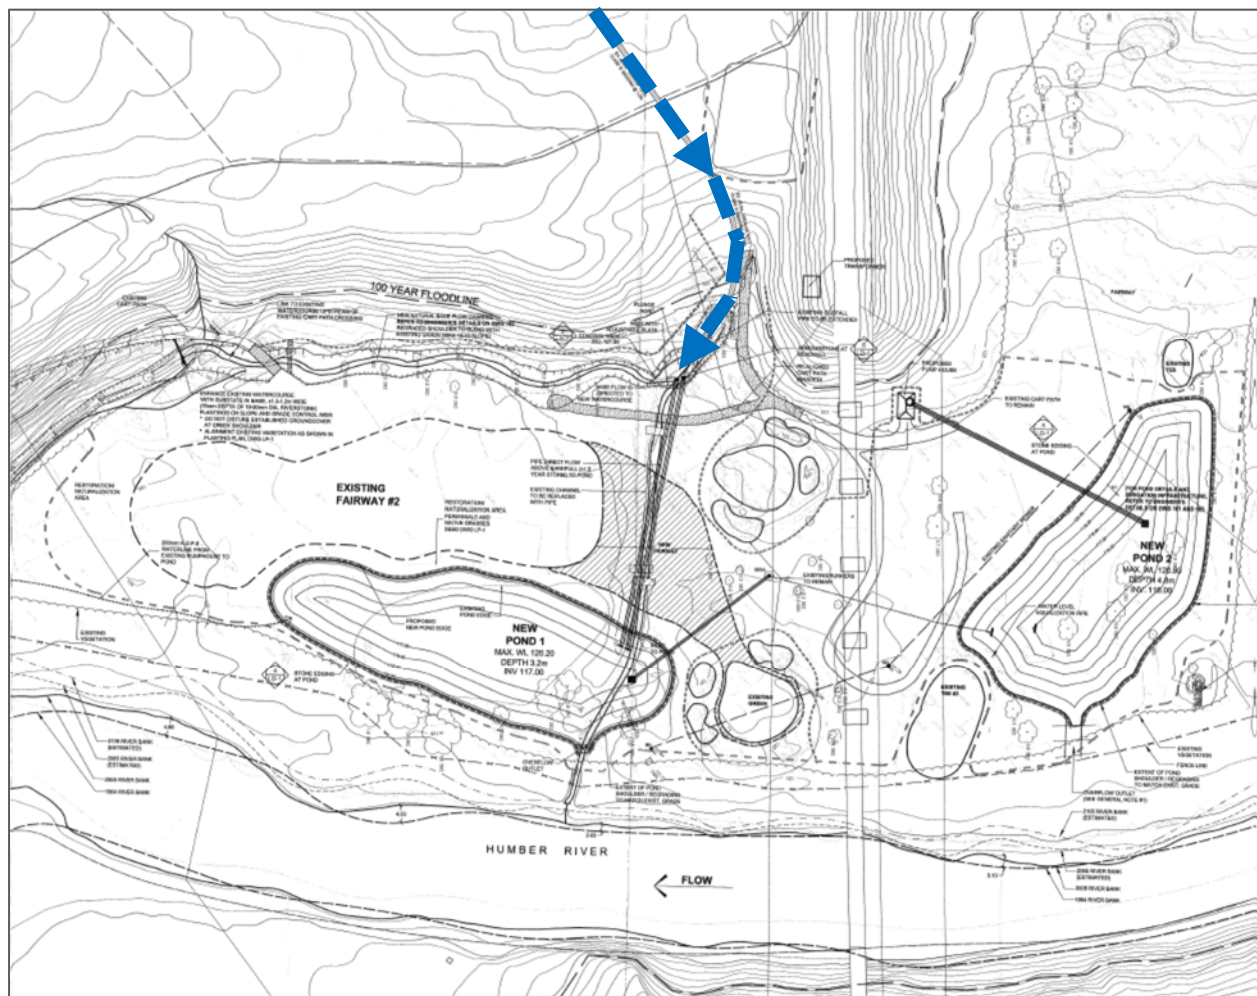
Figure 3-4: Weston Golf Club Culvert Alignment

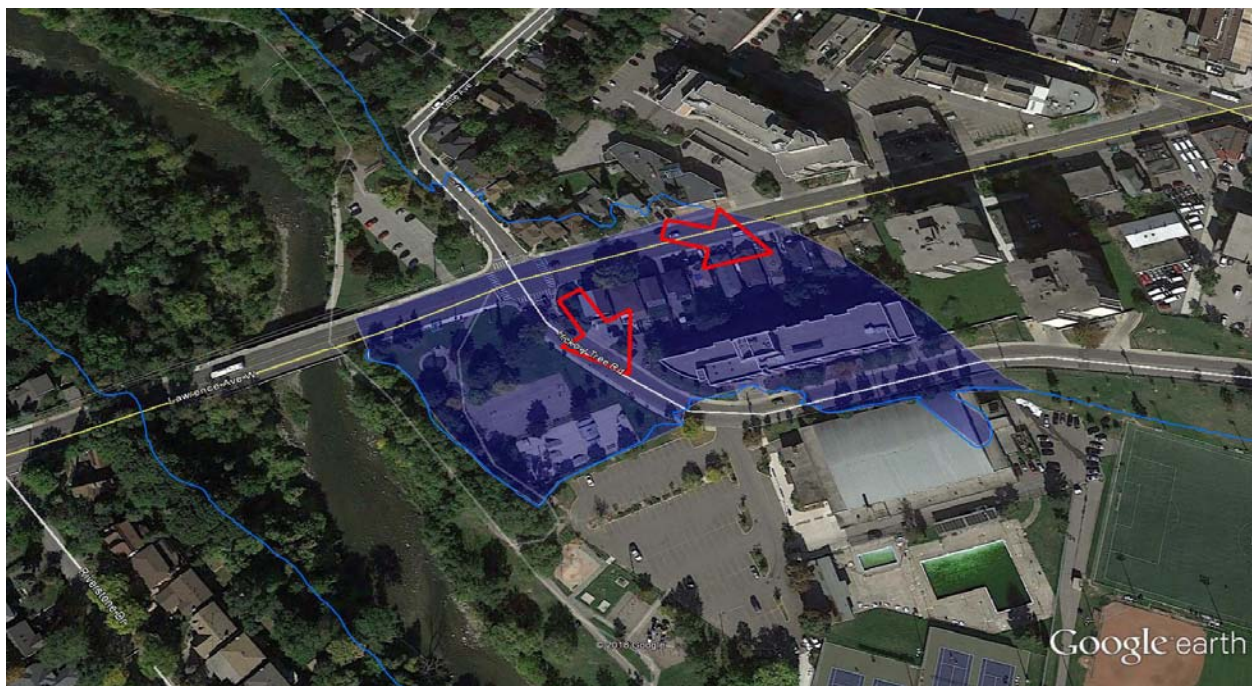
Figure 4-3: Spill Area #3 – Lawrence Avenue West / Hickory Tree Road

It is recommended that 2D modelling be used for this area to better delineate the floodplain on the east side of the Lawrence Avenue West Bridge and to better understand the flood risk associated with those properties in the spill zone.

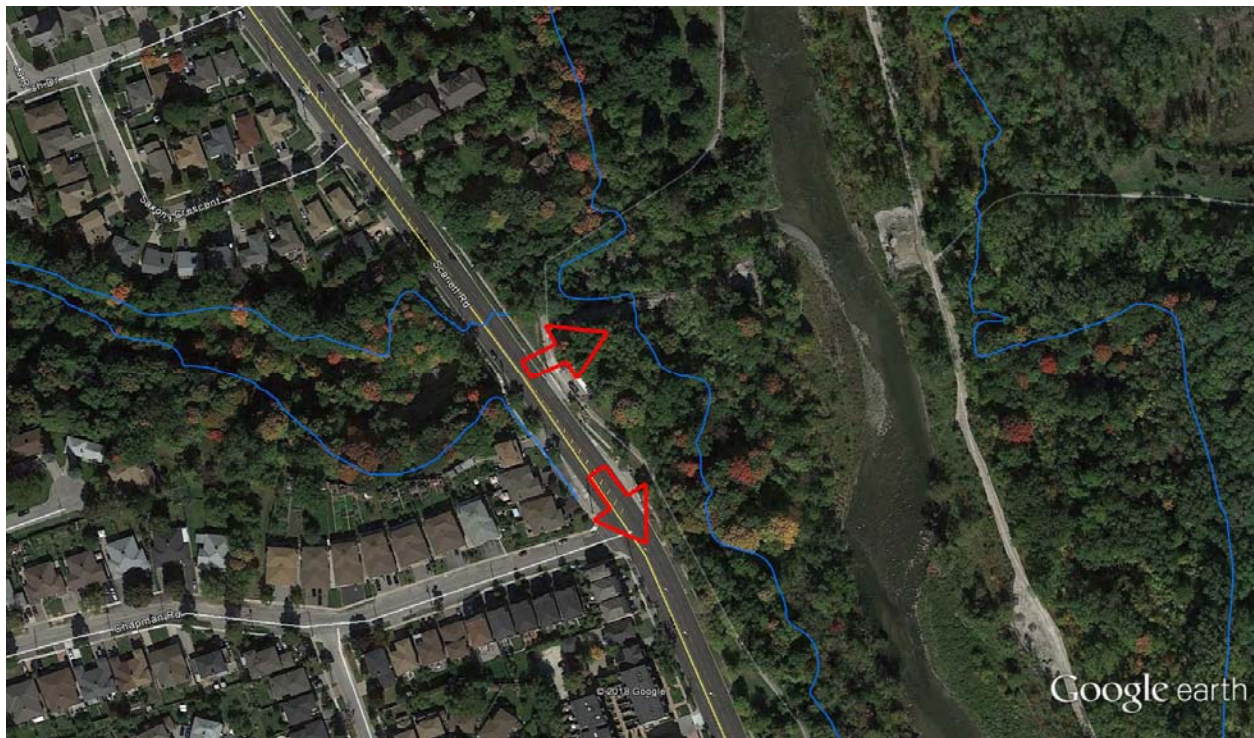
Figure 4-4: Spill Area #4 – Scarlett Road / Chapman Road

It is recommended that 2D modelling be used for this area to better delineate the floodplain along the section of Scarlett Road potentially impacted by the spill and to better understand the flood risk associated with those properties in the spill zone.

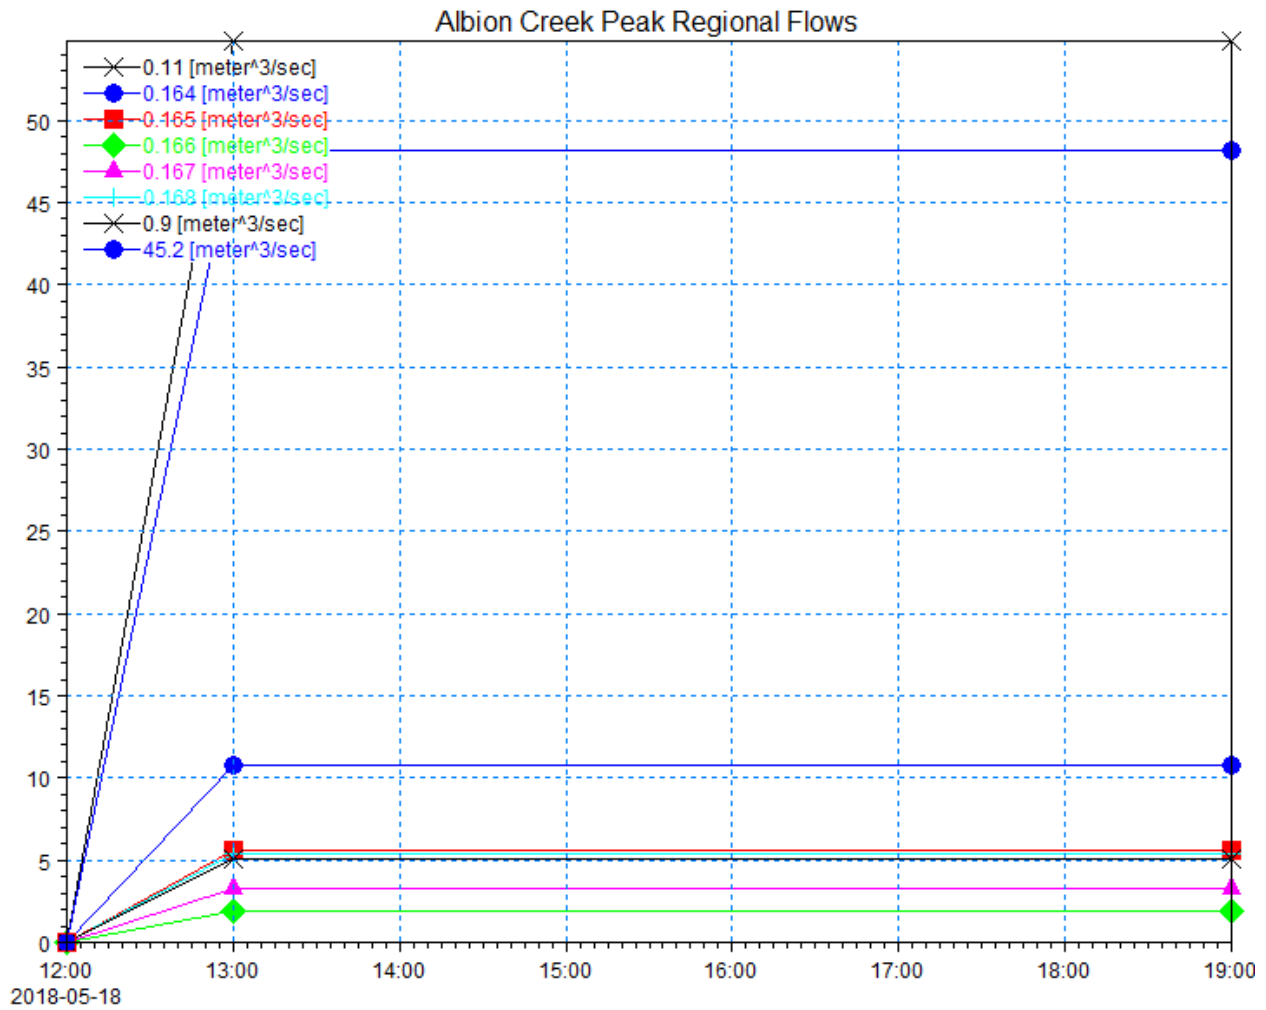
Figure 9 – Regional peak flows applied in the 2D MIKE 21 model

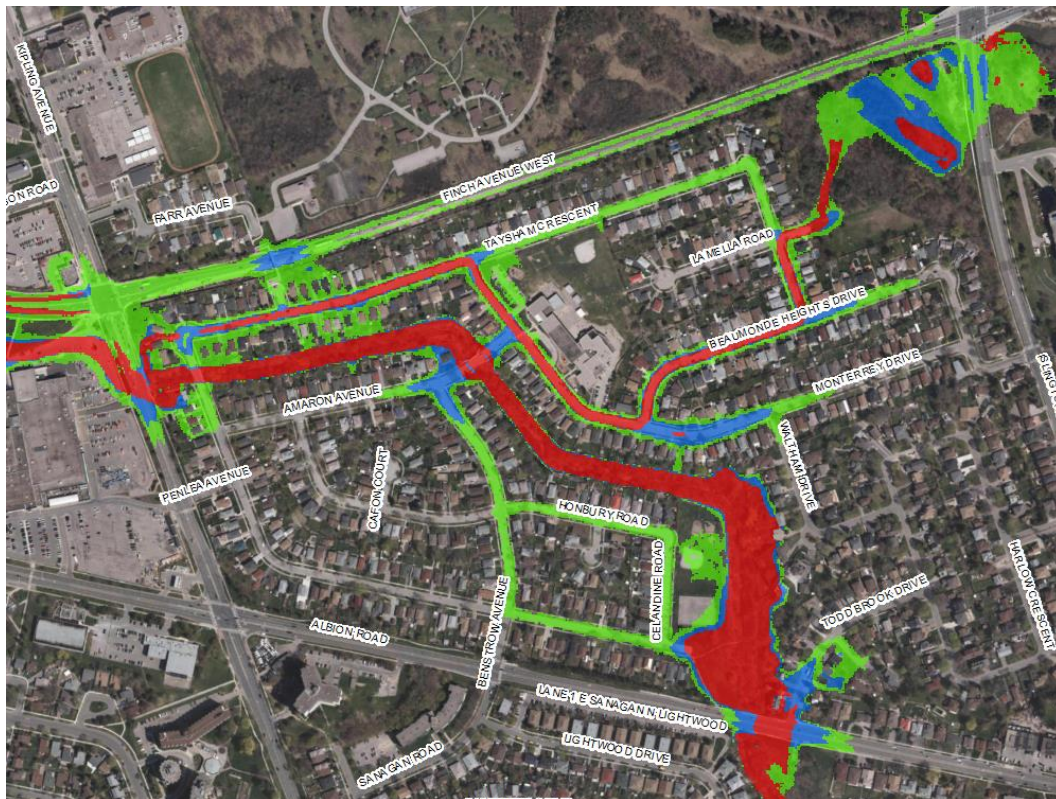
Figure 21 – Distribution of low- moderate- and high-risk flood at Finch Ave. W/Kipling Ave.
