watershed plan

SHORELINE MANAGEMENT PROGRAM

THE METROPOLITAN TORONTO AND REGION
CONSERVATION AUTHORITY

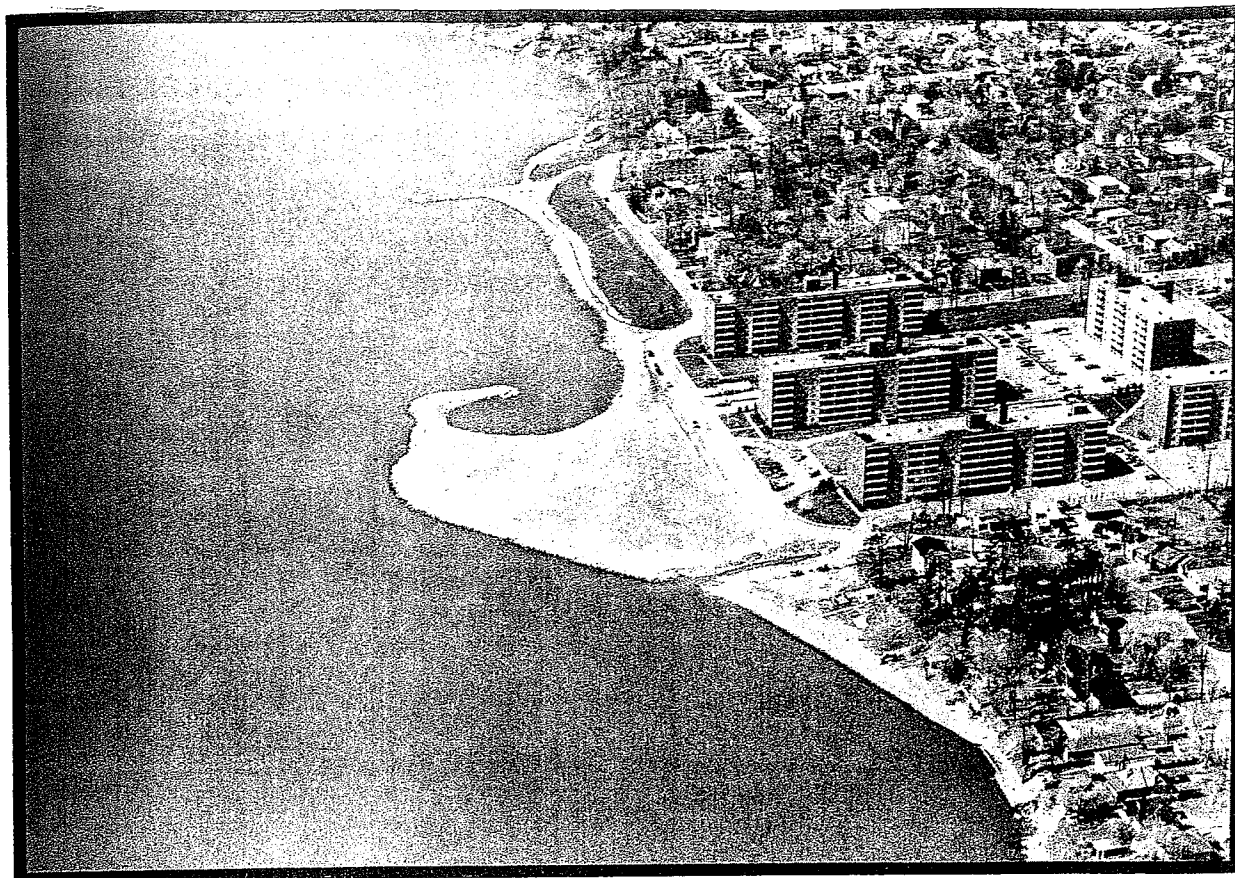
THE PROTECTION OF LONG BRANCH PARK IN ETOBICOKE WAS COMPLETED BY THE AUTHORITY IN 1974 TO STABILIZE THE FILLED AREA AND PREVENT THE LOSS OF THIS VALUABLE LOCAL OPEN SPACE. (PHOTO 1)

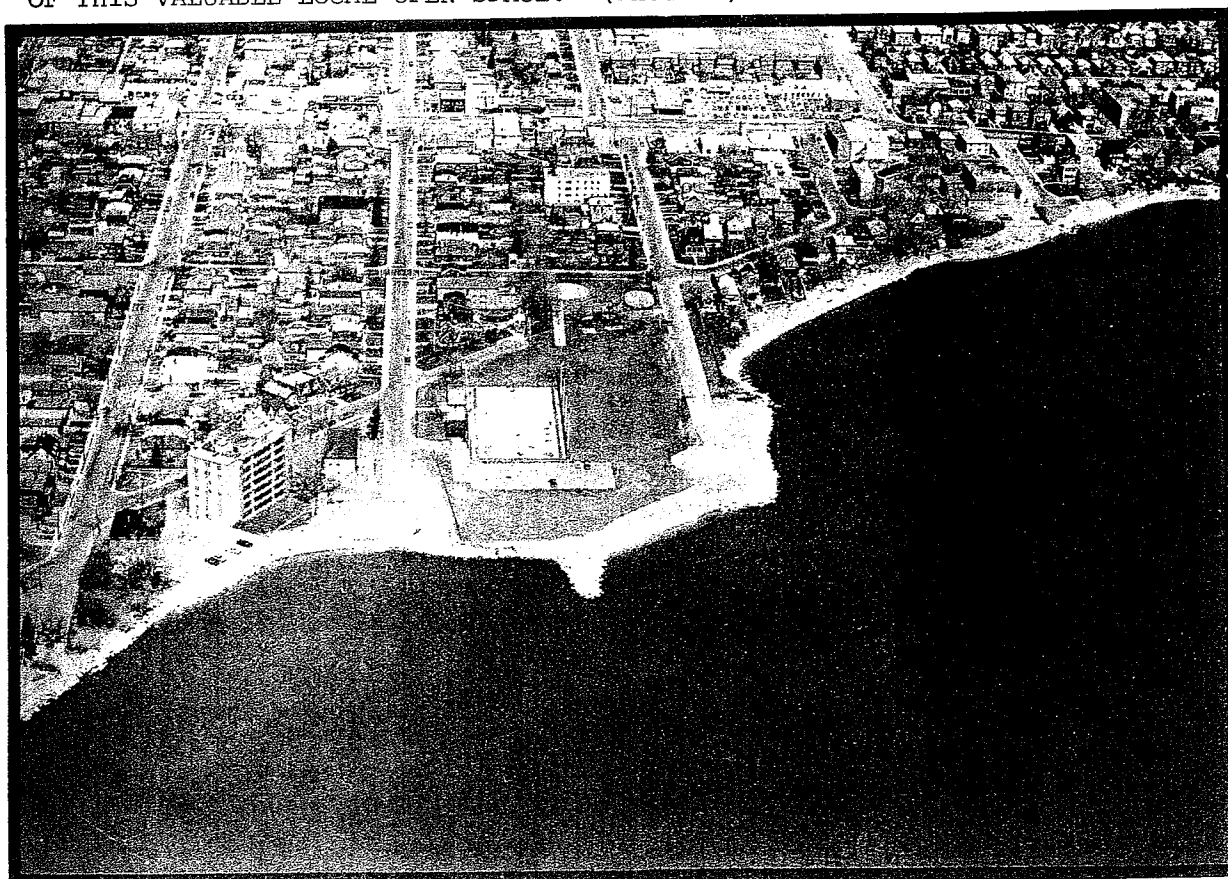
PRINCE OF WALES PARK SUFFERED SEVERE EROSION DURING THE HIGH LAKE LEVEL PERIOD OF 1973. SHORE PROTECTION WAS INSTALLED BY THE AUTHORITY EARLY IN 1974. (PHOTO 2)

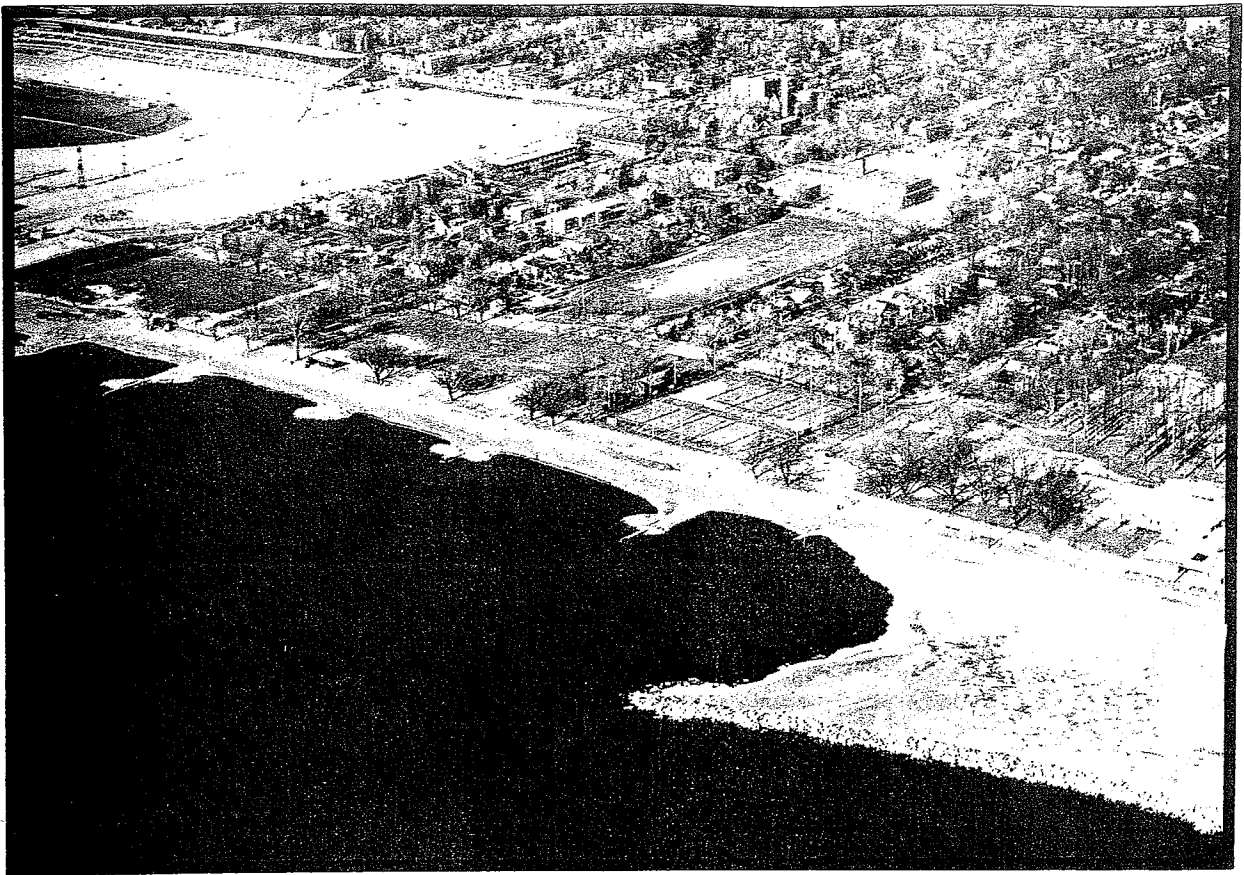
EASTERN BEACHES: THE POPULAR BOARDWALK WAS DESTROYED IN THIS AREA IN 1973. SHORELINE PROTECTION CONSTRUCTED BY THE AUTHORITY IN 1979 INCLUDED A WIDE PROTECTIVE BEACH. (PHOTO 3)

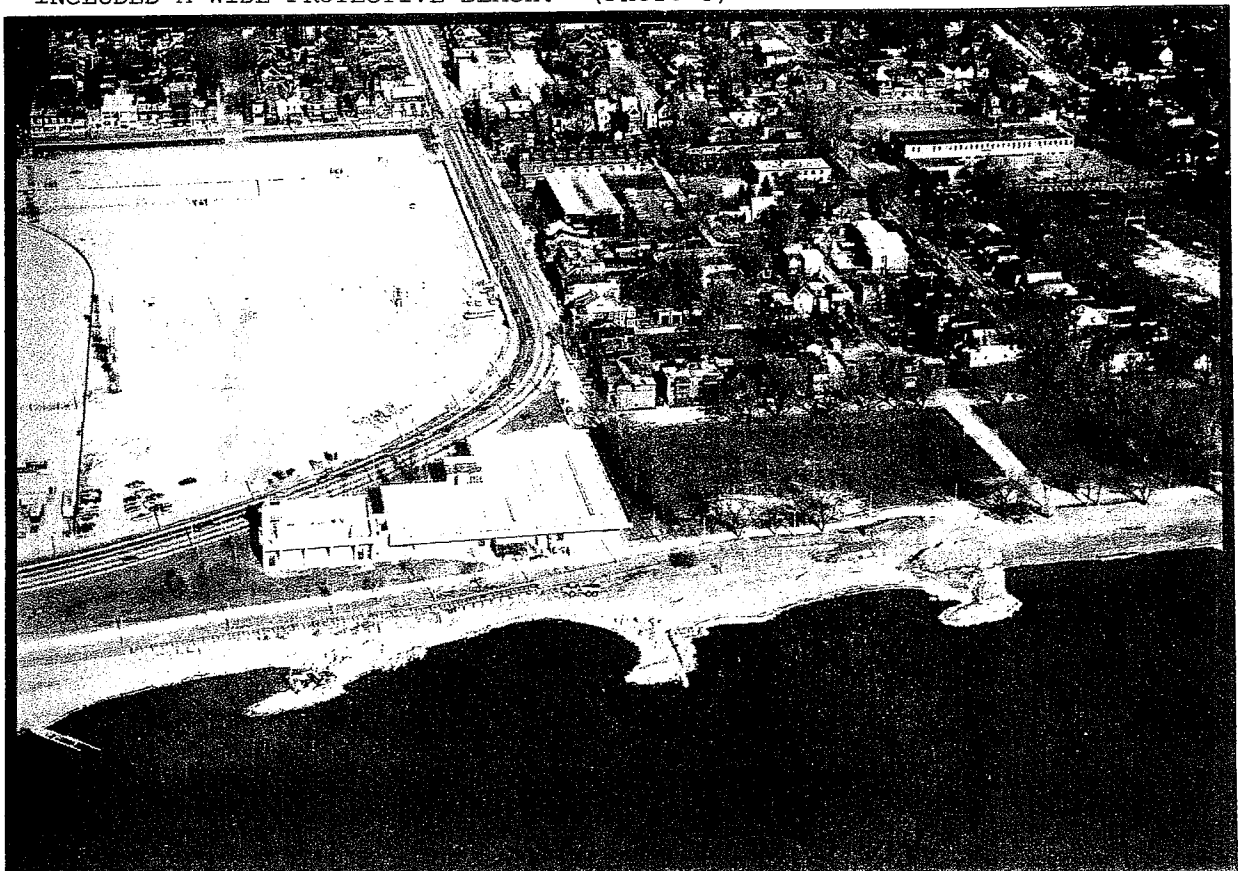
EASTERN BEACHES: LARGE ARMOUR STONE WAS PLACED TO CREATE BEACH ANCHORS. (PHOTO 4)

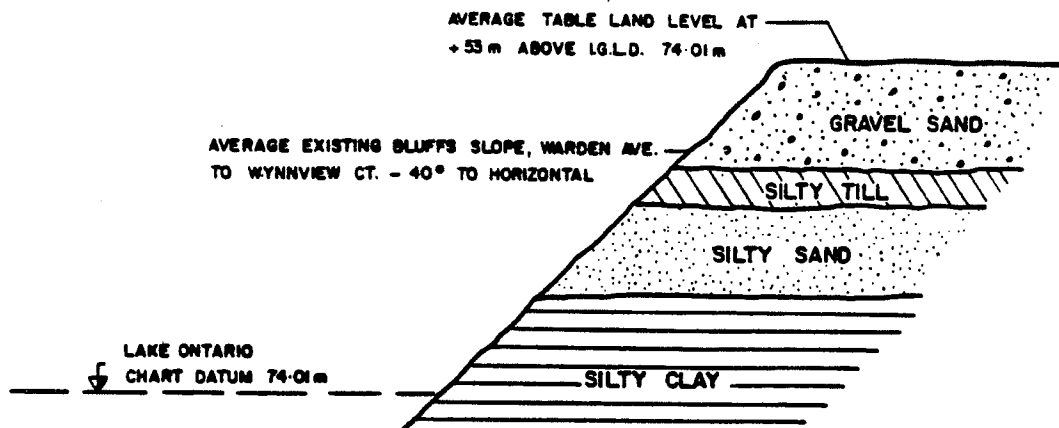
FIG. 2

East of the Hunt Club property the stability of the bluff face deteriorates rapidly. Figure 2 shows a representative profile of the bluff face between Warden and Birchmount. Throughout most of this area only a narrow beach exists to protect the toe of the bluff against wave attack. Therefore, during periods of high lake levels and storm conditions, the toe of the bluff is undermined, leading to subsequent failure of the bank above. In addition to the wave erosion problem, the bluff contains two sand layers carrying high volumes of groundwater which emerge on the bluff face. These sand layers have gradually been eroded by the groundwater flow at the face of the bluff, resulting in failure of the overlying strata.

TYPICAL BLUFF PROFILE

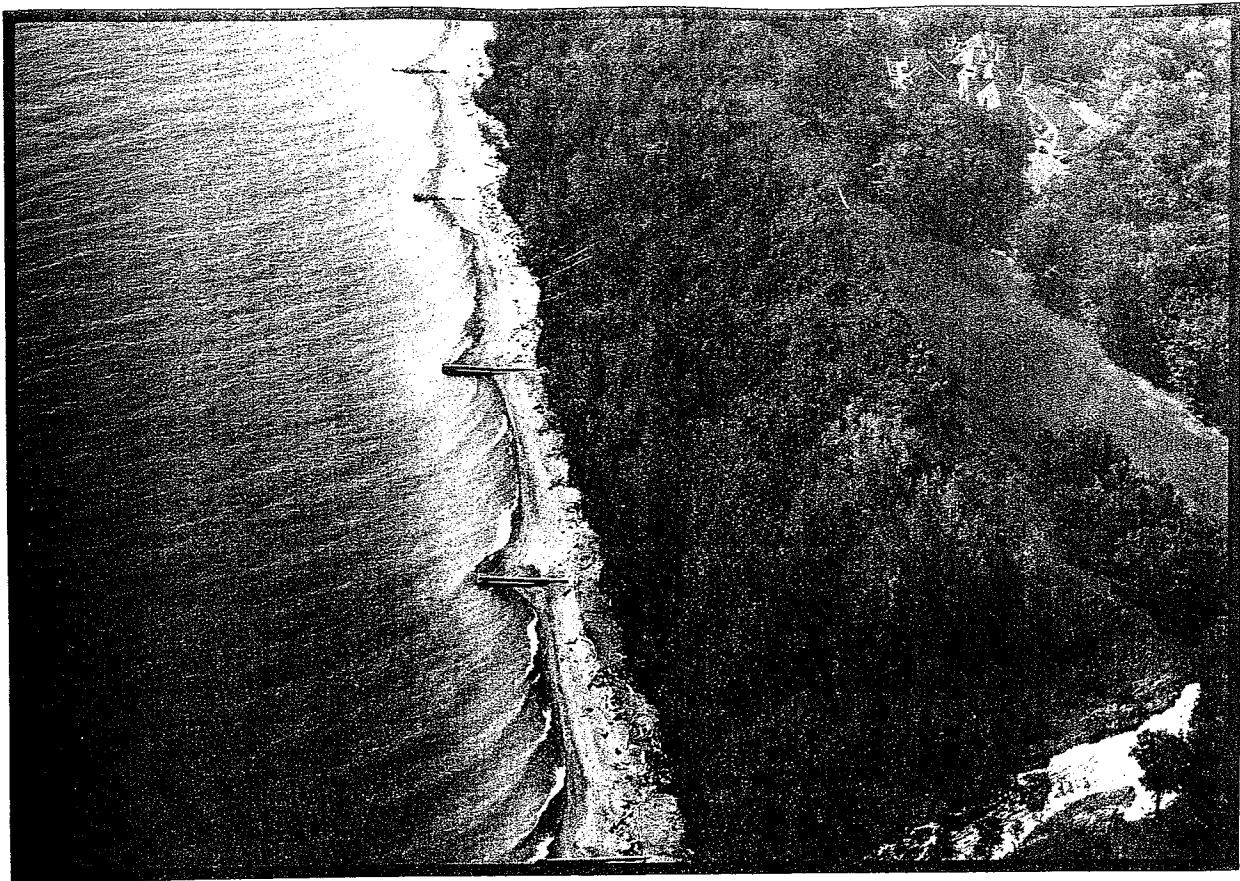
SEVERAL DECADES OF WORK BY THE TORONTO HUNT CLUB TO PROTECT THE TOE OF THE BLUFF, DRAIN THE FACE OF THE BLUFF AND ESTABLISH VEGETATION HAVE PRODUCED A RELATIVELY STABLE SHORELINE. (PHOTO 5)

supplemented in the 1950's (Photo 5). Although seriously damaged in the high water period of 1973, the groyne field held a protective beach which prevented wave attack from actively undermining the toe of the slope. Since the failure of a portion of the groyne field in 1973, some recurrence of toe erosion is evident, with the resultant failure in the bank above to be expected. The reestablishment of adequate toe protection along the Hunt Club property is essential to the long term stability of this area of the bluff face.

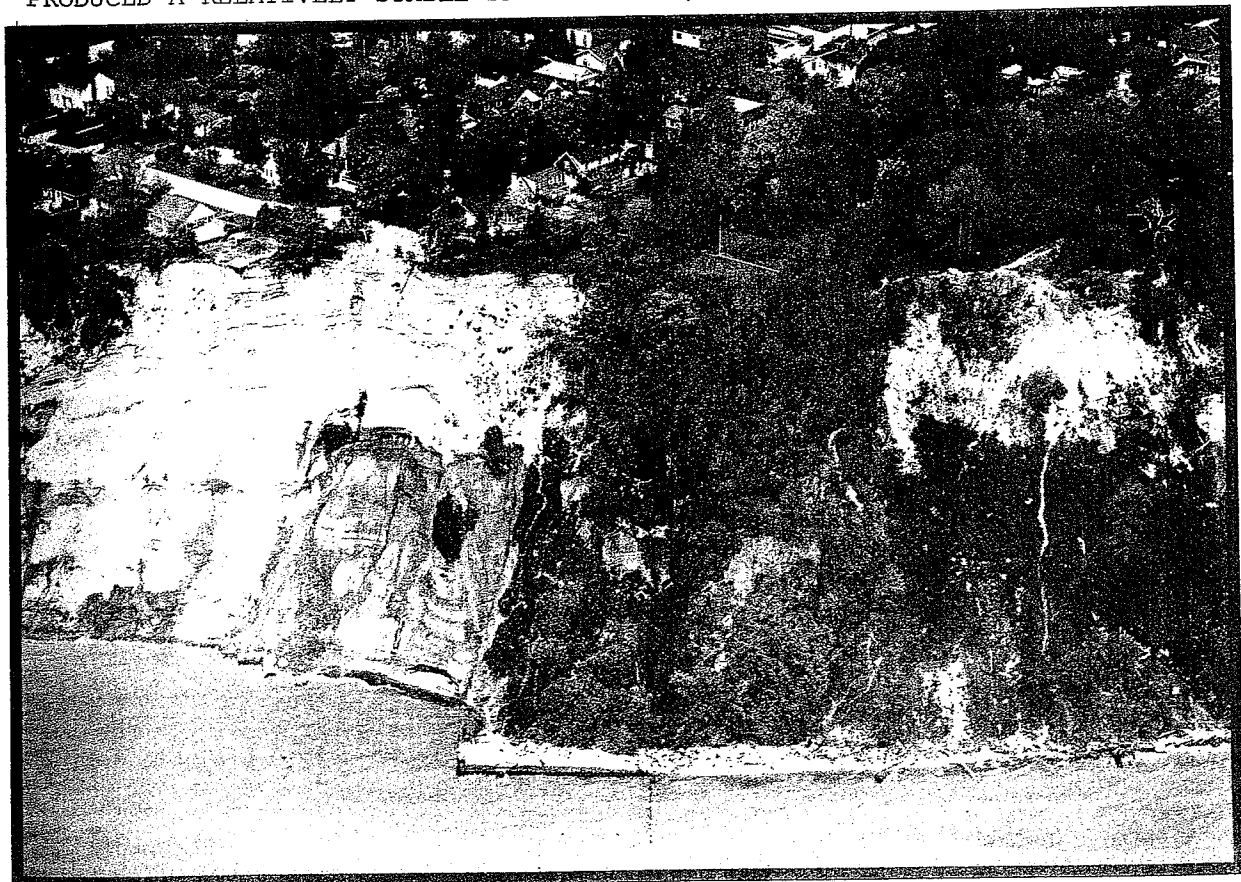
KINGSBURY/HARDING: THE EFFECT OF TOE PROTECTION ON TALUS STABILITY IS APPARENT HERE BUT THE IMPACT ON ADJACENT SHORELINES MUST BE CAREFULLY CONSIDERED. (PHOTO 6)

A similar situation occurred at the corner of Kingsbury Crescent and Harding Boulevard resulting in three houses becoming endangered and subsequently requiring their purchase and removal by the Authority. Again, only a massive filling program carried out by the Scarborough Works Department saved the road and servicing and delayed the requirement for removal of other houses. In both cases a serious hazard developed in a very short time period after lengthy periods of average recession rates. It is not unreasonable to assume that similar situations caused by concentrations of groundwater flow will result in future hazards at other locations.

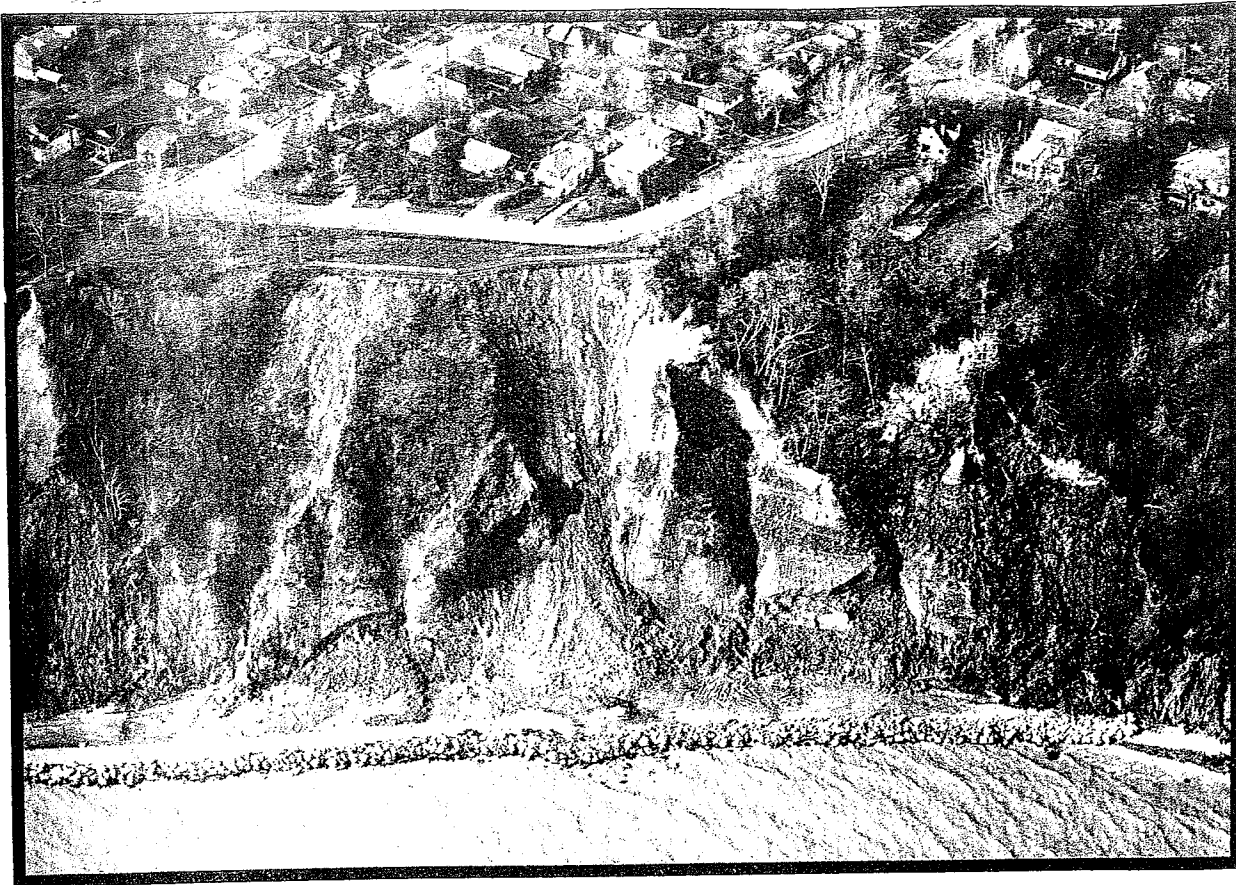
THE ARMOUR STONE REVETMENT CONSTRUCTED AT CRESCENTWOOD PARK IN 1979 WILL PROTECT THE TOE OF THE BLUFF AGAINST WAVE ATTACK AND ALLOW TALUS MATERIAL TO REMAIN. . (PHOTO 7)

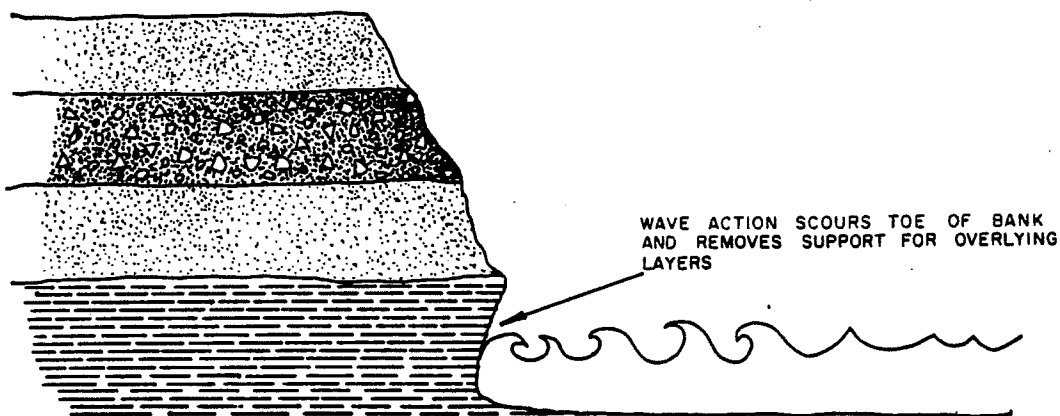
FIG.3

Waves acting on high bluff shorelines can undercut the slope by removing large volumes of material at the base of the slope, thereby eliminating support for overlying layers and causing bank failure. Talus material which may have accumulated at the base of the bluff can also be removed during periods of wave attack (Figure 3).

EFFECT OF WAVE UNDERCUTTING

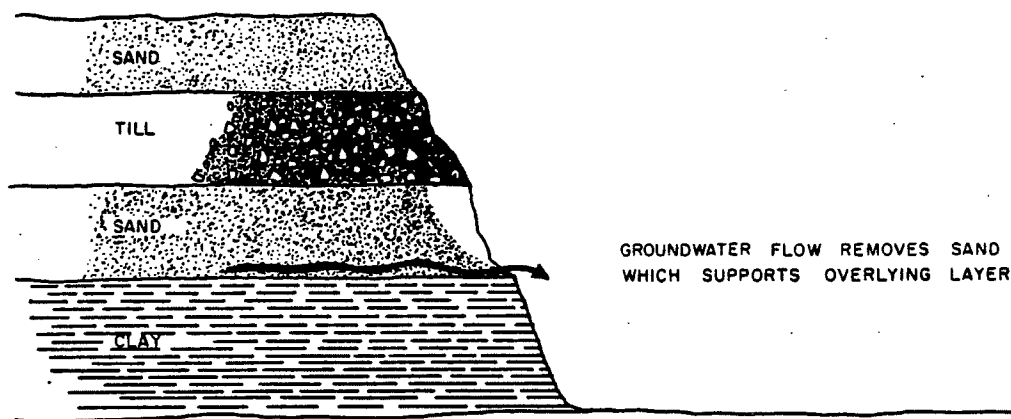
FIG. 6

Another important factor in shoreline erosion in the Toronto area, particularly along the high bluff shoreline in Scarborough, is surface erosion. Surface erosion generally occurs on slopes which are steeper than the natural angle of repose of the material and which are unable to support vegetative cover. It occurs because of the influence of rainfall and runoff as well as wind. Surface erosion can also be rapidly accelerated by groundwater seepage, as is frequently the case along Scarborough Bluffs. Surface erosion due to the influence of groundwater is particularly important in the high bluff shoreline which contains alternating layers of permeable and impermeable materials. The stratigraphy of the Scarborough Bluffs frequently contains a layer of sand over relatively impermeable clay or silty till material. The groundwater is confined in the sand layer until it reaches the face of the bluff, at which point it has sufficient velocity to carry away the sand material. As the sand layer is gradually deteriorated, the support for overlying layers is eliminated, resulting in surface sloughing of layers above the sand (Figure 6, Photo 9).

EFFECT OF SURFACE EROSION

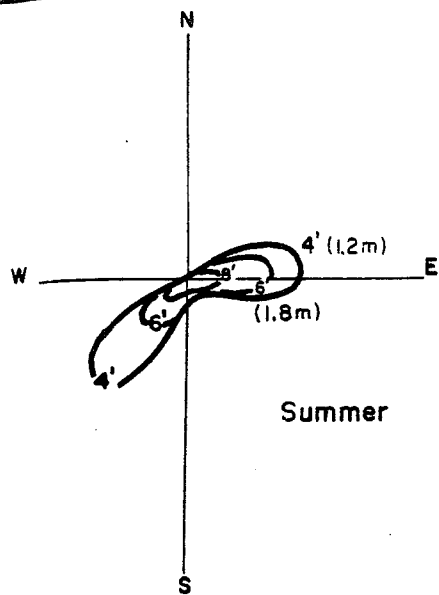
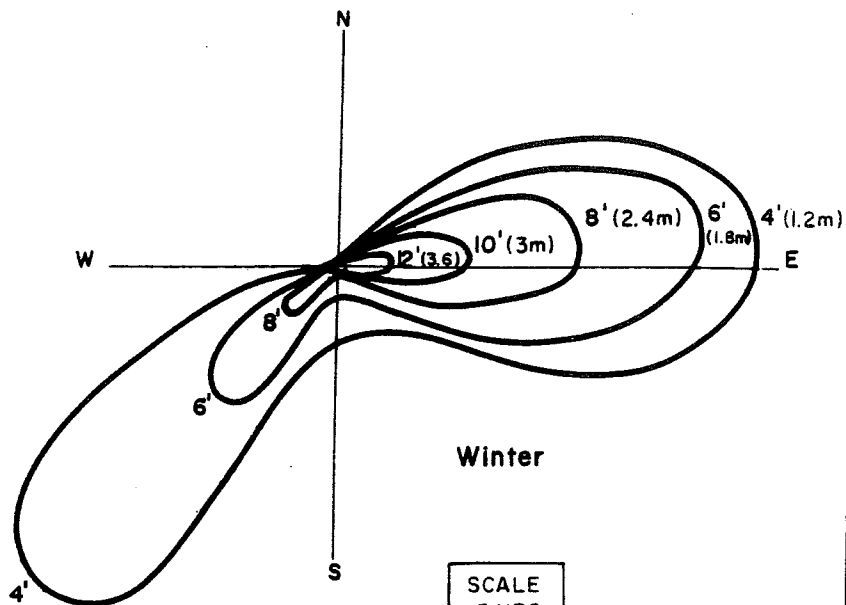
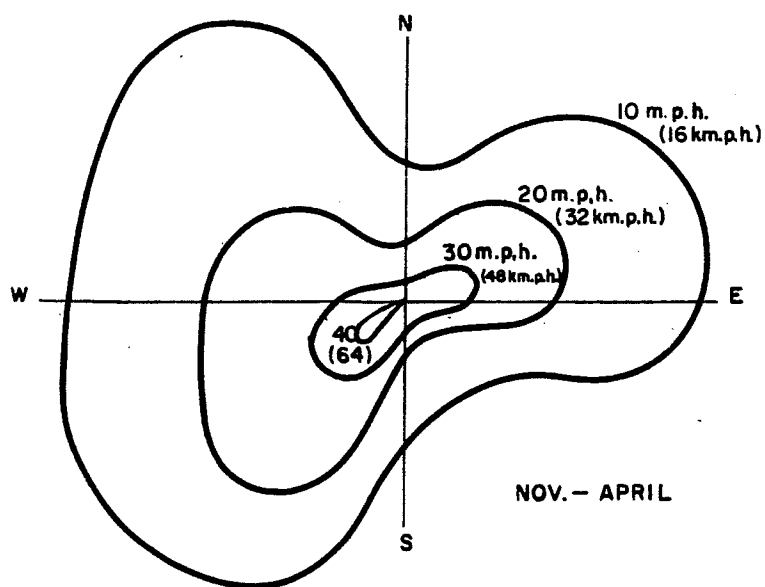
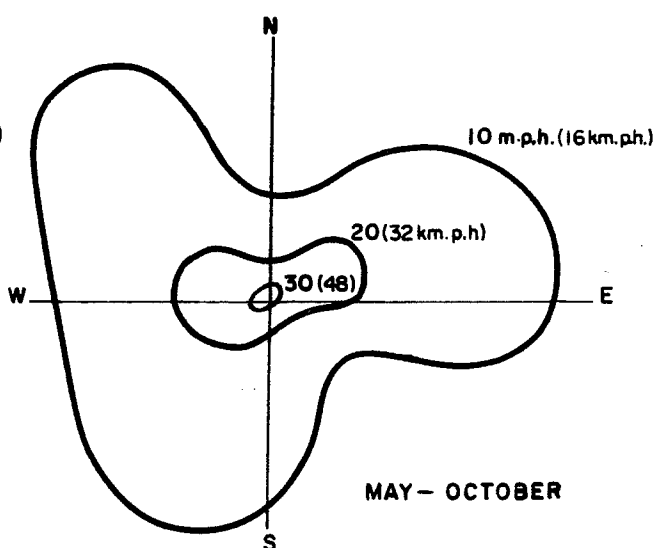
FIG. 4

Significant Wave Roses
South of Toronto Islands
1948-1964 AVG.

WINTER AND SUMMER
WAVE & WIND ROSES

The principal cause of erosion in the area under the Authority's jurisdiction is wave attack. Waves impinging on the shoreline under storm conditions have sufficient energy to take large volumes of material into suspension. Once the material is in suspension it can be carried parallel to the shoreline or offshore into deeper water, depending on current patterns at the time. Material moved in this manner is known as littoral drift. The amount of wave energy which reaches the shoreline is dependent upon a number of factors, including the wave height, wave length, wave period, underwater topography, and shoreline configuration. Waves striking the shoreline at an angle other than 90 degrees result in longshore currents being established. Generally, the longshore currents carry coarse sediments parallel to the shoreline while finer sediments remain in suspension longer and usually are deposited in deep water offshore. Littoral transport is important to the replenishment of beaches. Material can be transported in either direction depending upon the direction of wave attack under a particular storm condition. In the Toronto area the most severe storm conditions are generated by either southwesterly winds or southeasterly winds. Although the southeasterly storms are generally not as common as the southwesterly storms, they do result in more energy reaching the shoreline. As a result, in most areas the net transport of material is to the west.

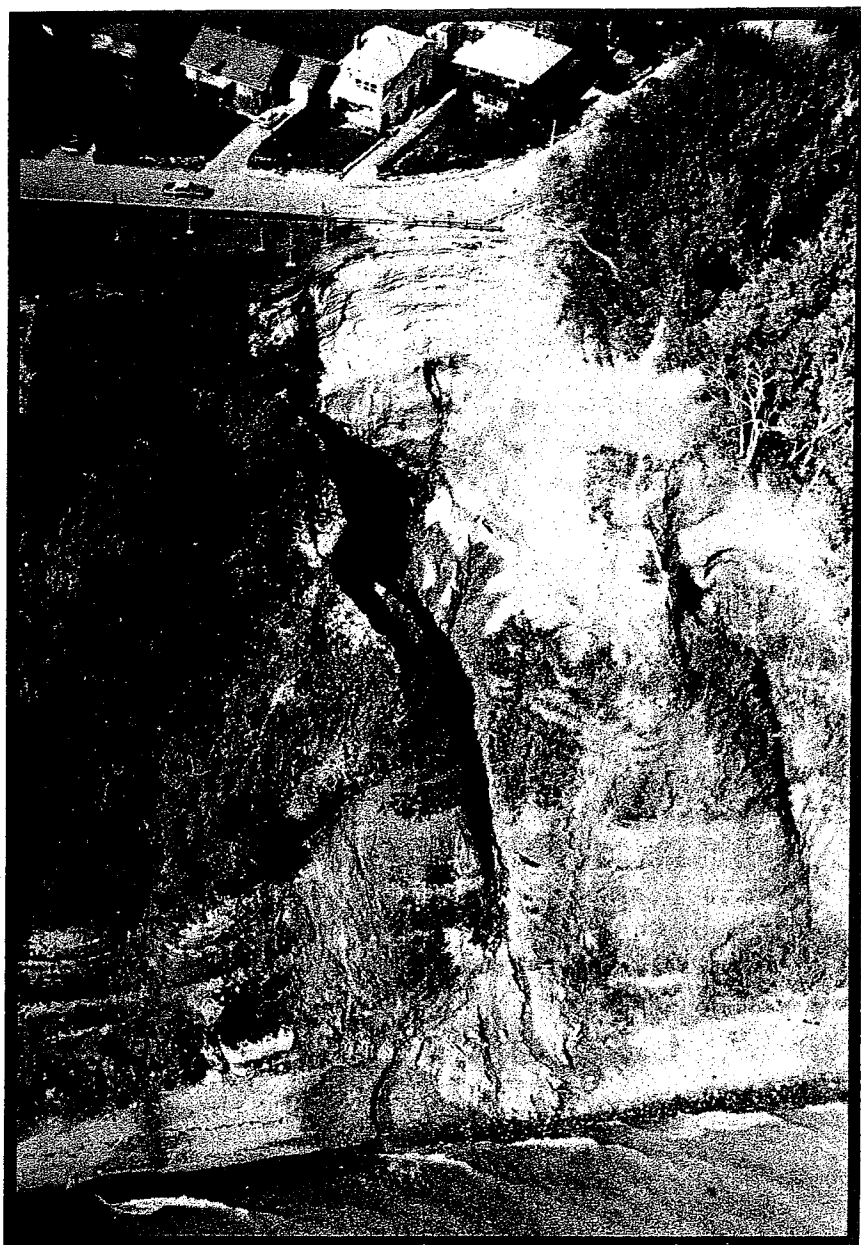
A HIGH FLOW OF GROUNDWATER EMERGING AT THE BLUFF
FACE NEAR KILDONAN DRIVE RESULTED IN A RECESSION
OF OVER 6 METRES IN ONE YEAR. (PHOTO 9)

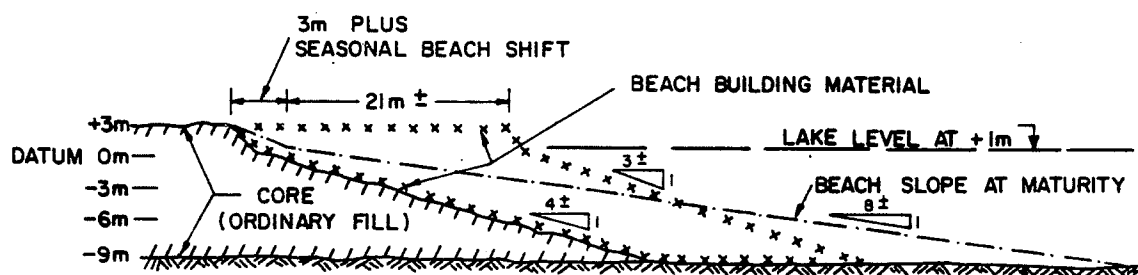
FIG. 7

TYPICAL PROFILE

BASIC DESIGN FEATURES OF
AN ANCHORED BEACH

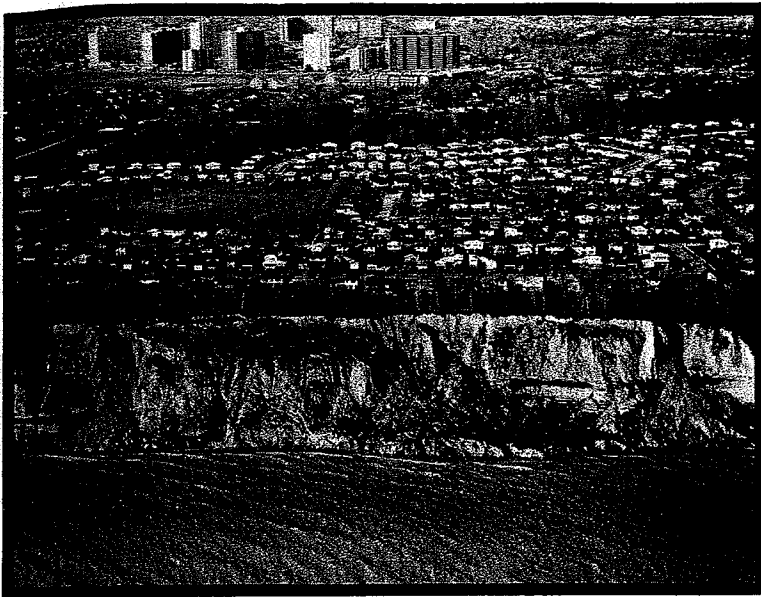
THE SHORELINE ADJACENT TO SOUTH MARINE DRIVE IS AFFECTED BY MASSIVE SLUMPING. THE SETBACK ZONE WHICH WAS ESTABLISHED AT THE TIME OF DEVELOPMENT HAS BEEN LOST TO EROSION IN SEVERAL LOCATIONS. (PHOTO 10)

In some isolated areas of the Scarborough Bluffs, particularly along South Marine Drive, slumping is a significant erosion mechanism resulting in rapid loss of tableland. Slumping is a mass soil movement resulting from unstable bluff slopes. A bluff slope can become unstable in a number of ways. In the South Marine Drive location it appears that the bluff material has sufficiently low permeability that on some occasions the water content of the soil is elevated to the point that the soil loses its internal strength and slippage zones are created (Photo 10).
