CLASS ENVIRONMENTAL ASSESSMENT FOR REMEDIAL FLOOD AND EROSION CONTROL PROJECTS

Yellow Creek Near Heath Street East
Erosion Control and Slope Stabilization Project
City of Toronto

PROJECT PLAN – FOR REVIEW
NOVEMBER 21, 2022

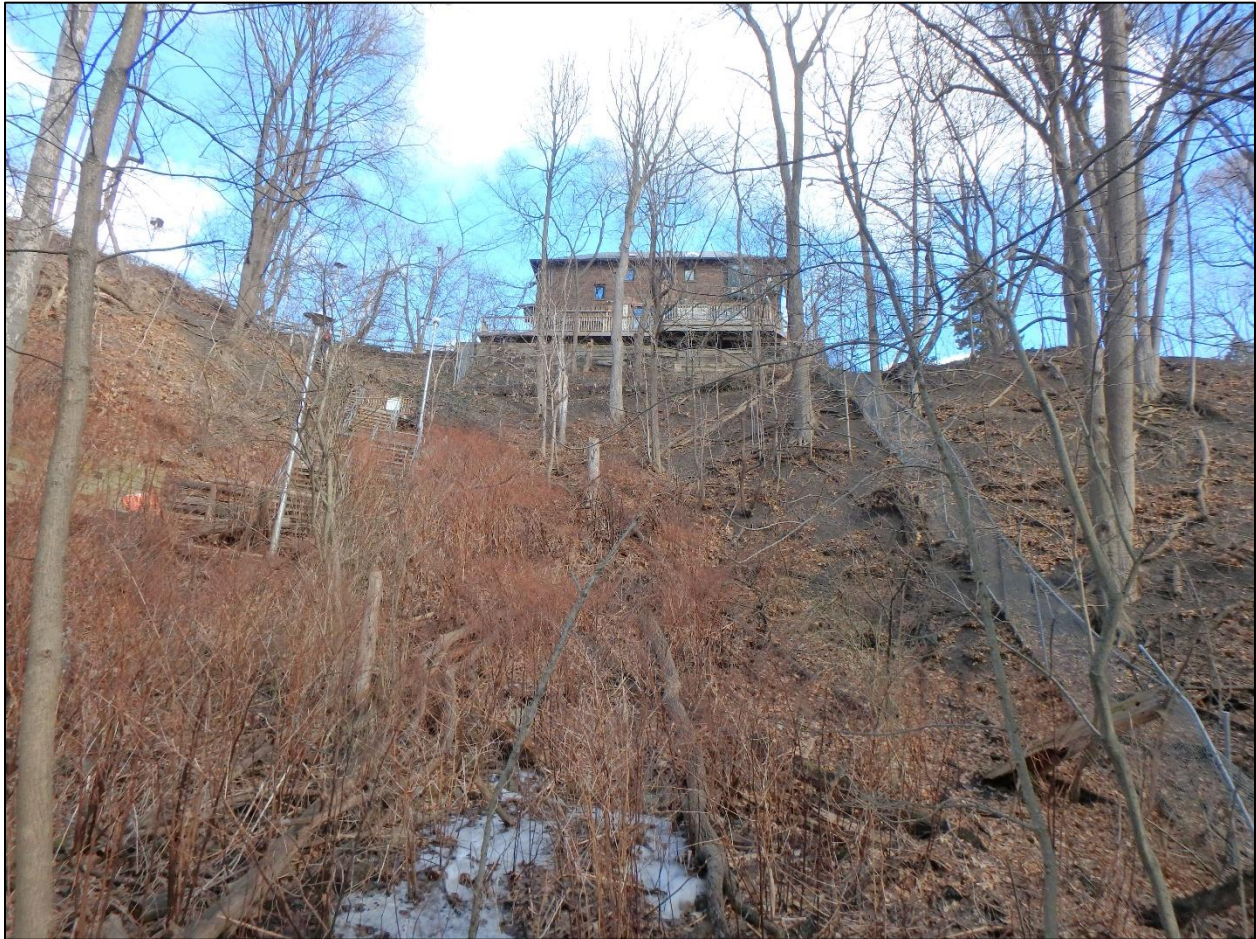
Figure 3: The eastern valley slope where slope stabilization work has been recommended (TRCA, 2016).

The focus of the Project involves stabilizing a steep segment of eastern valley slope within the Vale of Avoca ravine (**Figure 3**). The Project, located within a core area of the City of Toronto, is surrounded by heavy urban land use (**Figure 4**). Heavily urbanized environments have critical implications on storm water management and typically result in increased erosion issues.

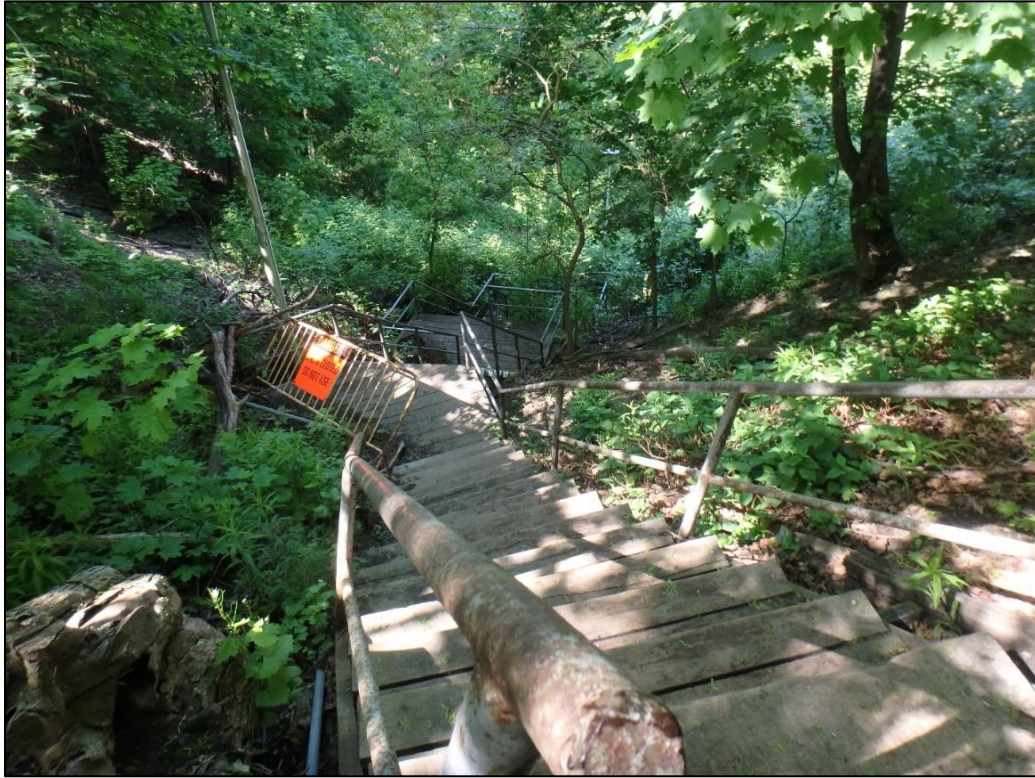
Figure 5: Displacement of soil across the lower landing and leaning guard rails of the municipally owned staircase (TRCA, 2017).

A City of Toronto owned pedestrian staircase located off of Heath Street East is located within the Project area and was reported to have been impacted by slope stability issues following the July 8, 2013 severe weather event. Due to continued slope stability concerns affecting the structural integrity of the staircase, it was closed in 2014 for the protection of public safety. The condition of the staircase prompted the City to undertake multiple investigations, which identified fundamental slope stability issues below the structure. The City subsequently notified TRCA of these findings and TRCA further investigated the east valley slope within the Project area to determine whether slope conditions were presenting a risk to essential structures located along the top of slope. TRCA's investigations identified that slope instability and erosion hazards were prevalent across the entire eastern slope within the Project area, and multiple essential structures at the top of slope were at long-term risk. Examples of erosion and slope instability impacting the eastern valley slope can be seen in **Figure 5** **Figure 6** **Figure 7**.

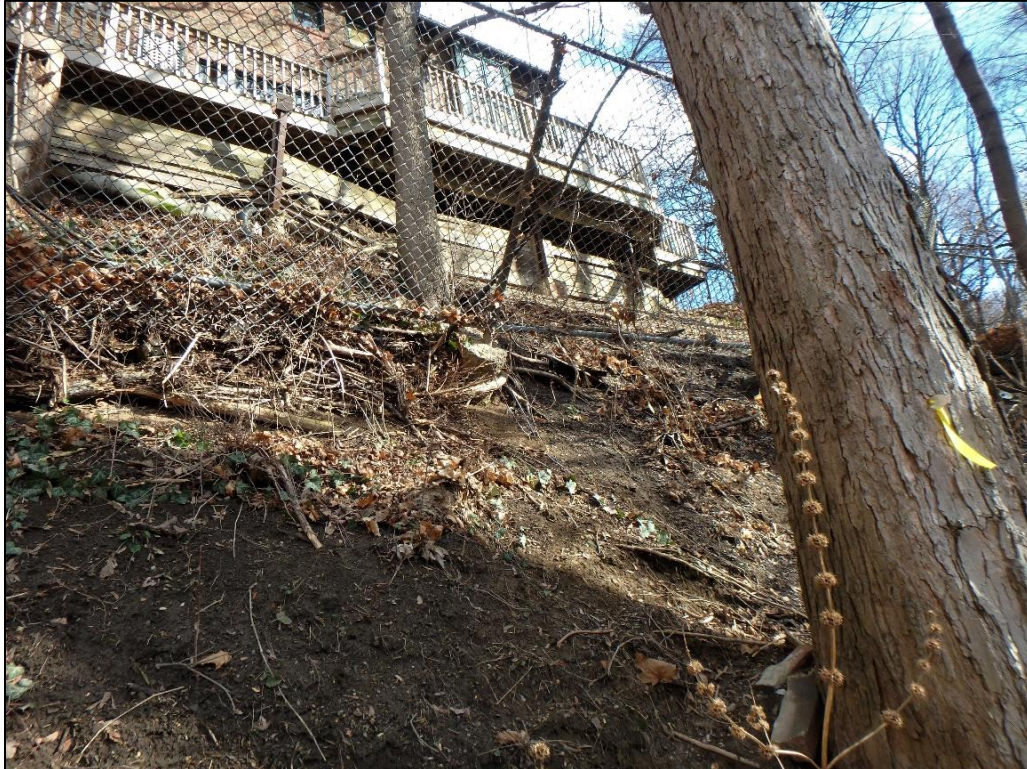
Figure 6: A failing retaining wall below a private residential dwelling can be seen above; the bare upper slope below this property is also indicative of active slope erosion (TRCA, 2016).

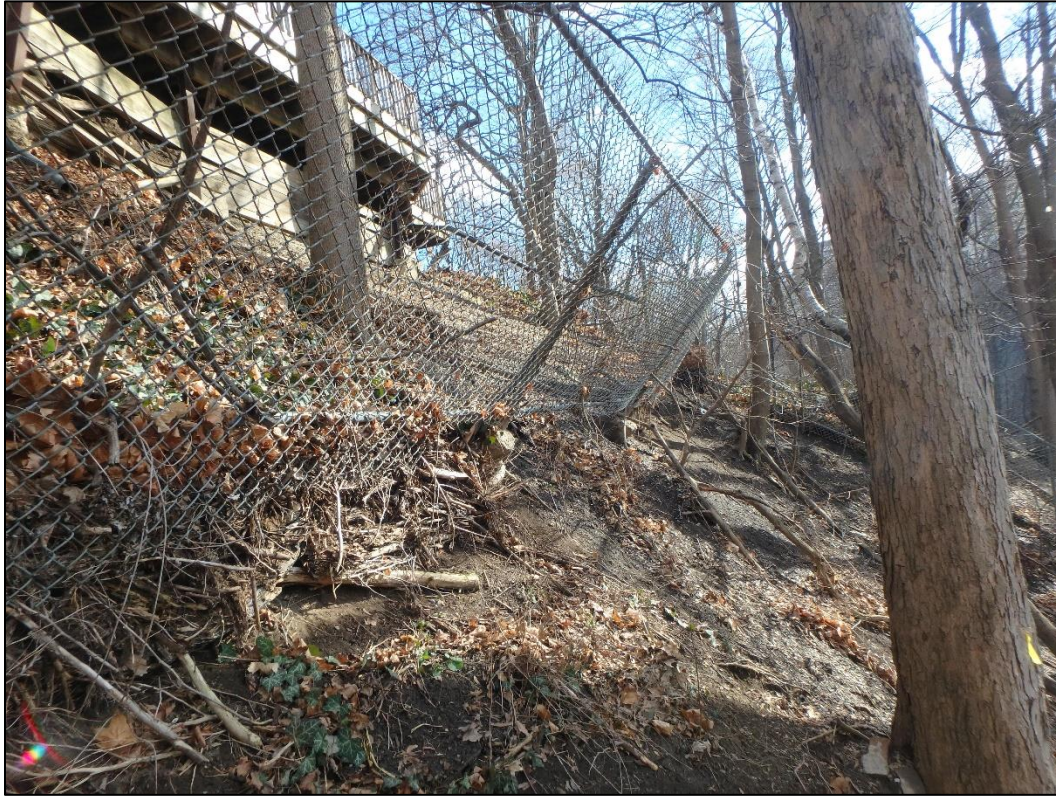
Figure 7: Slope instability and active erosion along the east valley wall have caused a property fence to lean and exposed its footings (TRCA, 2016).

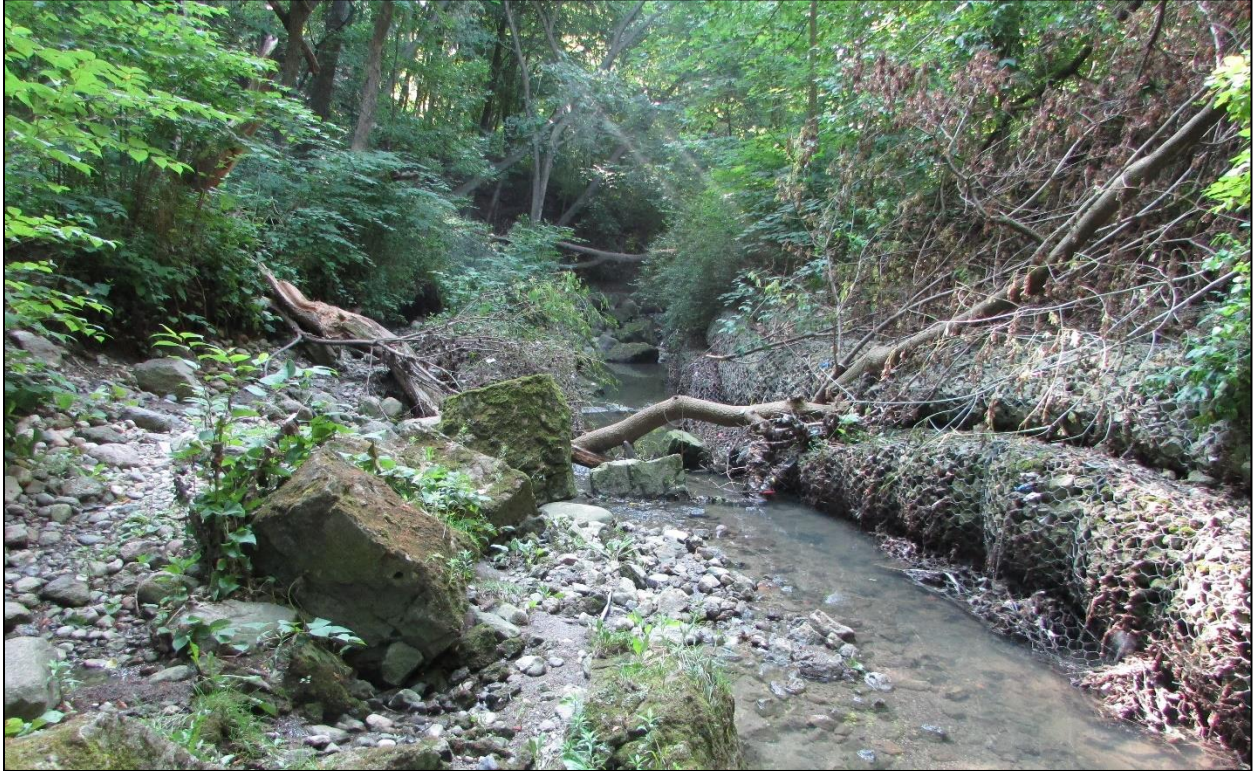
Figure 8: Looking downstream (south) along Yellow Creek, bank stabilization structures have been degraded and displaced by the forces of erosion (TRCA, 2019).

In addition to fundamental slope instability along the eastern valley wall, active toe erosion along the base of this slope is contributing to slope stability concerns. As such, channel remediation was identified as an important part of the solution to protect at-risk structures within the Project area (GeoTerre Ltd., 2017). This toe erosion is being caused by multiple factors including groundwater seepage, flooding events, and degraded bank structures along Yellow Creek. At multiple points, Yellow Creek has outflanked existing bank structures and significantly undercut the toe of slope. **Figure 8 – 10** below depict the degradation of the creek and resulting damage at the base of slope caused by erosion.

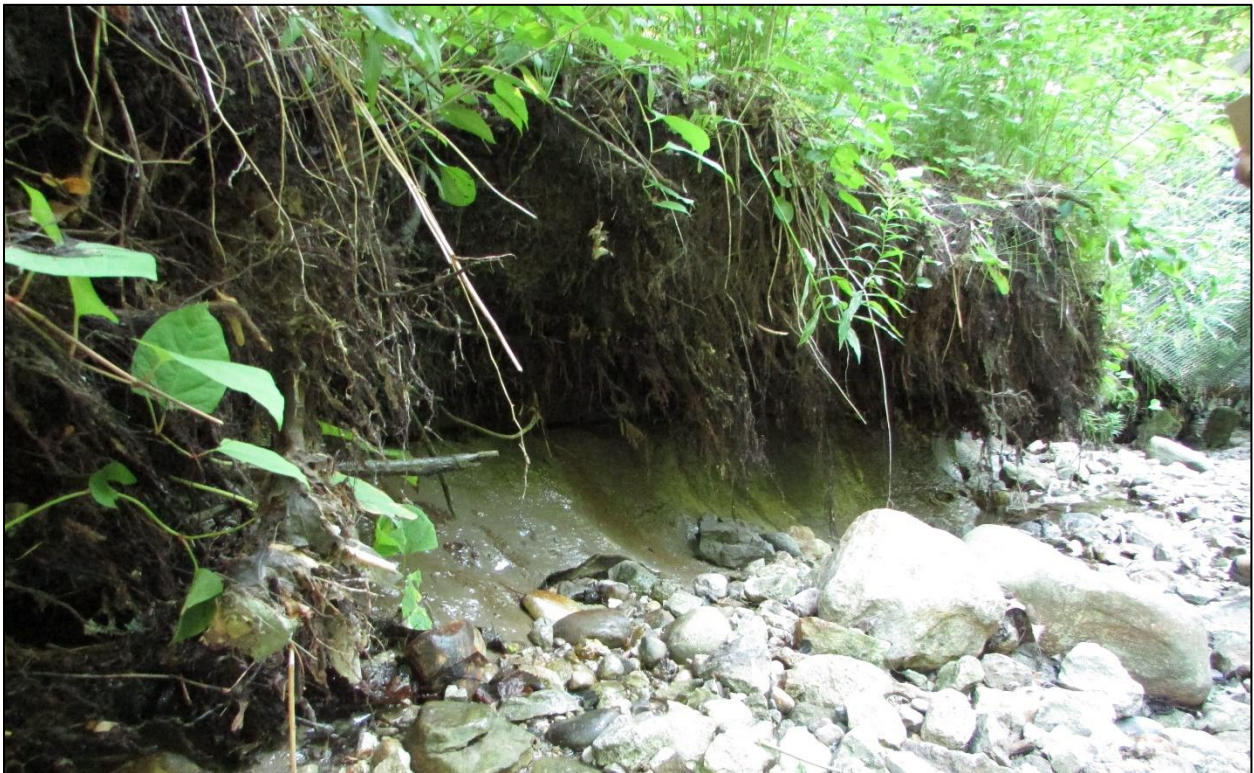
Figure 9: Undercutting at the toe of slope and active groundwater seepage (TRCA, 2019).

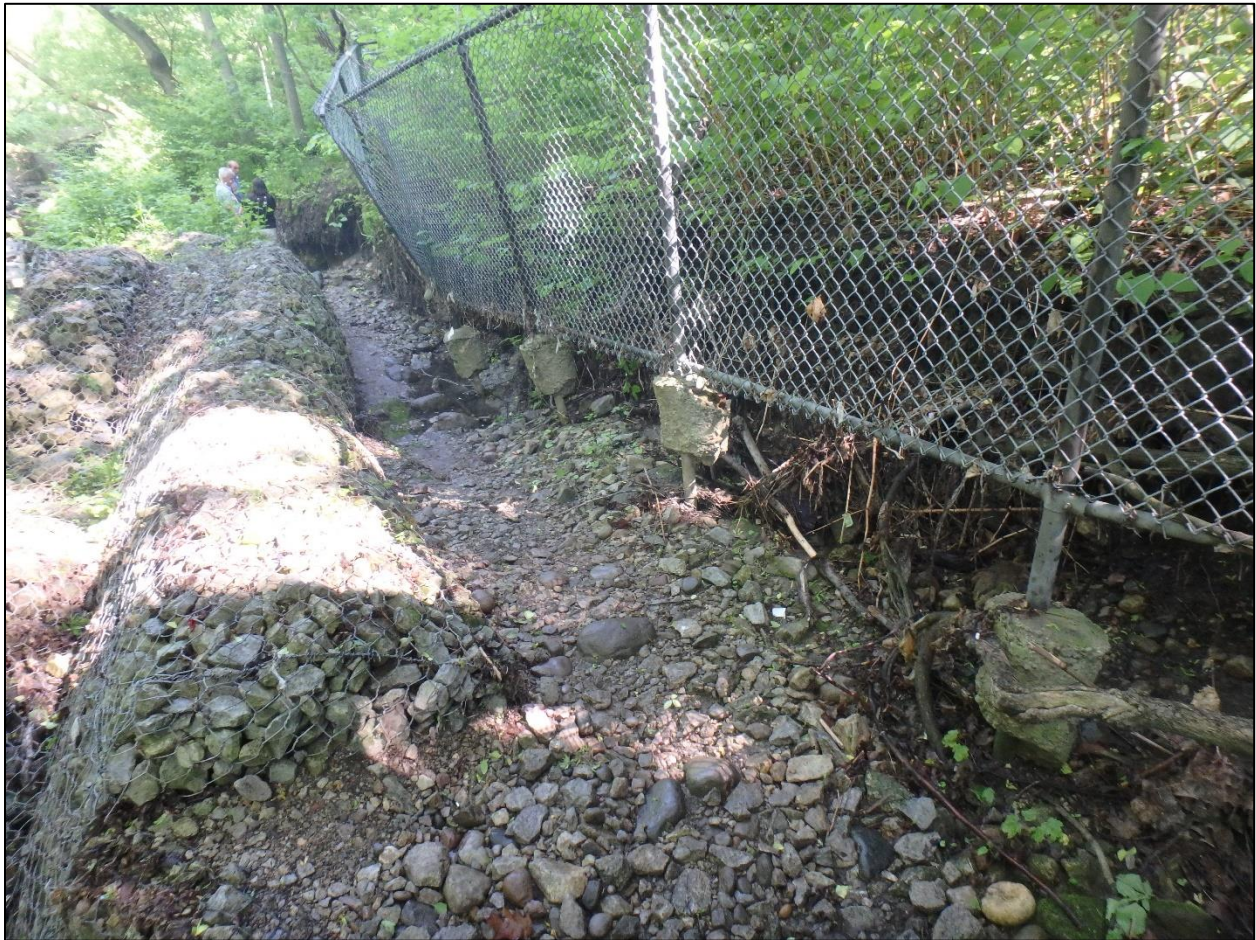
Figure 10: Elevated flows within Yellow Creek have outflanked the existing gabion stone bank structure, impacting a property fence line and eroding the toe of slope behind (TRCA, 2017).

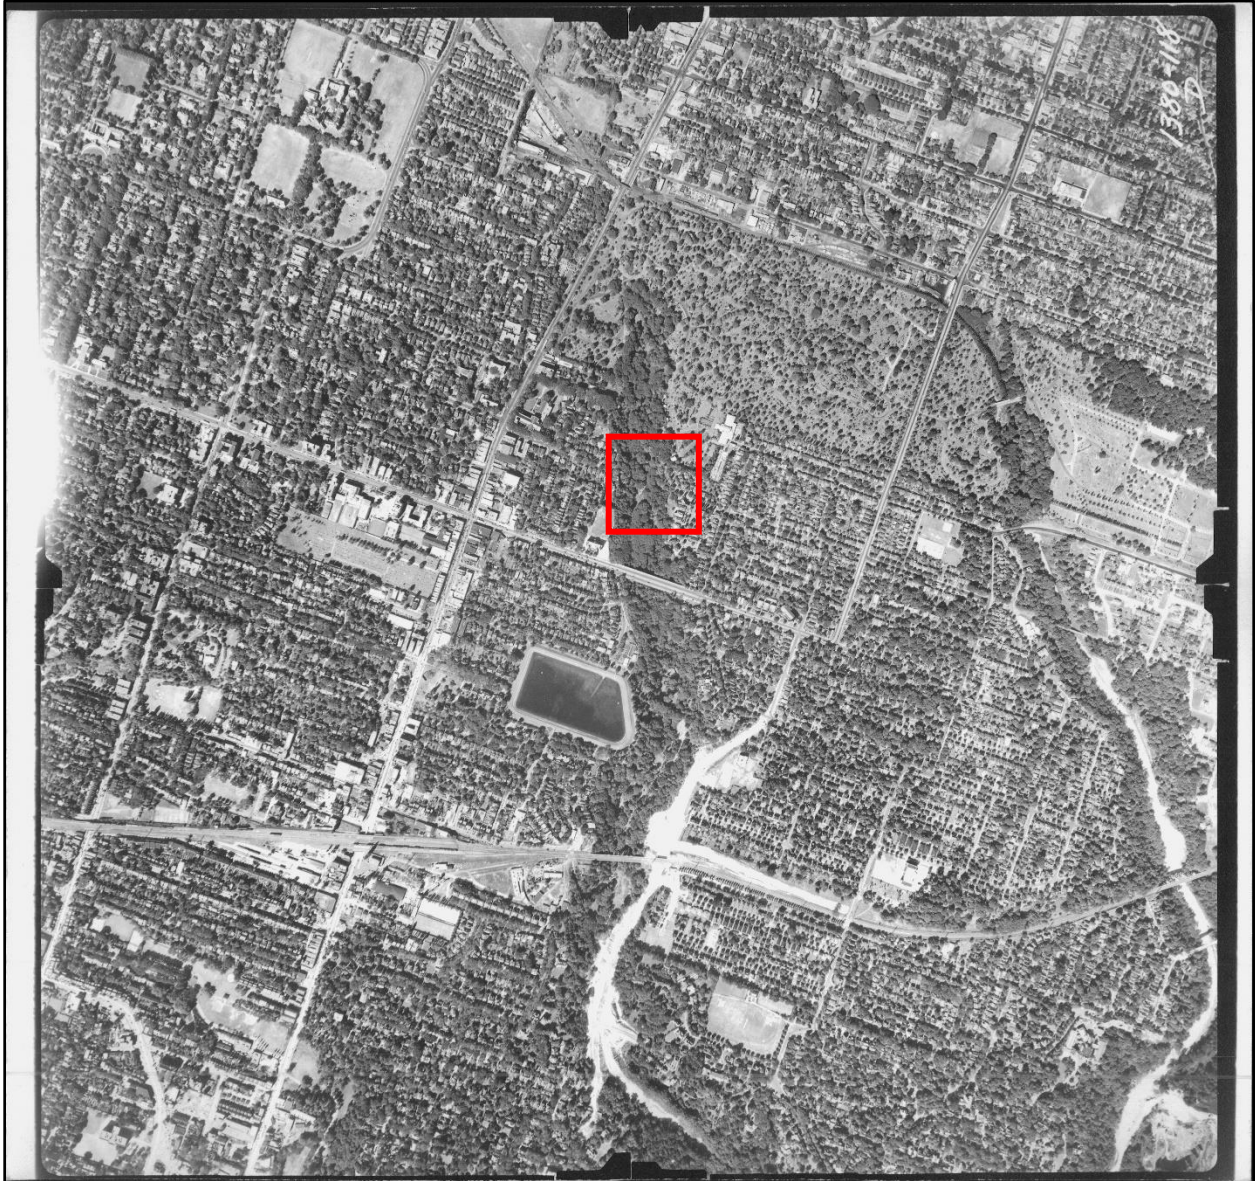
Figure 11: Historical aerial photograph taken in 1949 overlooking the Project area (TRCA, 2020).

As can be seen in the historical aerial photographs shown in **Figure 11** and **Figure 12**, the area surrounding the Project has been significantly urbanized since 1949 and has been subject to further urbanization in the years following through the development of dense, high-rise buildings and the commercialization of Yonge Street and other surrounding major roadways.

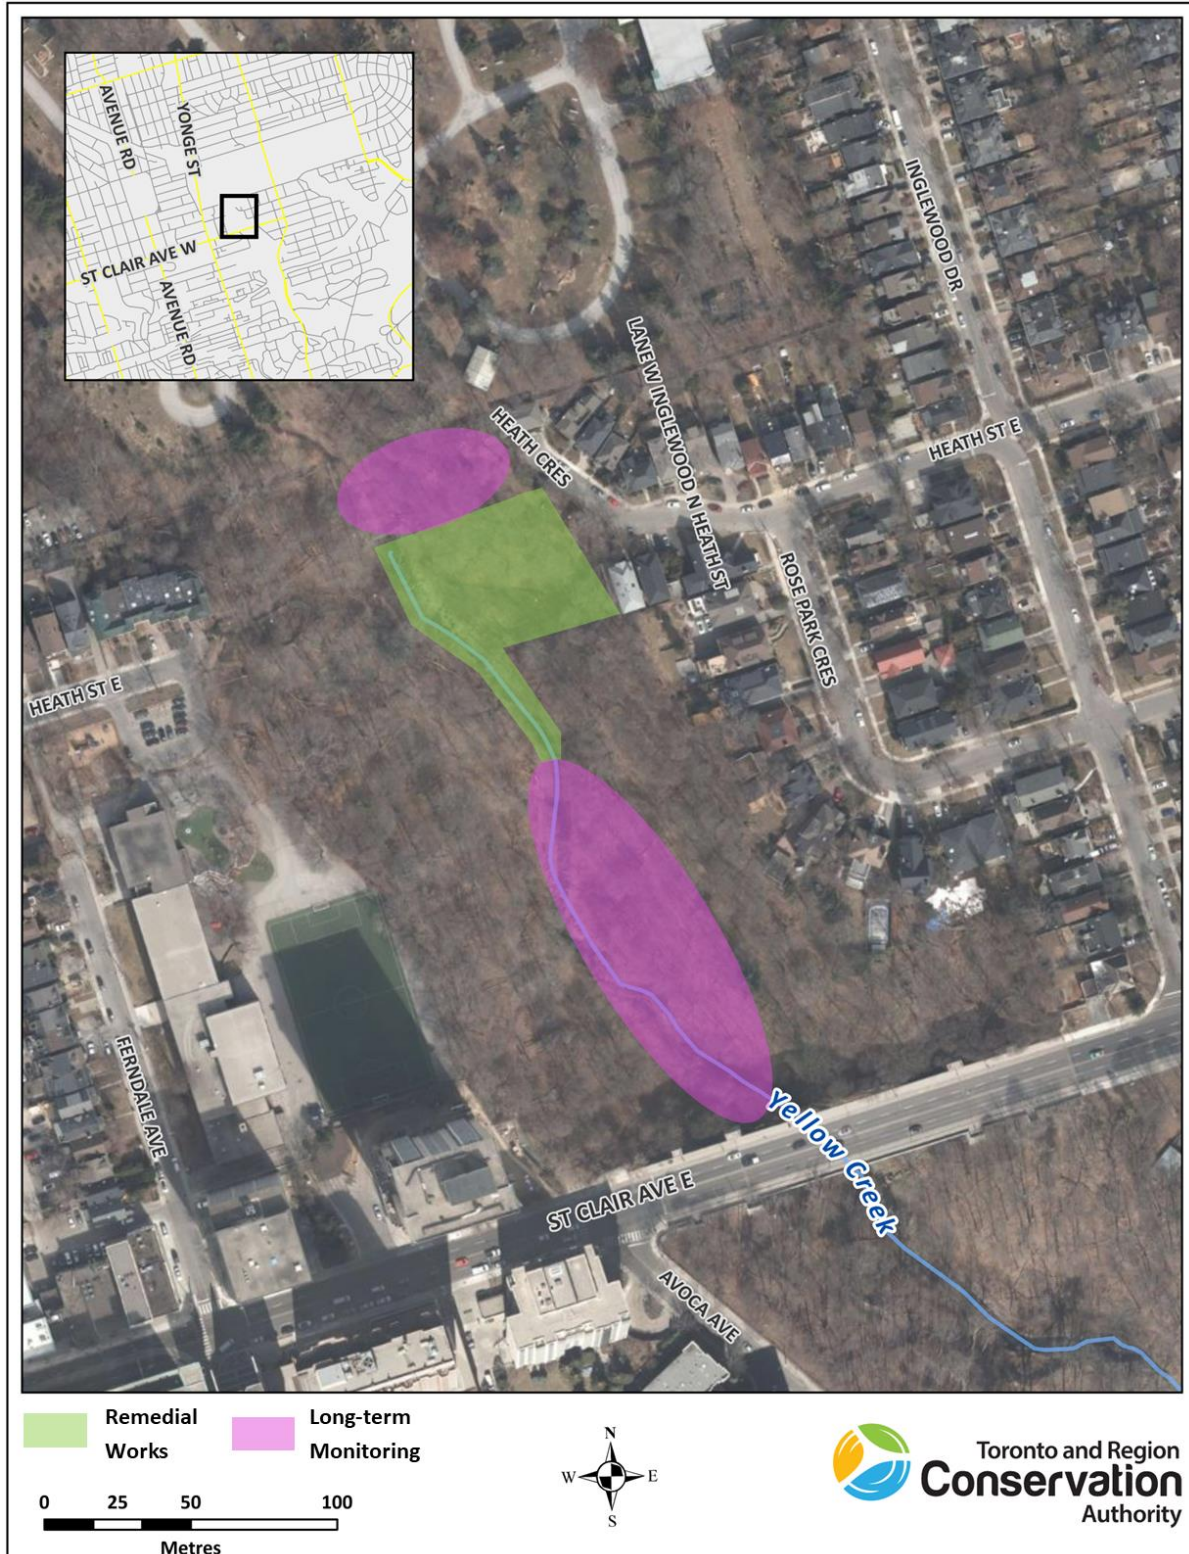
Figure 13: Proposed locations for remedial works and long-term monitoring (TRCA, 2020).

Based on the results of TRCA's investigations, the extent of risk to essential structures within the Project's study area varied due to differences in slope configuration. These differences include the rate of erosion, the condition of existing vegetation communities, and the overall set-back of essential structures along the top of slope. As such, there is notably less risk to essential structures across certain slope segments within the Project area. Due to this variation of risk, TRCA developed preliminary alternative solutions to stabilize areas within the Project area where the risk is highest. The area where TRCA has proposed to undertake remedial works is presented in the Project map shown in **Figure 13**.
