# Humber Bay Park West Shoreline Maintenance Project Project Overview

# Humber Bay Park West Shoreline Maintenance Project Maintenance Strategy

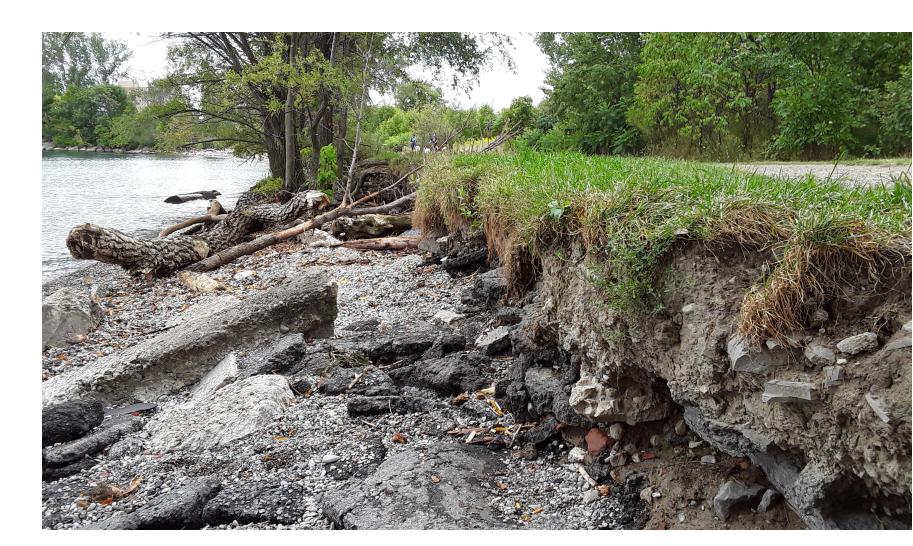
Waves have eroded banks placing trails and park infrastructure at risk. These areas need to be repaired to protect parkland and trails.

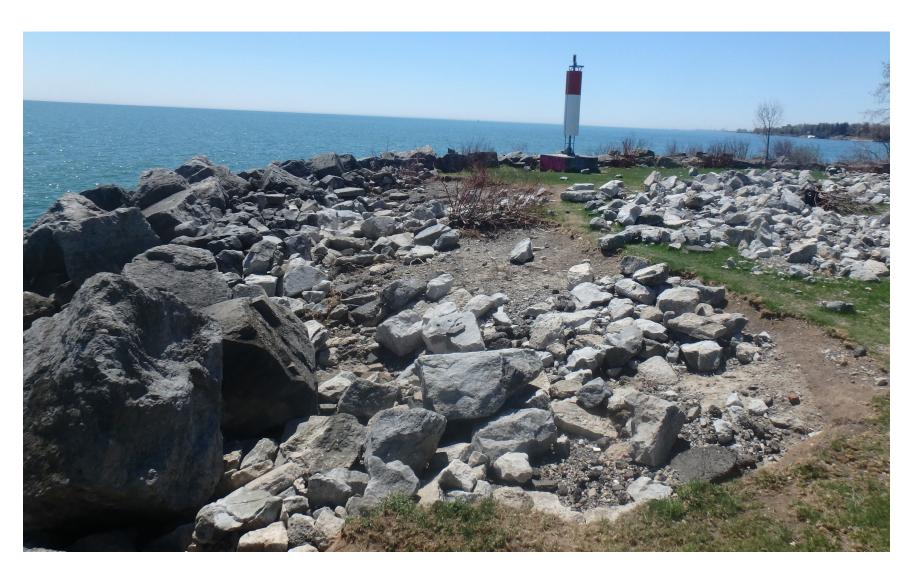
Waves have shifted rocks so they no longer provide proper protection, and parkland is starting to erode.

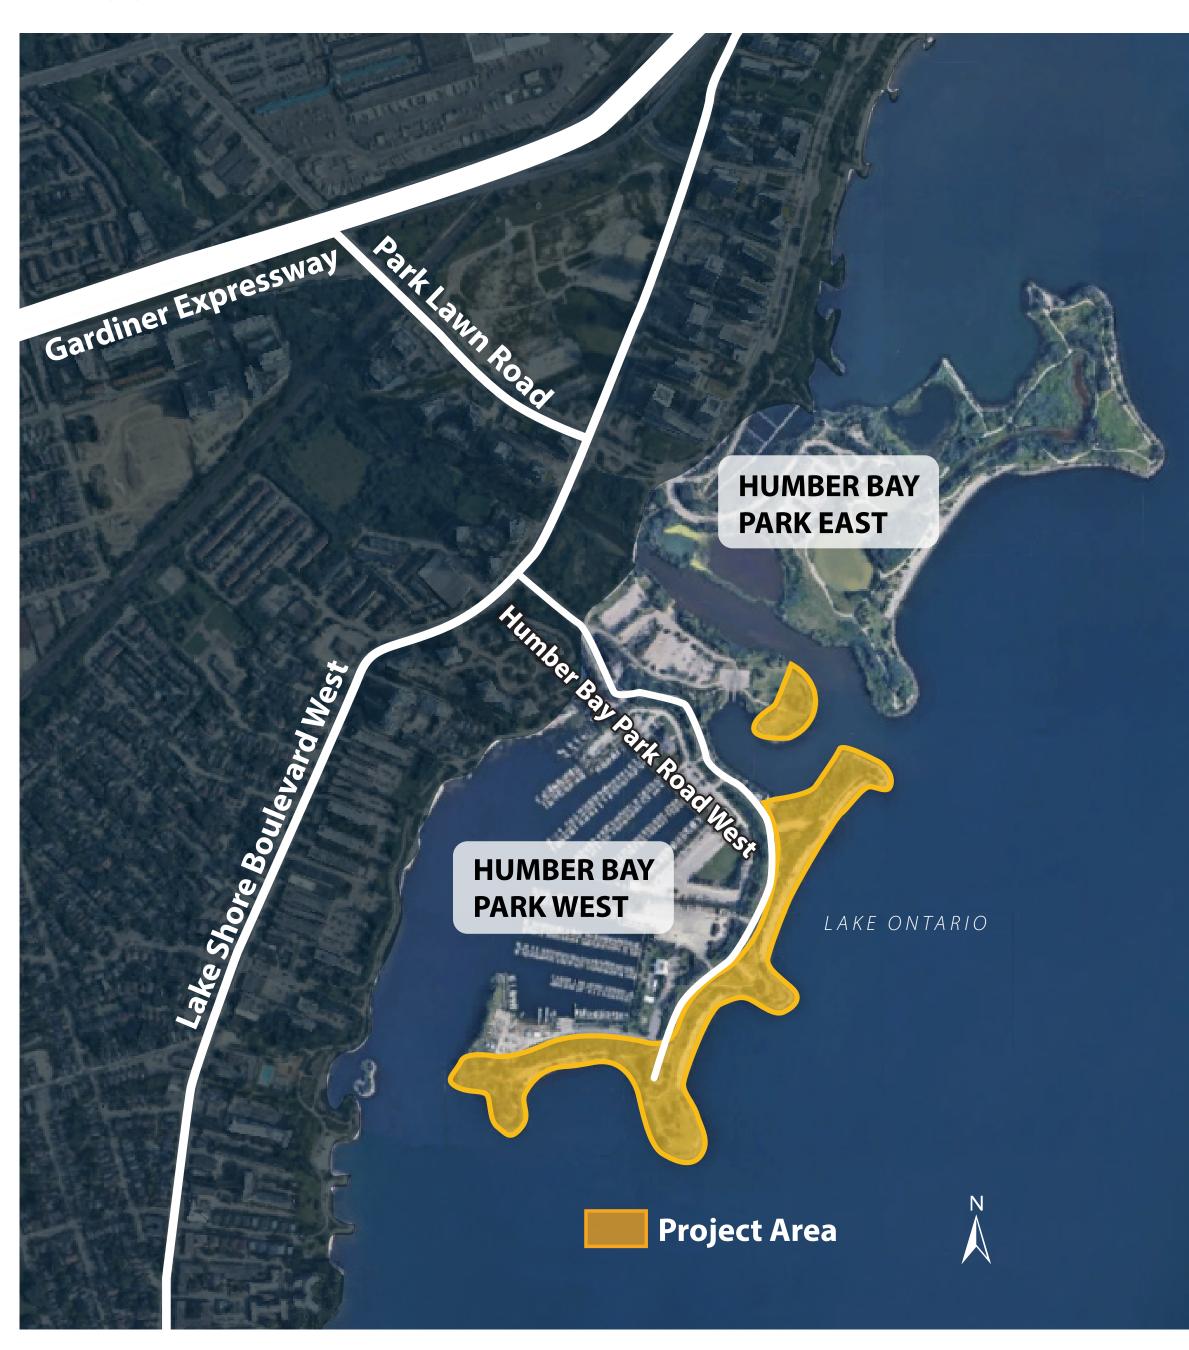
#### **PROJECT AREA MAP**

The work area is located along the southern shoreline of the park and includes the repair of five stone headlands and three rubble beaches. Work will include:

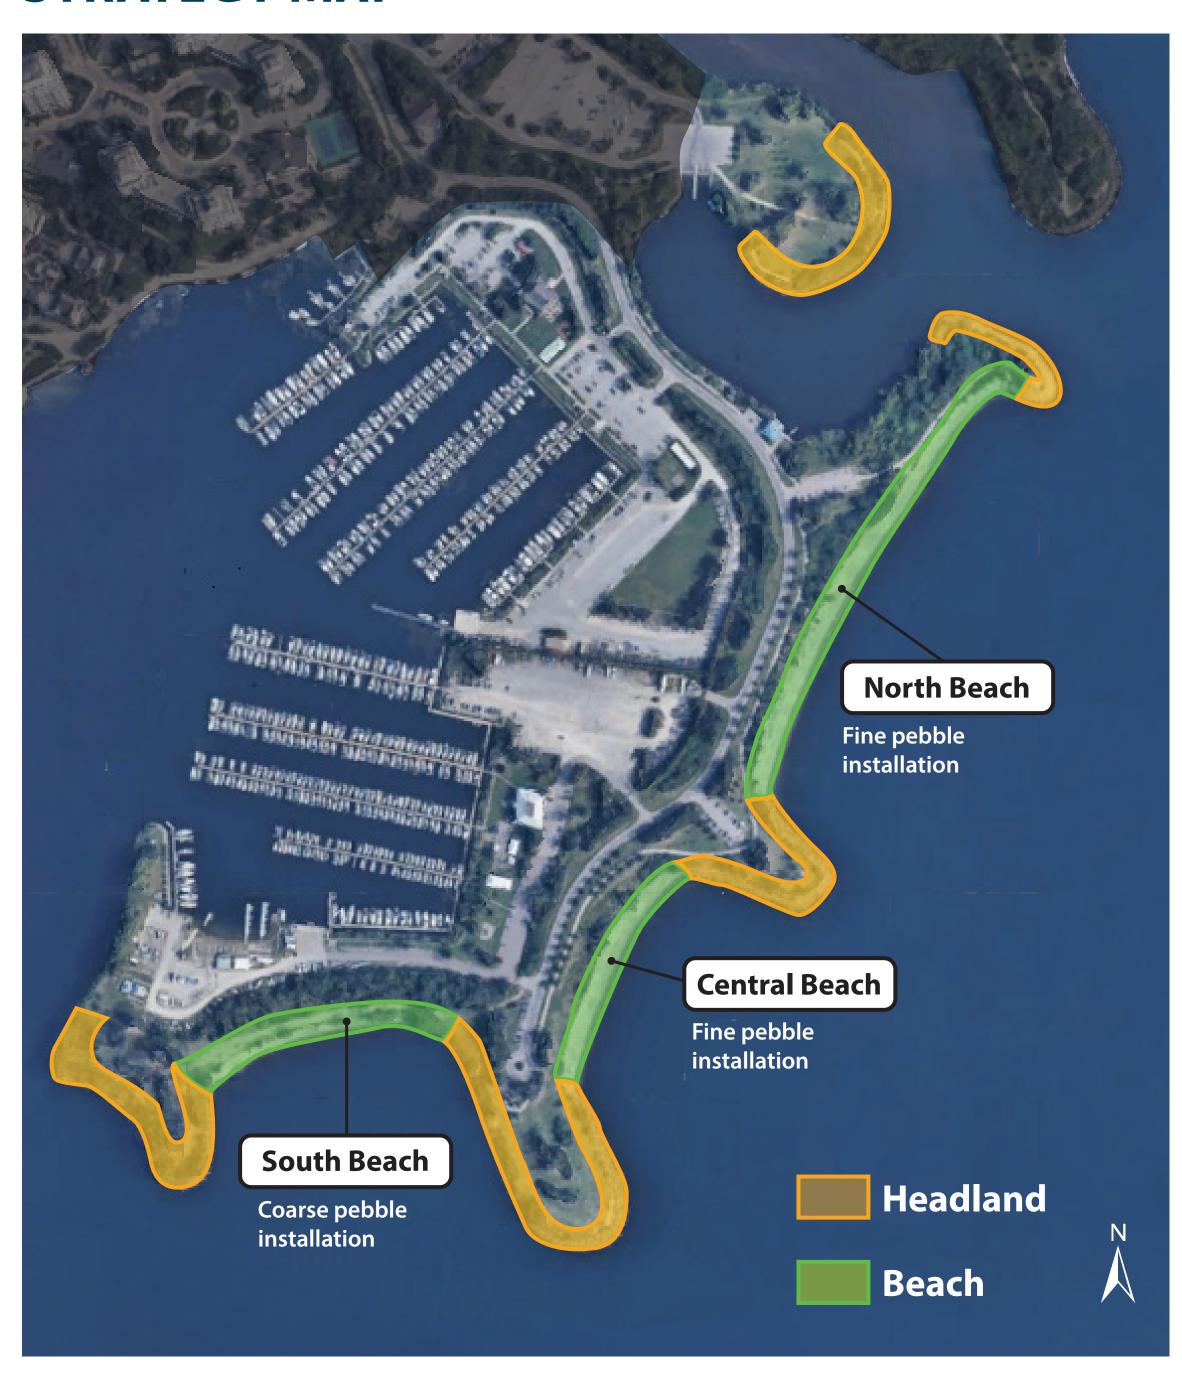
# SHORELINE STRUCTURES AND MAINTENANCE STRATEGY MAP

- Regrading and relocation of shifted material rocks and soil
- Rebuilding of damaged headlands
- Adding additional stone material to provide greater protection
- Installation of aquatic habitat and restoration planting

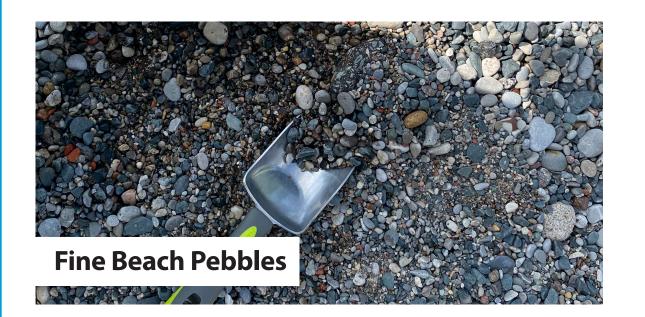
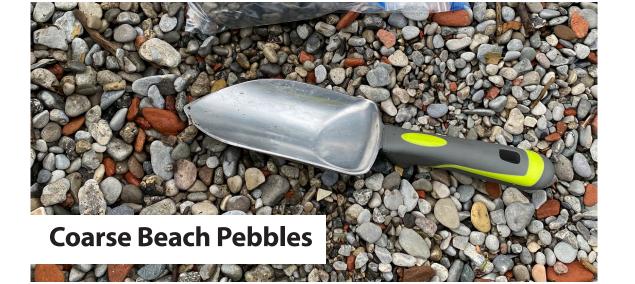
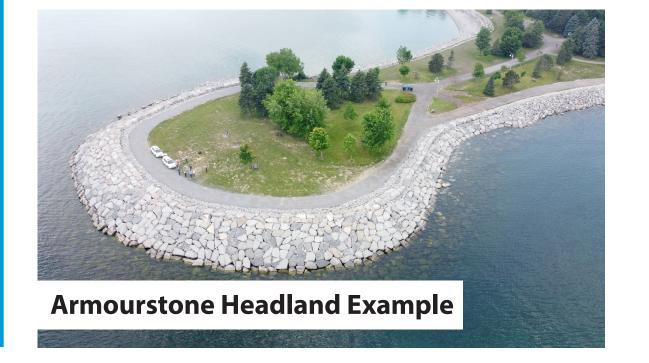
# **Examples of Shoreline Materials**

The images provide examples of the structures and materials that will be used to protect the shoreline from erosion. The wave action at this site will quickly deplete sand beaches. Pebbles are needed to provide more durable erosion protection. Large stone will also be placed behind the the beaches adjacent to the park at key erosion locations. Headlands made of large stone provide bookends that also help keep beach material in place and protect areas of the shore more at risk from heavy wave action.
