# Heart Lake Road Ecology Monitoring Project

## 2025 Report

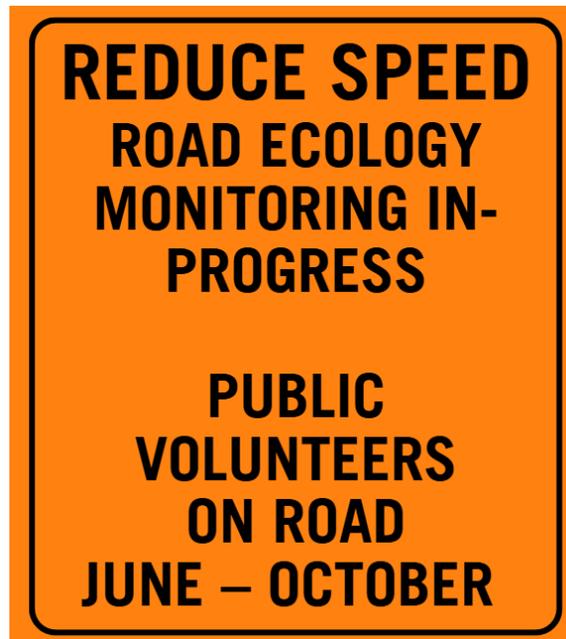
*Figure 1 The design for the speed reduction signs installed along Heart Lake Road for the monitoring season.*

In early June, two signs were installed on Heart Lake Road at Countryside Dr and Sandalwood Pkwy E providing notice to drivers of monitoring activity on the roads (Figure 2). These signs encourage drivers to slow down during the monitoring season when

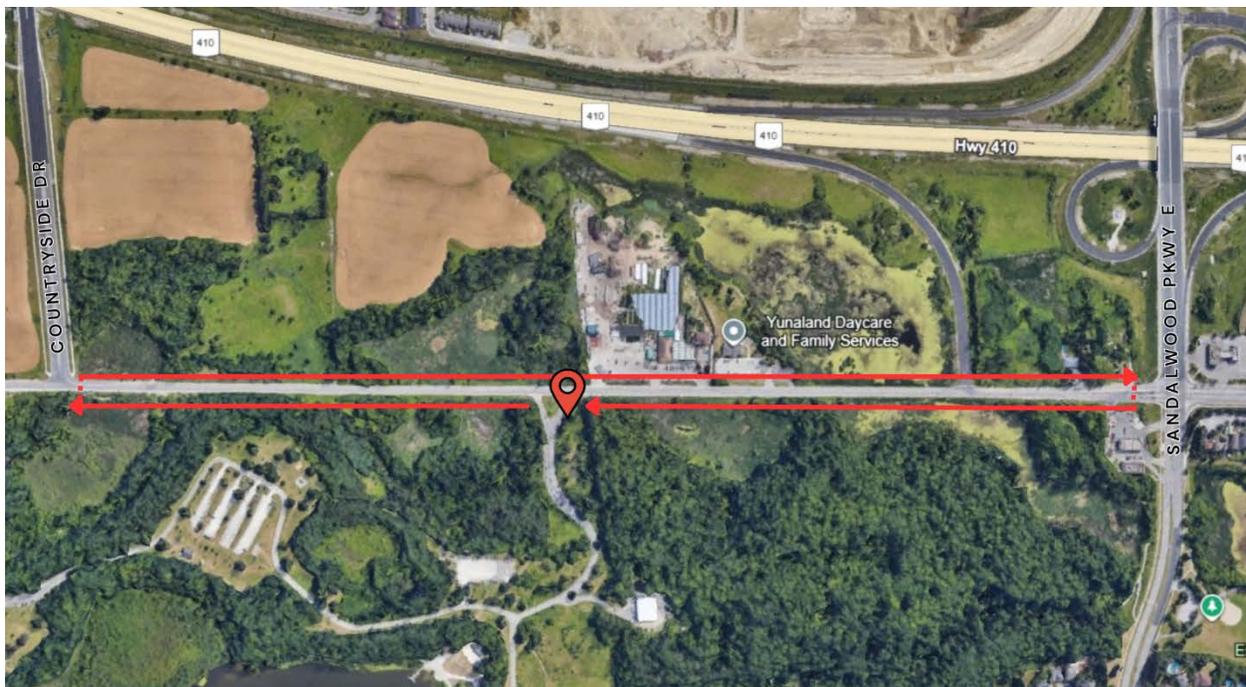
*Figure 2 The HLREMP volunteer monitoring route, where the pin at the starting point is the Heart Lake Conservation Park entrance at Heart Lake Road.*

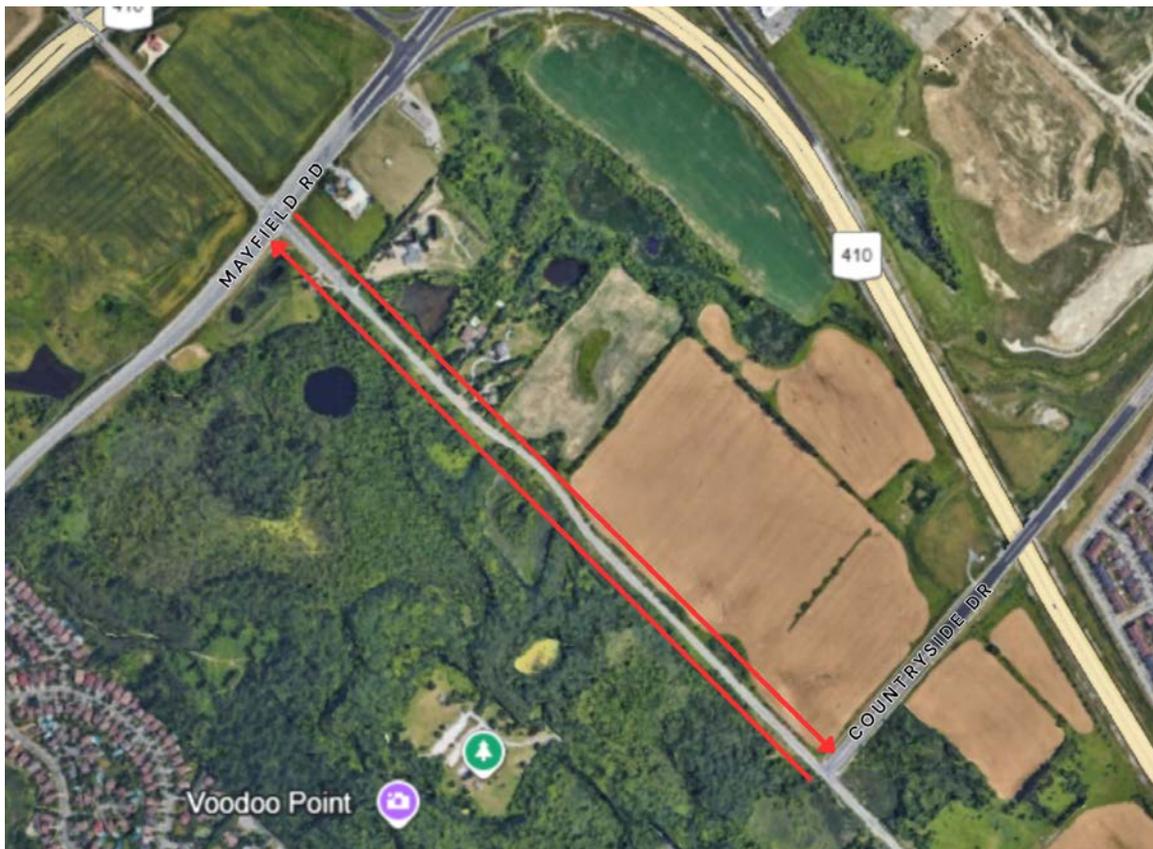
Figure 3 The HLREMP monitoring route for the northern segment of Heart Lake Road, from Countryside Dr to Mayfield Rd.

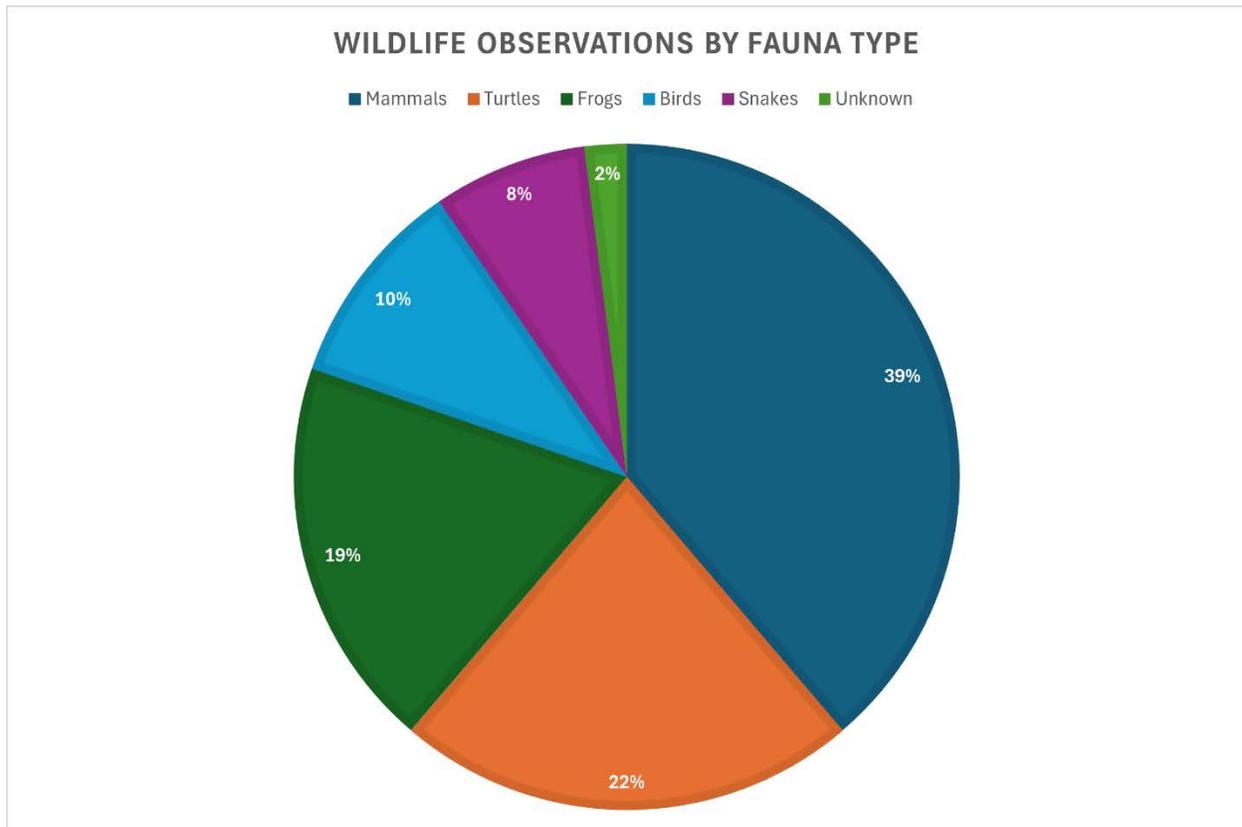
Figure 4 All wildlife observations by fauna type, as observed by monitoring volunteers and TRCA staff.

The wildlife observations by fauna type are summarized in Figure 5. Mammals were amongst the most reported fauna type along both monitoring segments of Heart Lake Road. The most recorded mammal species, both alive and dead, was the Gray Squirrel (*Sciurus carolinensis*).

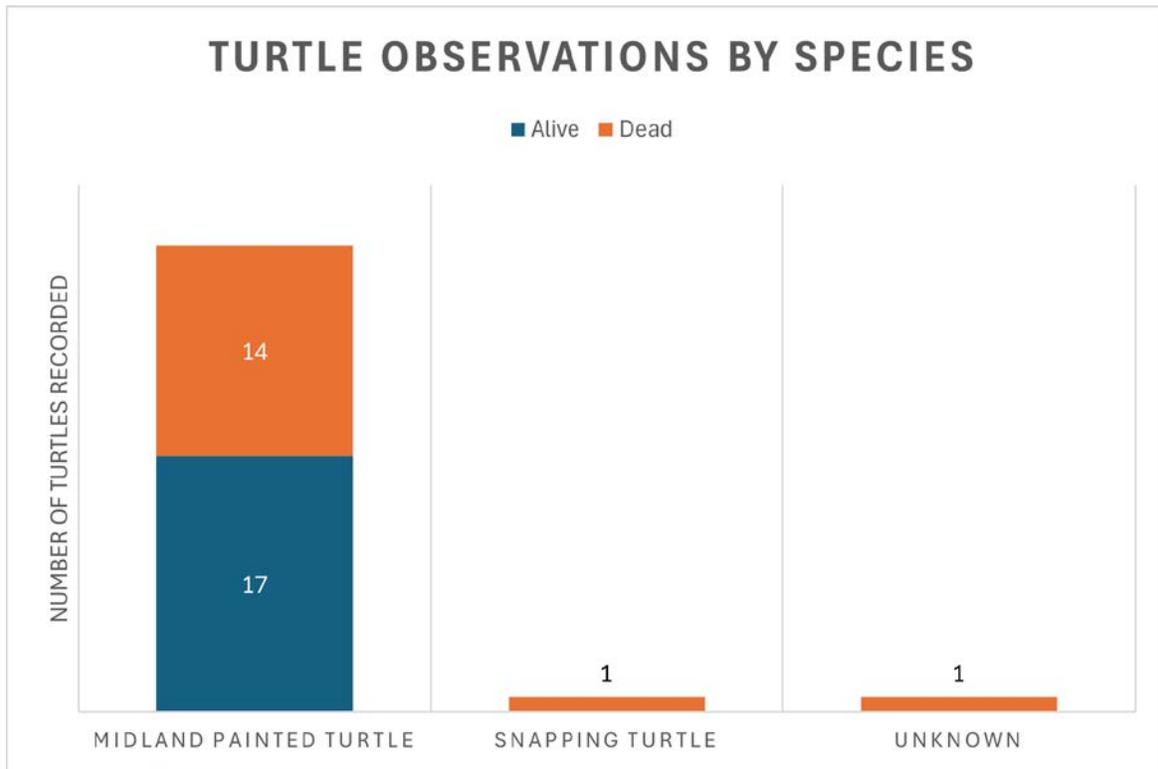
Turtles were the second highest recorded fauna type. Nearly half of the observed turtles (48%) were found deceased on the road or on the shoulder. All Midland Painted Turtles (*Chrysemys picta*) recorded as alive were observed off-road, beyond the exclusion fencing and in the surrounding wetlands. Figure 6 summarizes all recorded turtle observations by species. Of the recorded observations, 6% were hatchlings, 18% were juveniles, 54% were adults, and 21% were unknown.

Figure 5 The number of recorded turtle observations by species.

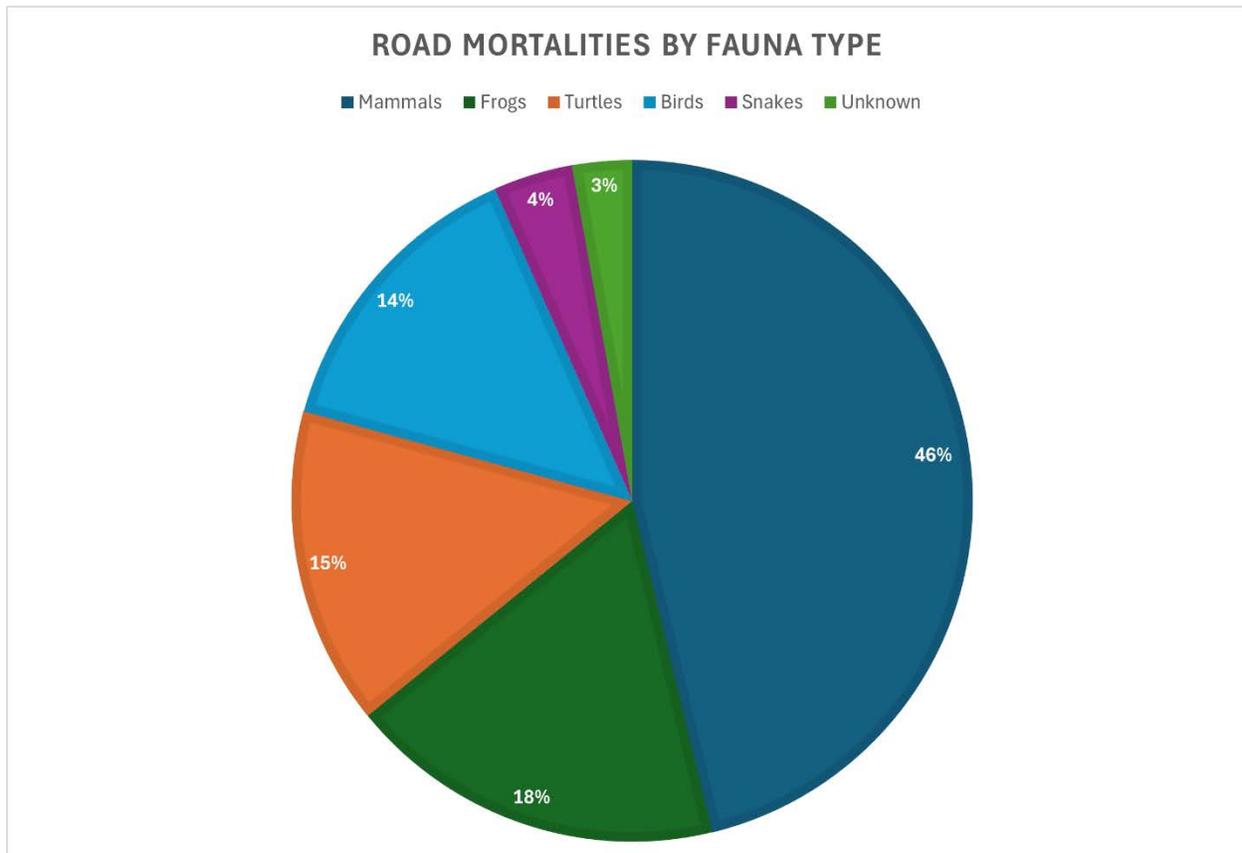
Mortalities caused by Wildlife Vehicle Collisions (WVCs) dominated the observations collected by both volunteers and TRCA staff. A total of 106 mortalities were reported, with mammals being the most impacted by WVCs (Figure 7). Species identification of WVCs was less certain or reliable, depending on the severity of the collision or the duration of time between collision and observation. Of the mammal mortalities, 21% were labelled as unknown, due to the severity of the collisions, predation or time elapsed since the collision occurred. Despite this, mammal mortalities proved to be the easiest to identify, as they remained intact for longer than their herpetofauna or ornitofauna counterparts. Gray Squirrels (*Sciurus carolinensis*) were amongst the highest reported mortalities (24.5%).

*Figure 6 Percentage of Wildlife Vehicle Collision mortalities by fauna type, as observed by monitoring volunteers and TRCA staff.*

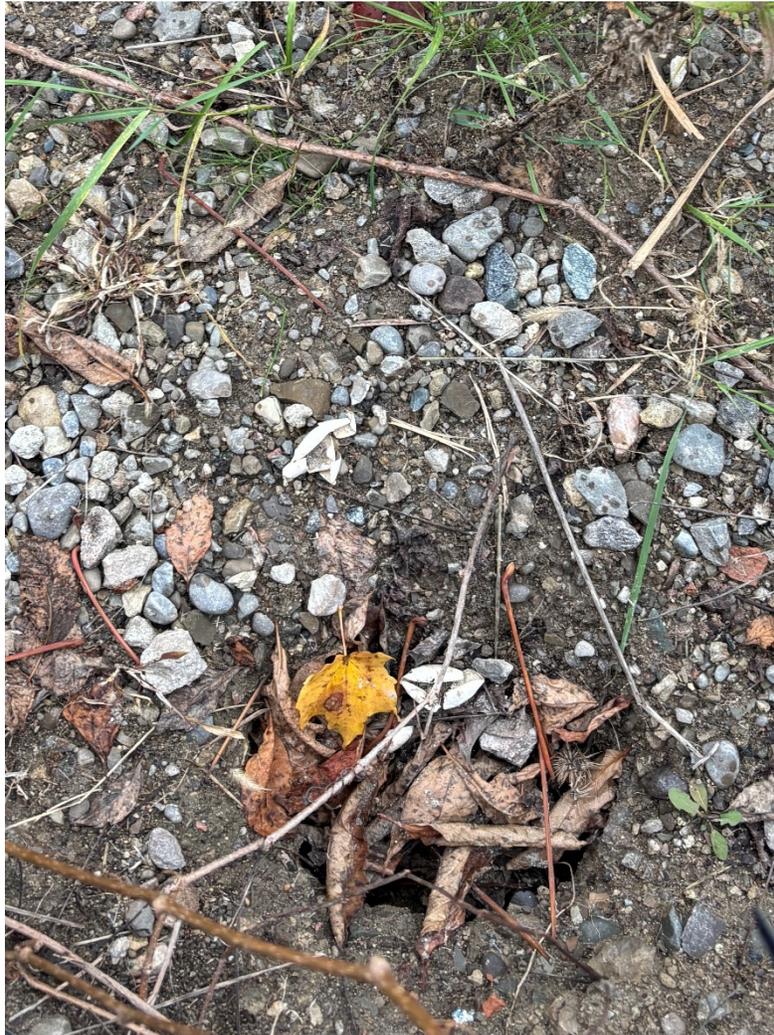
Two turtle nests were recorded on November 7<sup>th</sup> on the eastern side of Heart Lake Road, less than 30 meters north of Highway 410. Both nests had been constructed off road, behind the exclusionary fencing. This particular area borders a wetland. The nests were found to be predated, with a hole dug at each nest and fragments of eggs scattered (Figure 8).

*Figure 7 Predated turtle nest observed on South Heart Lake Road monitoring route.*

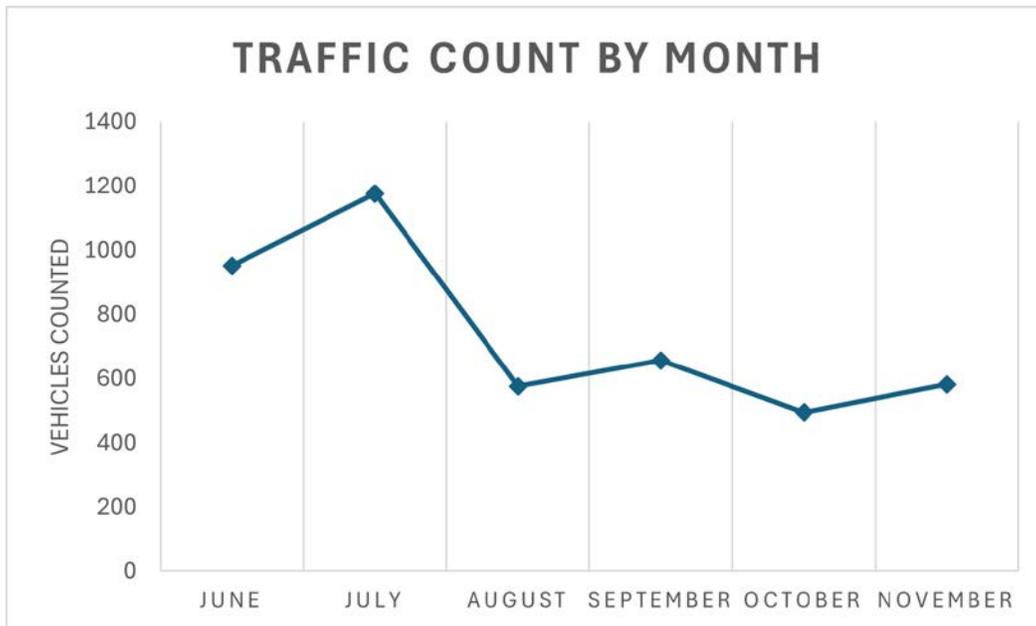
The results from traffic counts completed during this project are summarized in Figure 9. The highest number of vehicles was observed in the month of July, with a total of 1,176 recorded. Total traffic counts plateaued between the months of August and November, with the limitations imposed by the construction along Heart Lake Road. Traffic counts remained a component of the monitoring shift; however, fewer shifts were delivered at this time, and traffic was bottlenecked with the reduction of the road to one lane for both directions of traffic. Despite construction complications, an average of 143 vehicles per

Figure 8 Vehicles counted within a 15-minute time period throughout the monitoring season.

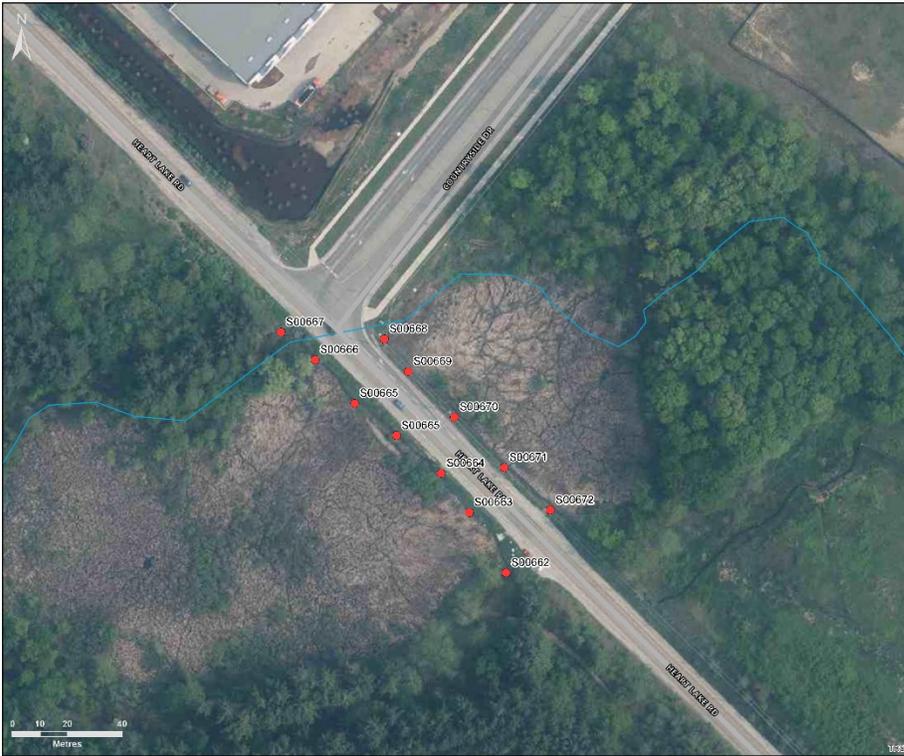
**Map B**

**Heart Lake Road Ecology Monitoring  
Exclusion Fencing Tags**

The exclusion fencing has been tagged at an interval of every 10 panels. The first tag was placed on the fence north of the Heart Lake Conservation Area entrance, and tags were installed in ascending order north to Countryside Drive, south to Sandalwood Pkwy, and back north to the park entrance.

Fence tag numbers begin at S00651 and end at S00720. The sequence of tags follow the monitoring route walked by TRCA volunteers and Brampton Roads staff.

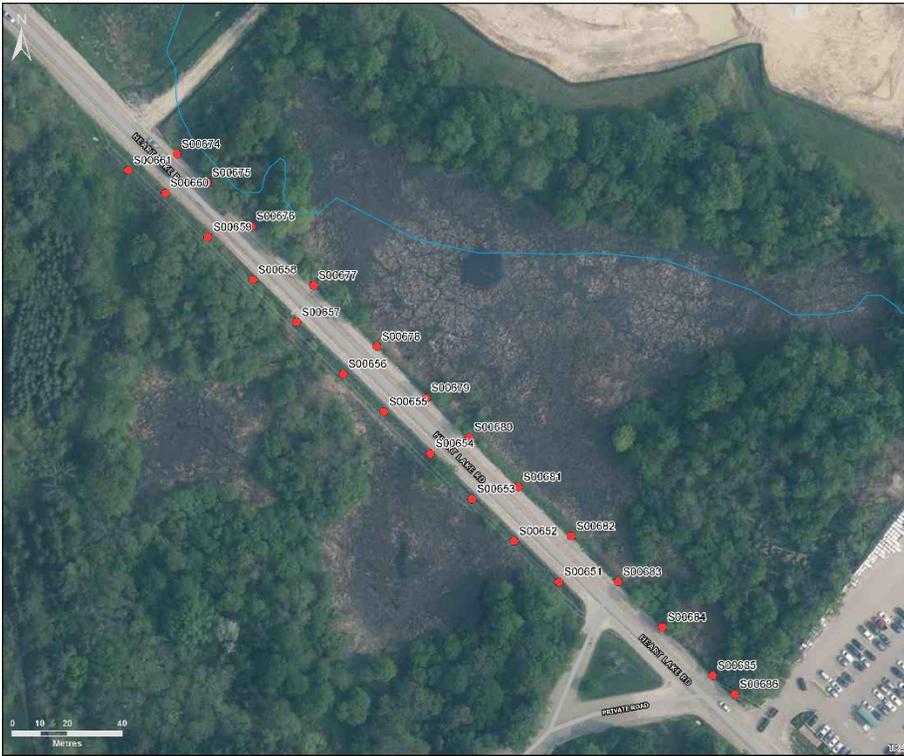
**Map C**

**Heart Lake Road Ecology Monitoring  
Exclusion Fencing Tags**

The exclusion fencing has been tagged at an interval of every 10 panels. The first tag was placed on the fence north of the Heart Lake Conservation Area entrance, and tags were installed in ascending order north to Countryside Drive, south to Sandalwood Pkwy, and back north to the park entrance.

Fence tag numbers begin at S00651 and end at S00720. The sequence of tags follow the monitoring route walked by TRCA volunteers and Brampton Roads staff.

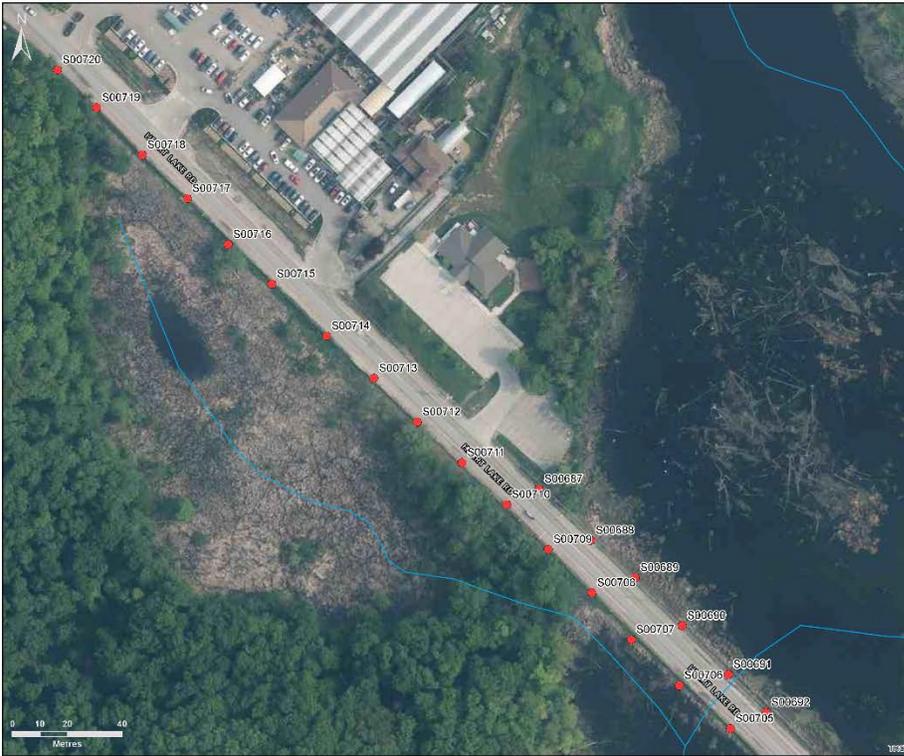
**Map D**

**Heart Lake Road Ecology Monitoring Exclusion Fencing Tags**

The exclusion fencing has been tagged at an interval of every 10 panels. The first tag was placed on the fence north of the Heart Lake Conservation Area entrance, and tags were installed in ascending order north to Countryside Drive, south to Sandalwood Pkwy, and back north to the park entrance.

Fence tag numbers begin at S00651 and end at S00720. The sequence of tags follow the monitoring route walked by TRCA volunteers and Brampton Roads staff.

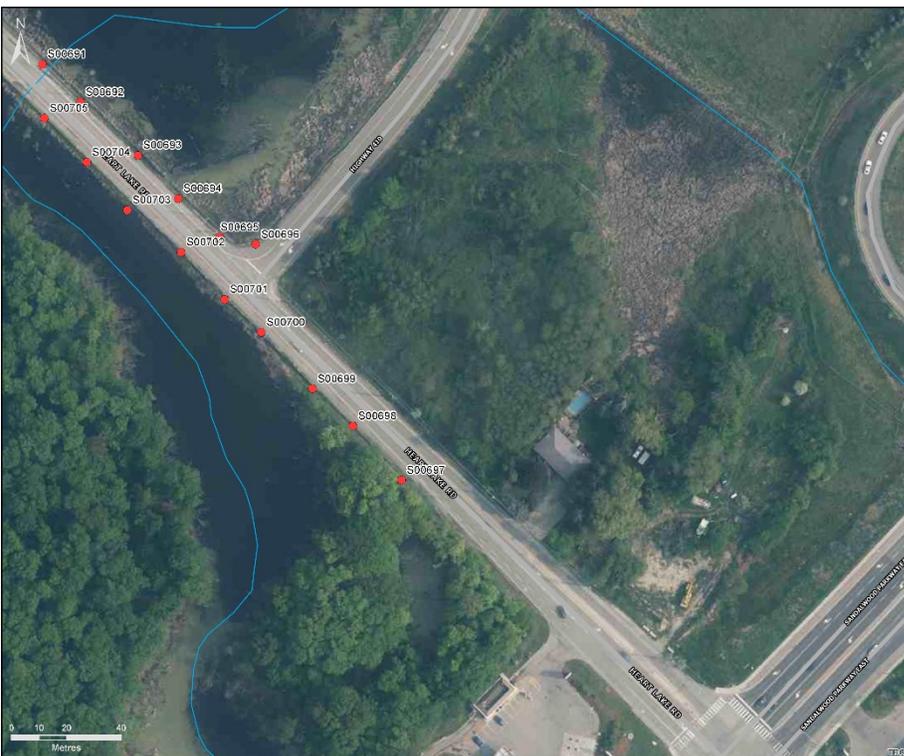
**Map E**

**Heart Lake Road Ecology Monitoring Exclusion Fencing Tags**

The exclusion fencing has been tagged at an interval of every 10 panels. The first tag was placed on the fence north of the Heart Lake Conservation Area entrance, and tags were installed in ascending order north to Countryside Drive, south to Sandalwood Pkwy, and back north to the park entrance.

Fence tag numbers begin at S00651 and end at S00720. The sequence of tags follow the monitoring route walked by TRCA volunteers and Brampton Roads staff.

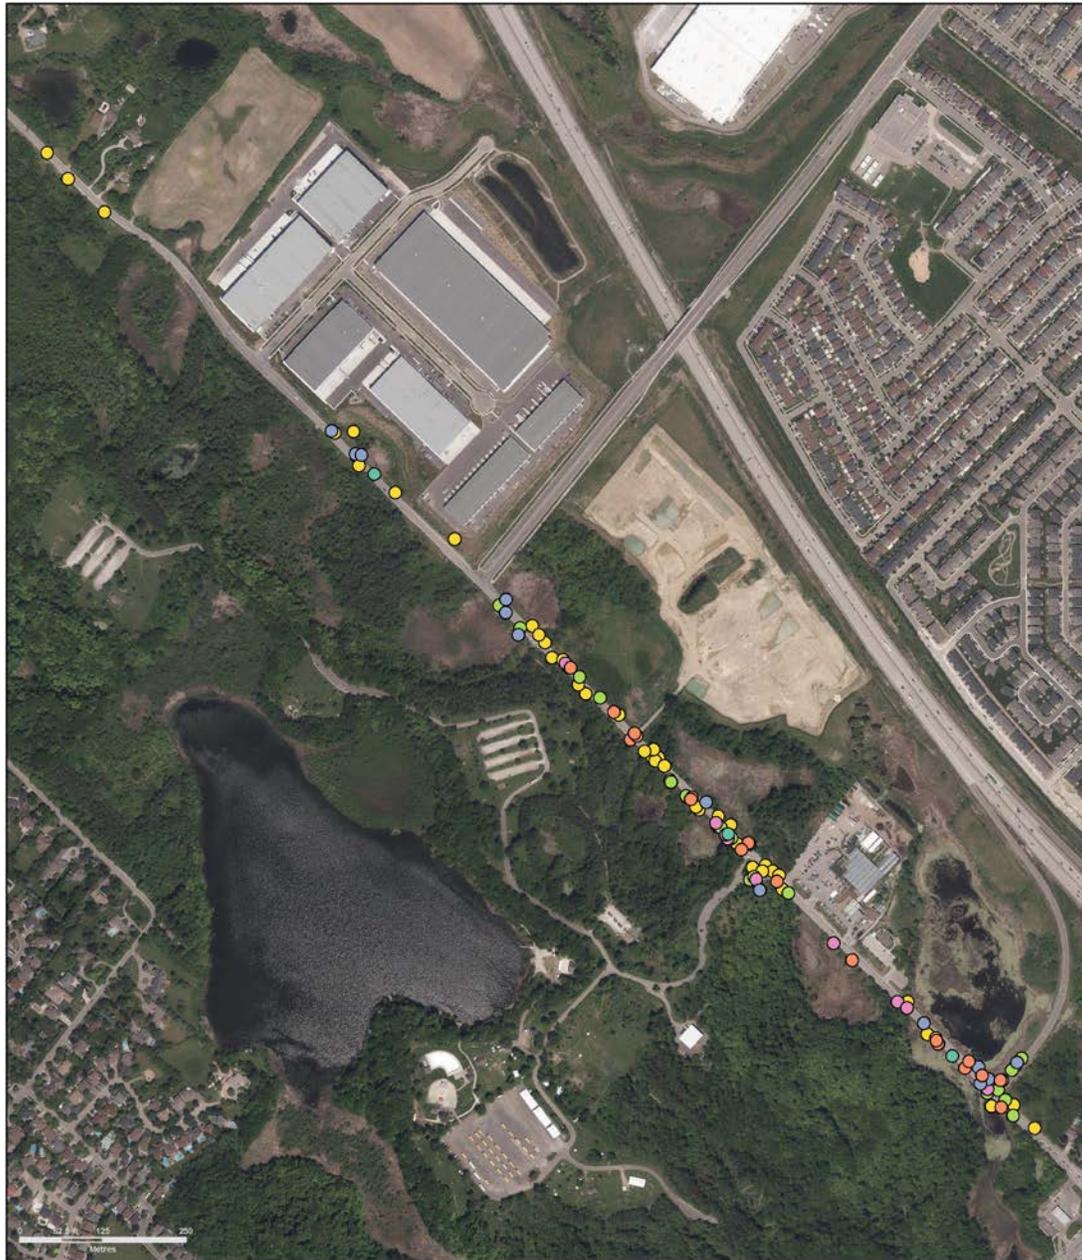
<p> <b>Toronto and Region Conservation Authority</b>                  Date: 2025-12-04                  Created by: Restoration and Infrastructure                  Designator: First Base Solutions, City of Toronto, Peel Region, York Region, Durham Region, 2024             </p>	<p> <b>Heart Lake Road Ecology Monitoring</b>                  All Observations             </p>	<p><b>Legend</b></p> <ul style="list-style-type: none"> <li><span style="color: orange;">●</span> Turtles</li> <li><span style="color: blue;">●</span> Birds</li> <li><span style="color: green;">●</span> Frogs</li> <li><span style="color: yellow;">●</span> Mammals</li> <li><span style="color: pink;">●</span> Snakes</li> <li><span style="color: cyan;">●</span> Unknown</li> </ul>
<p><small>Disclaimer: The data used to create this map was compiled from a variety of sources &amp; dates. The TRCA takes no responsibility for errors or omissions in the data and retains the right to make changes &amp; corrections at anytime without notice. For further information about the data on this map, please contact the TRCA Restoration and Infrastructure Division (416) 661-6600. May not be reproduced without permission. This is not a plan of survey. Produced by Toronto and Region Conservation Authority under license with the Ministry of Natural Resources &amp; Forestry. © Queen's Printer for Ontario.</small></p>

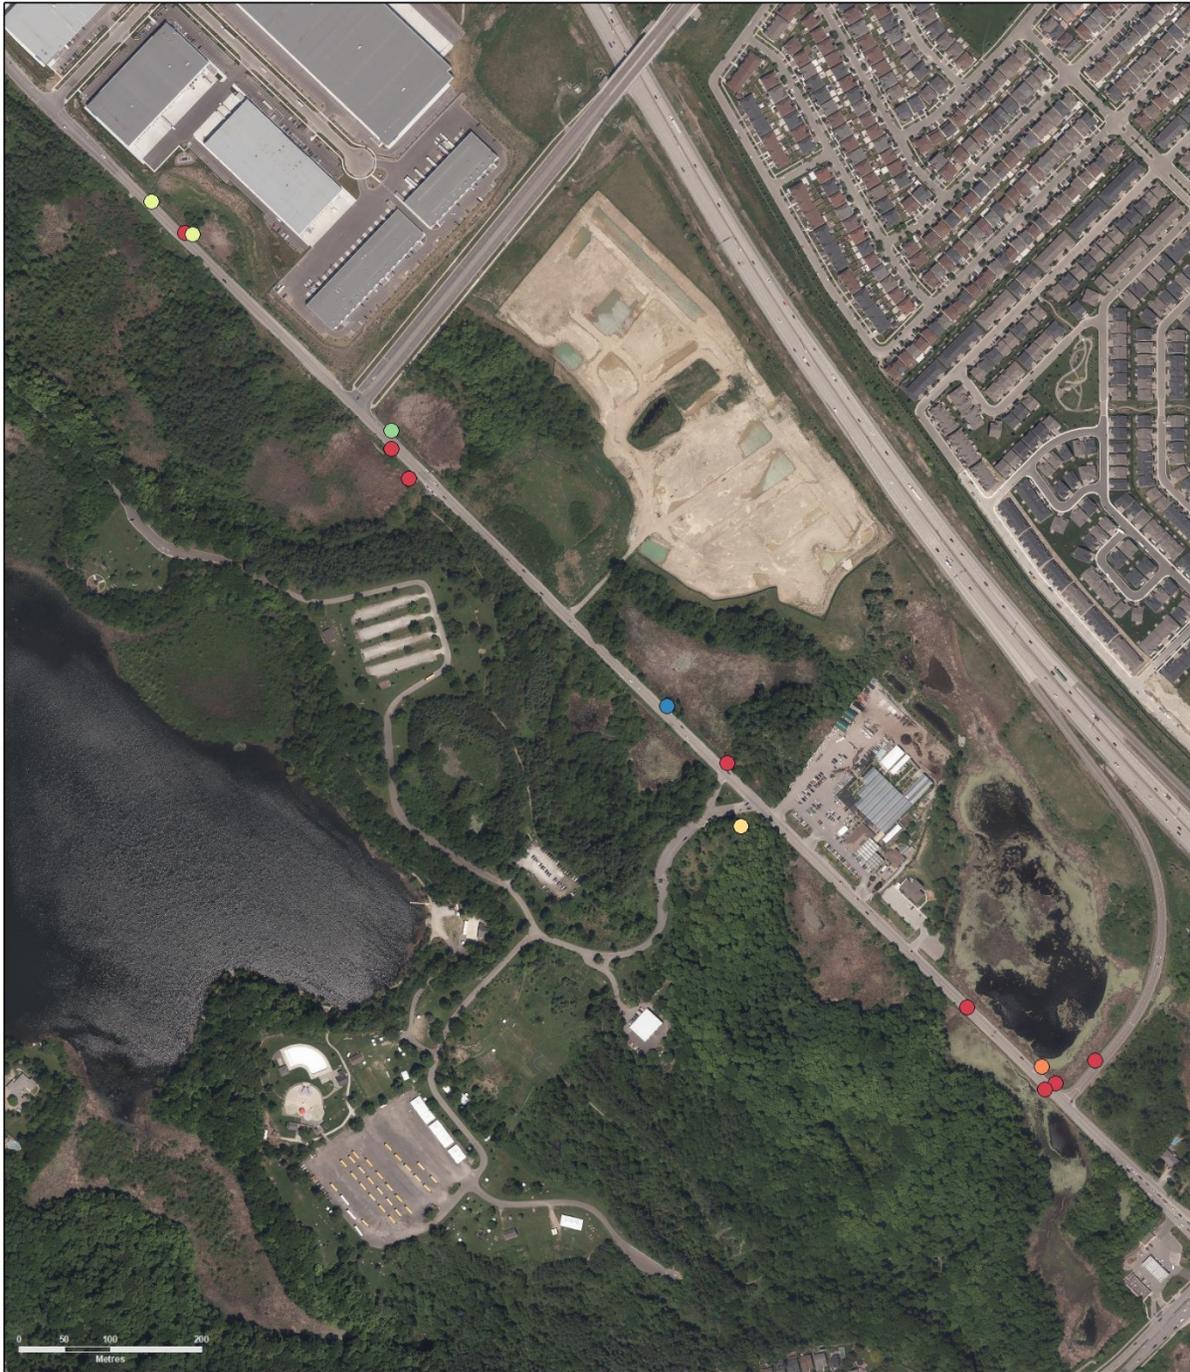
<p>Date: 2025-12-04 Created by: Restoration and Infrastructure Orthophoto: First Base Solutions, City of Toronto, Peel Region, York Region, Durham Region, 2024</p>	<p><b>Heart Lake Road Ecology Monitoring</b></p> <p>Bird Observations</p>	<p><b>Species Recorded</b></p>

<span style="color: blue;">●</span> Northern Cardinal	<span style="color: yellow;">●</span> European Starling	<span style="color: green;">●</span> Black-Capped Chickadee	<span style="color: orange;">●</span> Downy Woodpecker	<span style="color: lightgreen;">●</span> Grey Catbird	<span style="color: red;">●</span> Unknown Bird
<span style="color: blue;">●</span> Northern Cardinal	<span style="color: yellow;">●</span> European Starling							
<span style="color: green;">●</span> Black-Capped Chickadee	<span style="color: orange;">●</span> Downy Woodpecker							
<span style="color: lightgreen;">●</span> Grey Catbird	<span style="color: red;">●</span> Unknown Bird							
<p><small>Disclaimer: The data used to create this map was compiled from a variety of sources &amp; dates. The TRCA takes no responsibility for errors or omissions in the data and retains the right to make changes &amp; corrections at anytime without notice. For further information about the data on this map, please contact the TRCA Restoration and Infrastructure Division, (416) 661-6600. May not be reproduced without permission. This is not a plan of survey. Produced by Toronto and Region Conservation Authority under licence with the Ministry of Natural Resources &amp; Forestry. © Queen's Printer for Ontario</small></p>

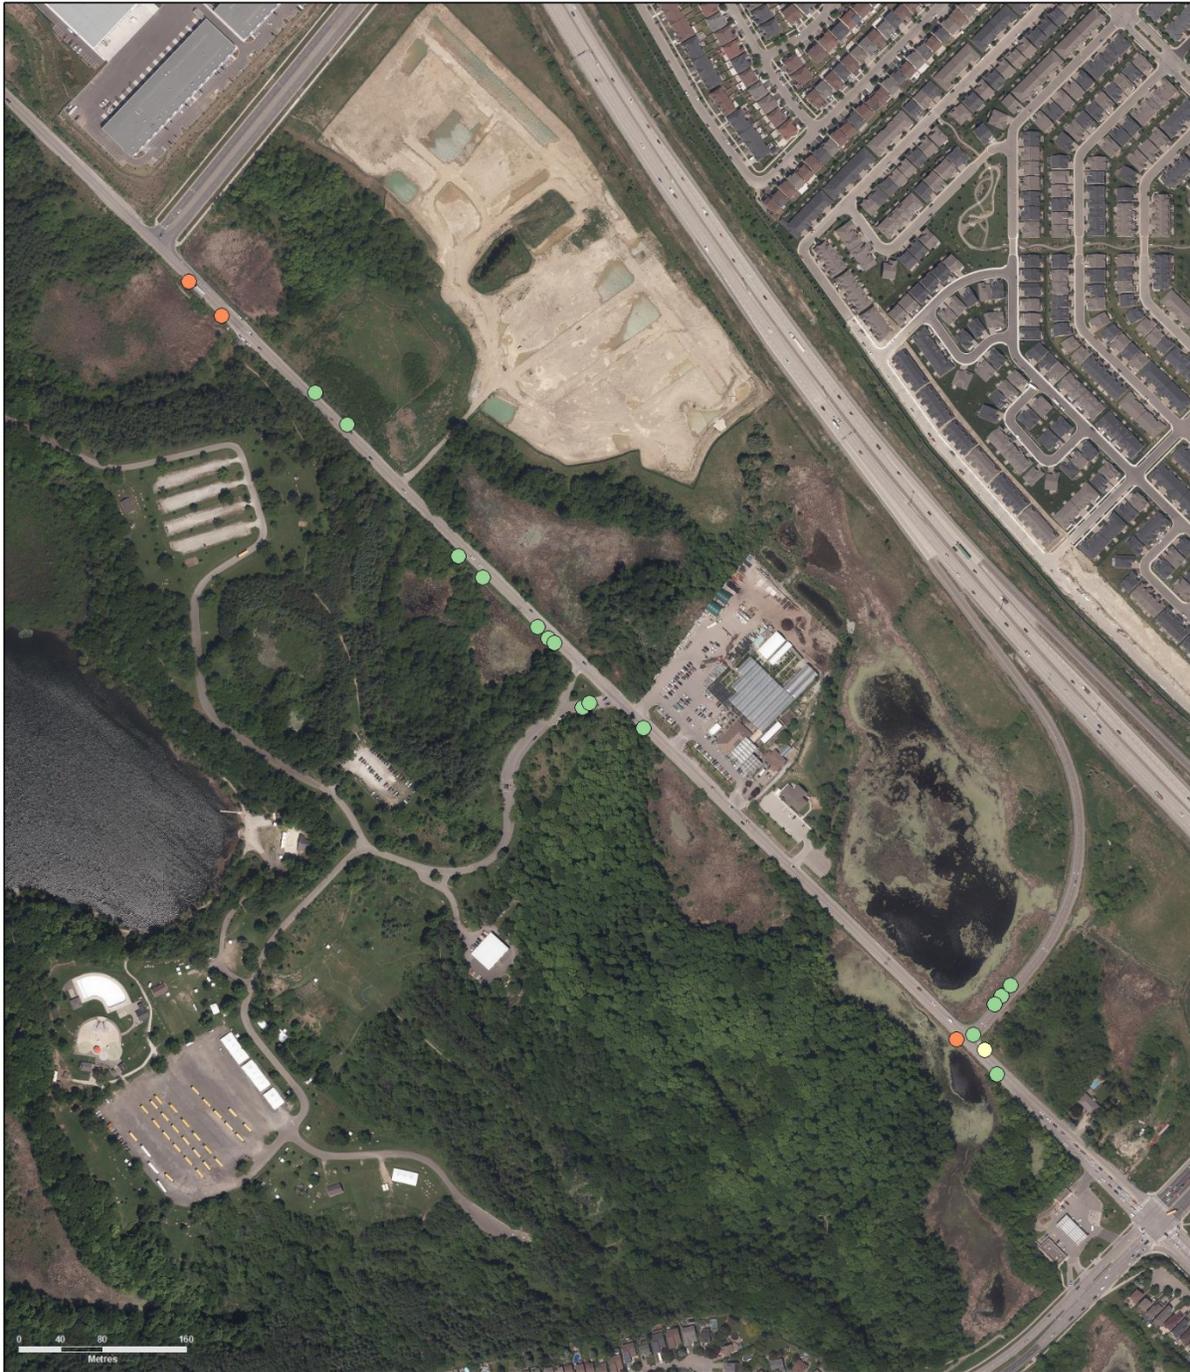
<p>             Date: 2025-12-04              Created by: Restoration and Infrastructure              Orthophoto: First Base Solutions, City of Toronto,              Peel Region, York Region, Durham Region, 2024         </p>	<p> <b>Heart Lake Road Ecology Monitoring</b>              Frog and Toad Observations         </p>	<p><b>Legend</b></p> <ul style="list-style-type: none"> <li><span style="color: green;">●</span> Green Frog</li> <li><span style="color: orange;">●</span> Leopard Frog</li> <li><span style="color: green;">●</span> Unknown Frog/Toad</li> </ul>
<p><small>Disclaimer: The data used to create this map was compiled from a variety of sources &amp; dates. The TRCA takes no responsibility for errors or omissions in the data and retains the right to make changes &amp; corrections at anytime without notice. For further information about the data on this map, please contact the TRCA Restoration and Infrastructure Division, (416) 661-6600. May not be reproduced without permission. This is not a plan of survey. Produced by Toronto and Region Conservation Authority under licence with the Ministry of Natural Resources &amp; Forestry. © Queen's Printer for Ontario.</small></p>
