## **Final Report: High Park Wildlife and Road Mortality Monitoring – Assessing Cycling and Roadway Impacts**

Prepared by Toronto and Region Conservation Authority (TRCA)

July 30, 2025

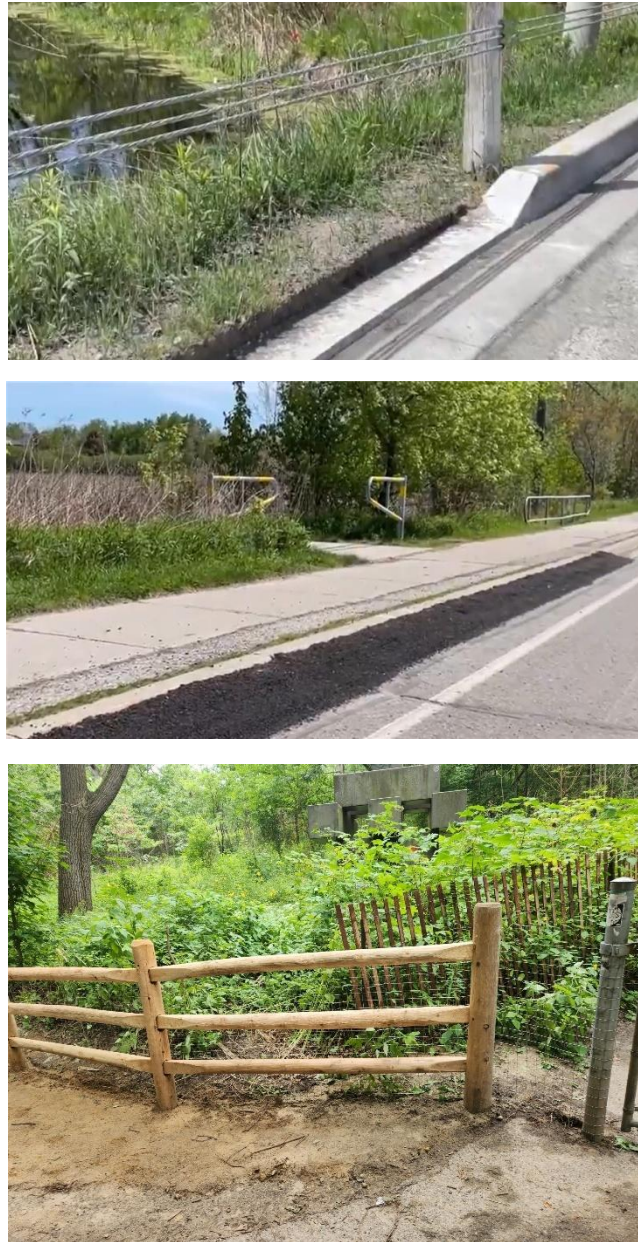
**Figure 4.** From top to bottom: a curb cut implemented in Richmond Hill; a curb ramp constructed with asphalt also in Richmond Hill; and an example of post and paddle fencing.

structures, and this would have to be completed by another contractor or potentially city staff. Examples of wildlife crossing structures are shown in Figure 4, and include:

- a) **Curb cuts:** This would allow small fauna to more easily cross roads that currently have tall curbs, which are difficult for them to get overtop of.

- b) **Curb ramps:** The same reasoning as curb cuts applies, however ramps are an alternative option. Curb ramps can be constructed simply using asphalt.

- a) TRCA recommends installing post and paddle fencing (example shown in Figure 4), with a small gauge wire mesh along the bottom to prevent and/or direct wildlife movement. This would require a total of 220m of fencing, and the cost estimated to be ~\$407/m including staff, equipment, and materials (~\$89,500 total).

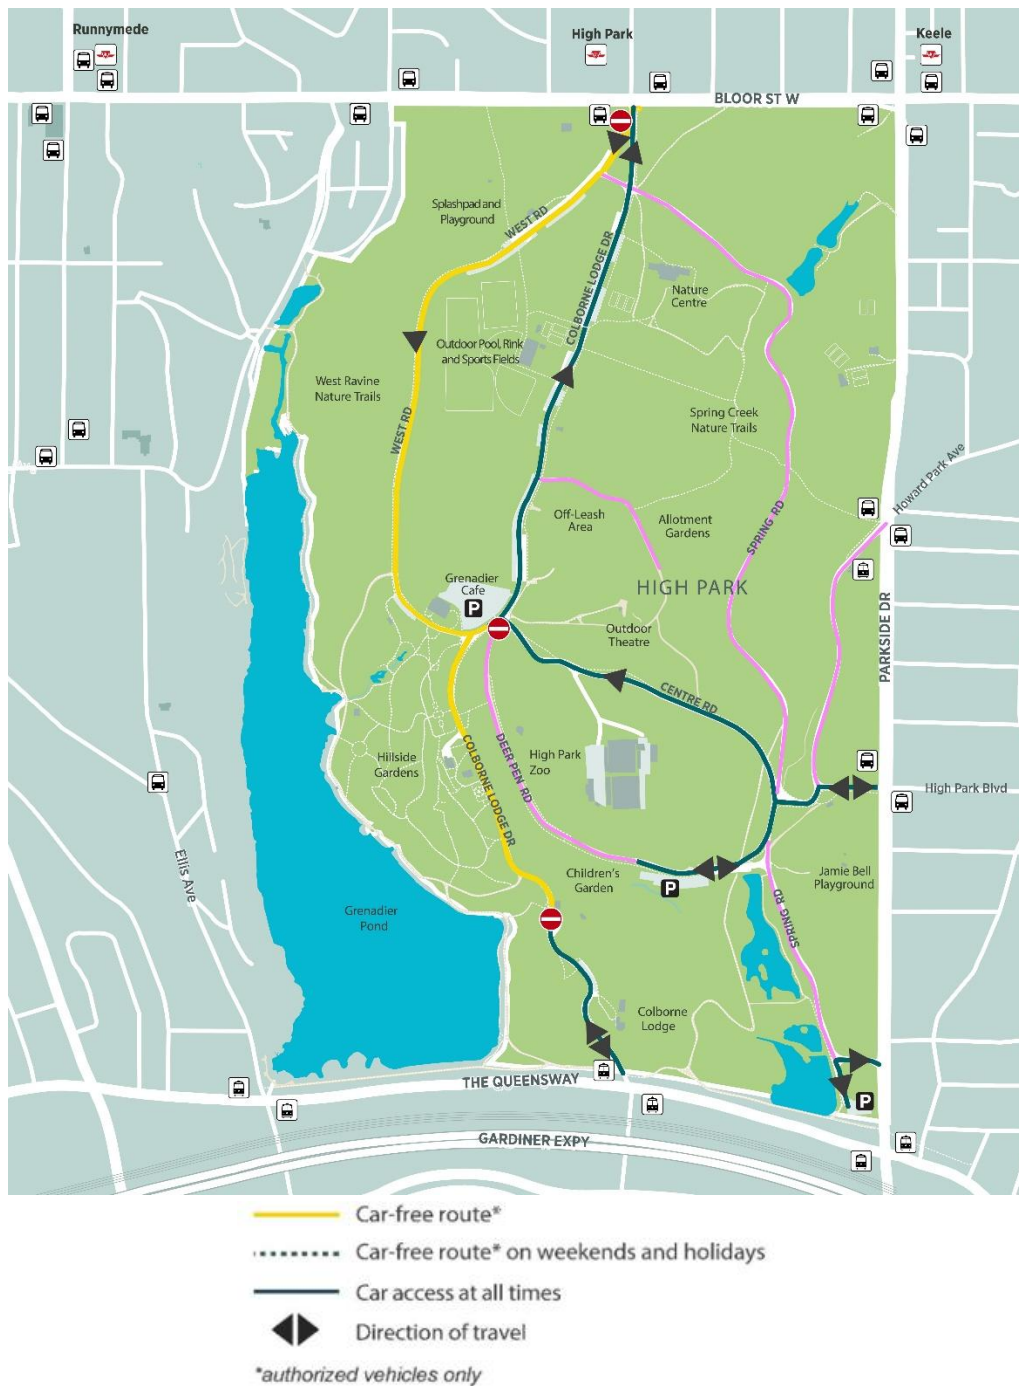
**Figure 1A.** The High Park Movement Strategy with designated roads and directions for vehicle use in the park (map provided by the City of Toronto).

The City of Toronto, hereafter referred to as “the City”, developed the High Park Movement Strategy (HPMS) in 2021. The strategy’s goal was to better serve park users and the surrounding community, while prioritizing improvements to safety, accessibility, and the park’s natural environment. The City Council approved the HPMS in May 2023 (IE3.7), including the long-term goal of full road closures to visitor vehicles (Figure 1A).
