# CLASS ENVIRONMENTAL ASSESSMENT FOR REMEDIAL FLOOD AND EROSION CONTROL PROJECTS

Parkview Hill Crescent Slope Stabilization Project  
City of Toronto

**PROJECT PLAN**  
OCTOBER 13, 2026

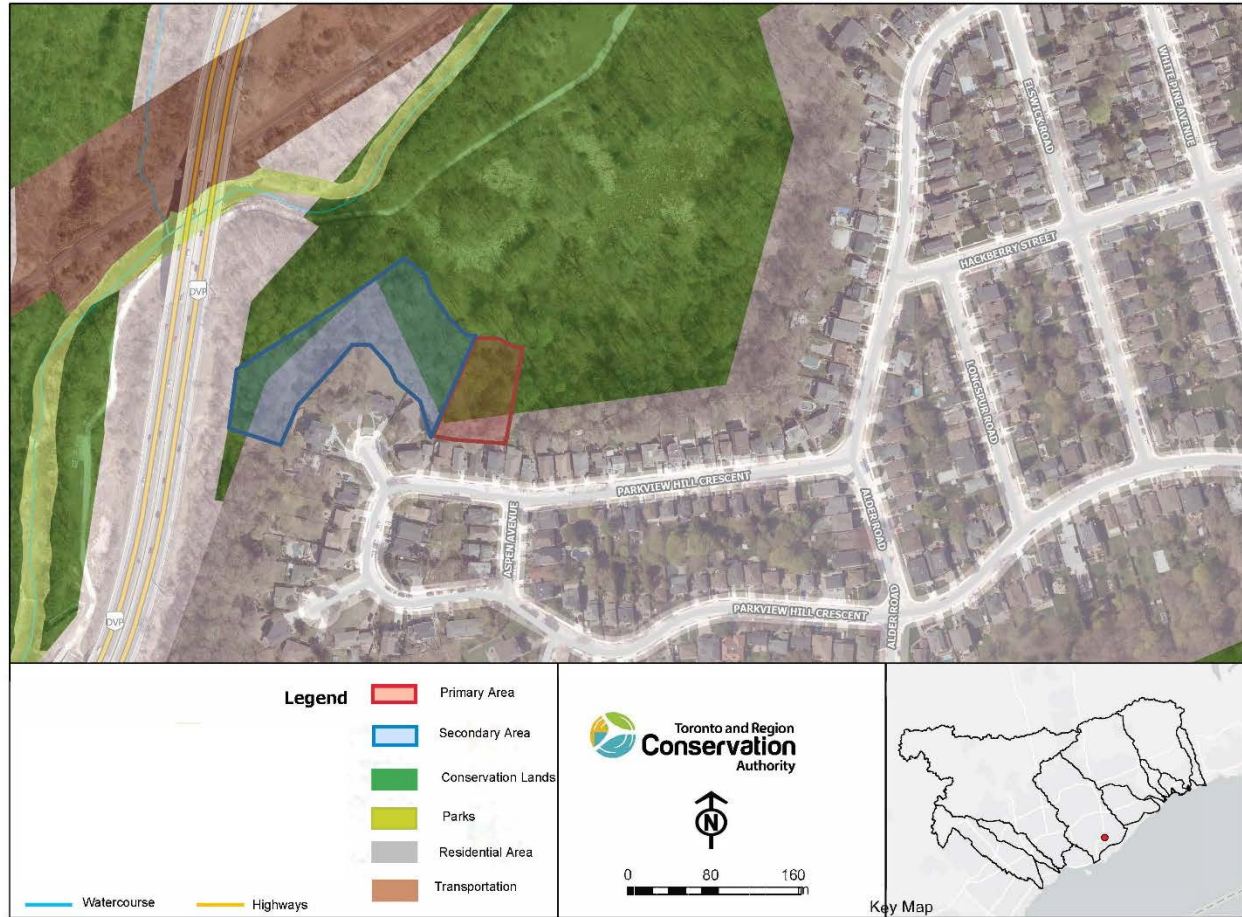
**Figure 4:** Categorized land use surrounding the Project area. Source: TRCA, 2026.

The current land use within and surrounding the Study Area is primarily residential and green space, with partial ravine lands within E.T. Seaton and Linkwood Lane Parks. Minor institutional and commercial lands are located approximately 900m northeast of the Study Area, with a hydroelectric corridor approximately 400m to the south (Figure 4).

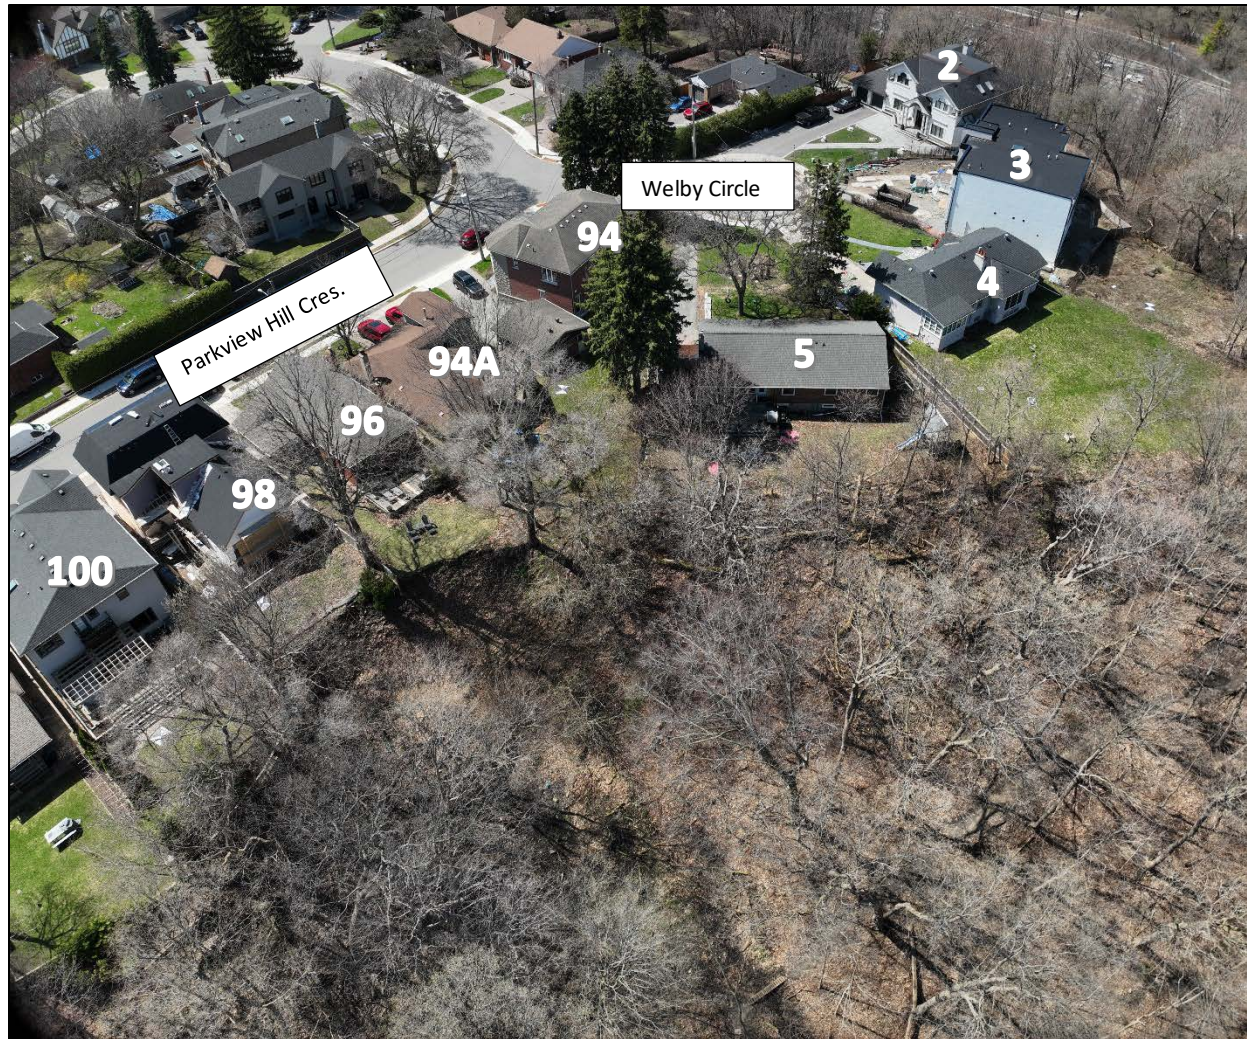
**Figure 6:** Overview of the Project limits including the Primary (Parkview Hill Crescent) and Secondary (Welby Circle) Areas.  
Source: TRCA, 2026.

**Figure 5** shows the Primary Project area and the slope failure to the rear of the participating properties. **Figure 6** shows the condition of the ravine slopes (Primary and Secondary Areas) including the observable erosion (rotational slump) behind 96 and 98 Parkview Hill Crescent originally reported to TRCA in 2019.

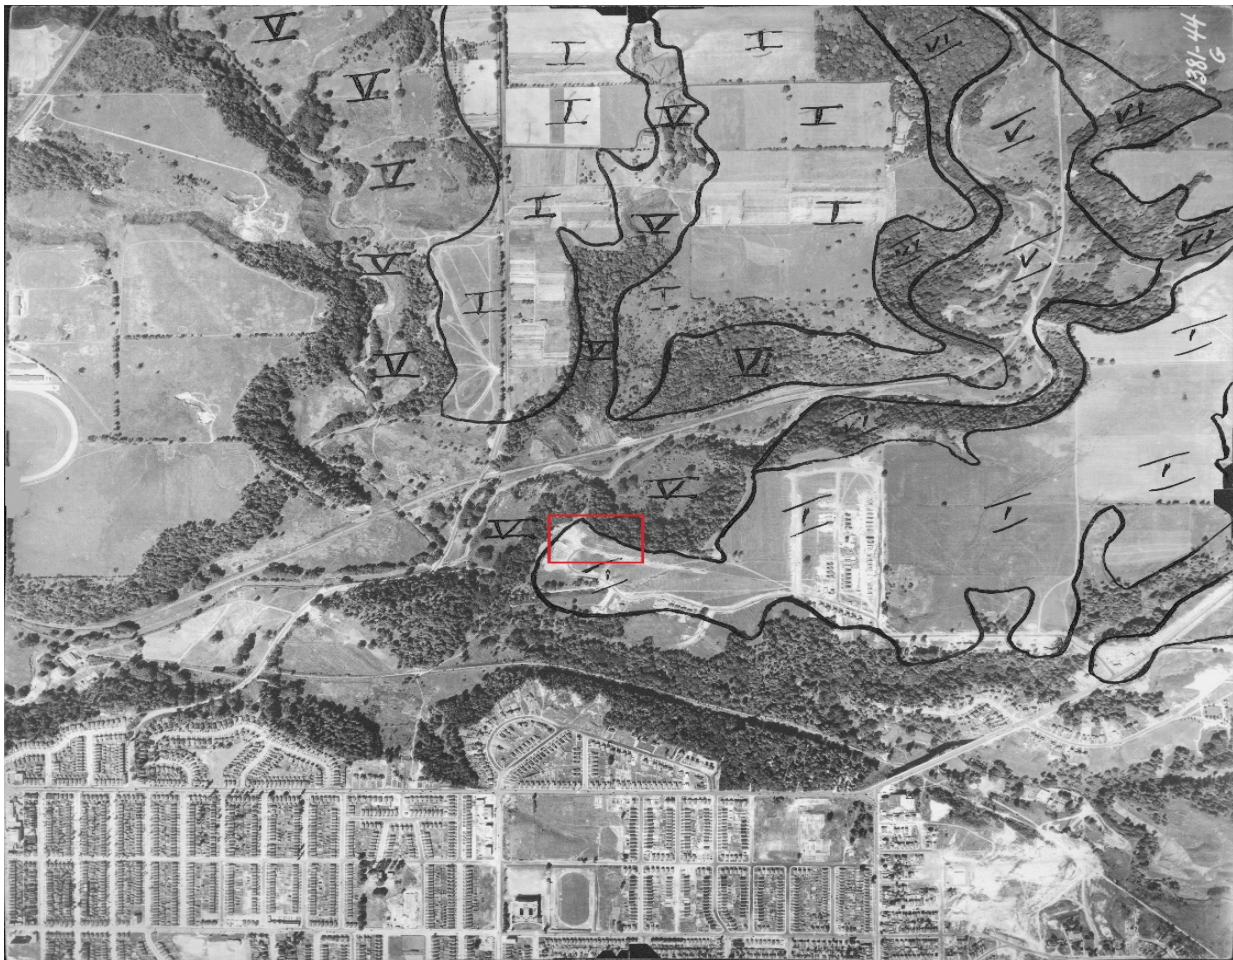
**Figure 9:** 1949 historical aerial photograph of area surrounding the location of the Parkview Hill Crescent Slope Stabilization Project. Source: TRCA, 2026.

Situated in the City of Toronto, the Project area is subject to significant pressures resulting from the development of the surrounding urban environment. As can be observed in historical aerial imagery shown in **Figure 9**, **Figure 10** and **Figure 11**, the region surrounding the Project limits has been subject to significant urbanization over the past 70+ years, with original development of the subject lots in approximately 1949.

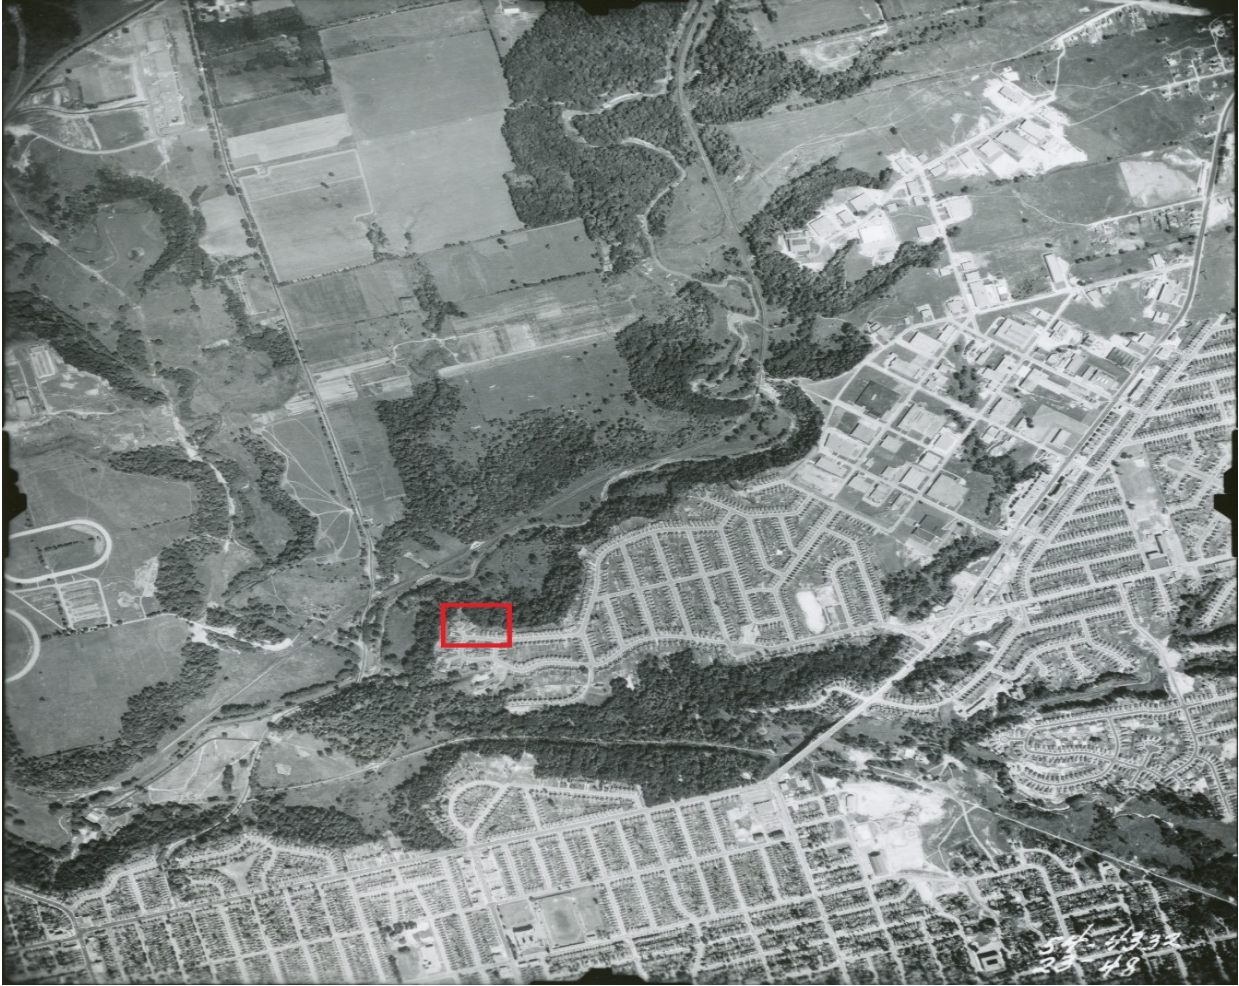
**Figure 10** : 1954 historical aerial photograph of area surrounding the location of the Parkview Hill Crescent Slope Stabilization Project. Source: TRCA, 2026.
