Appendix C Fluvial Geomorphic Assessment

September 15, 2022

Subject: Lavender Creek Fluvial Geomorphology Assessment

**Rockcliffe Riverine Flood Mitigation
Municipal Class Environmental Assessment**

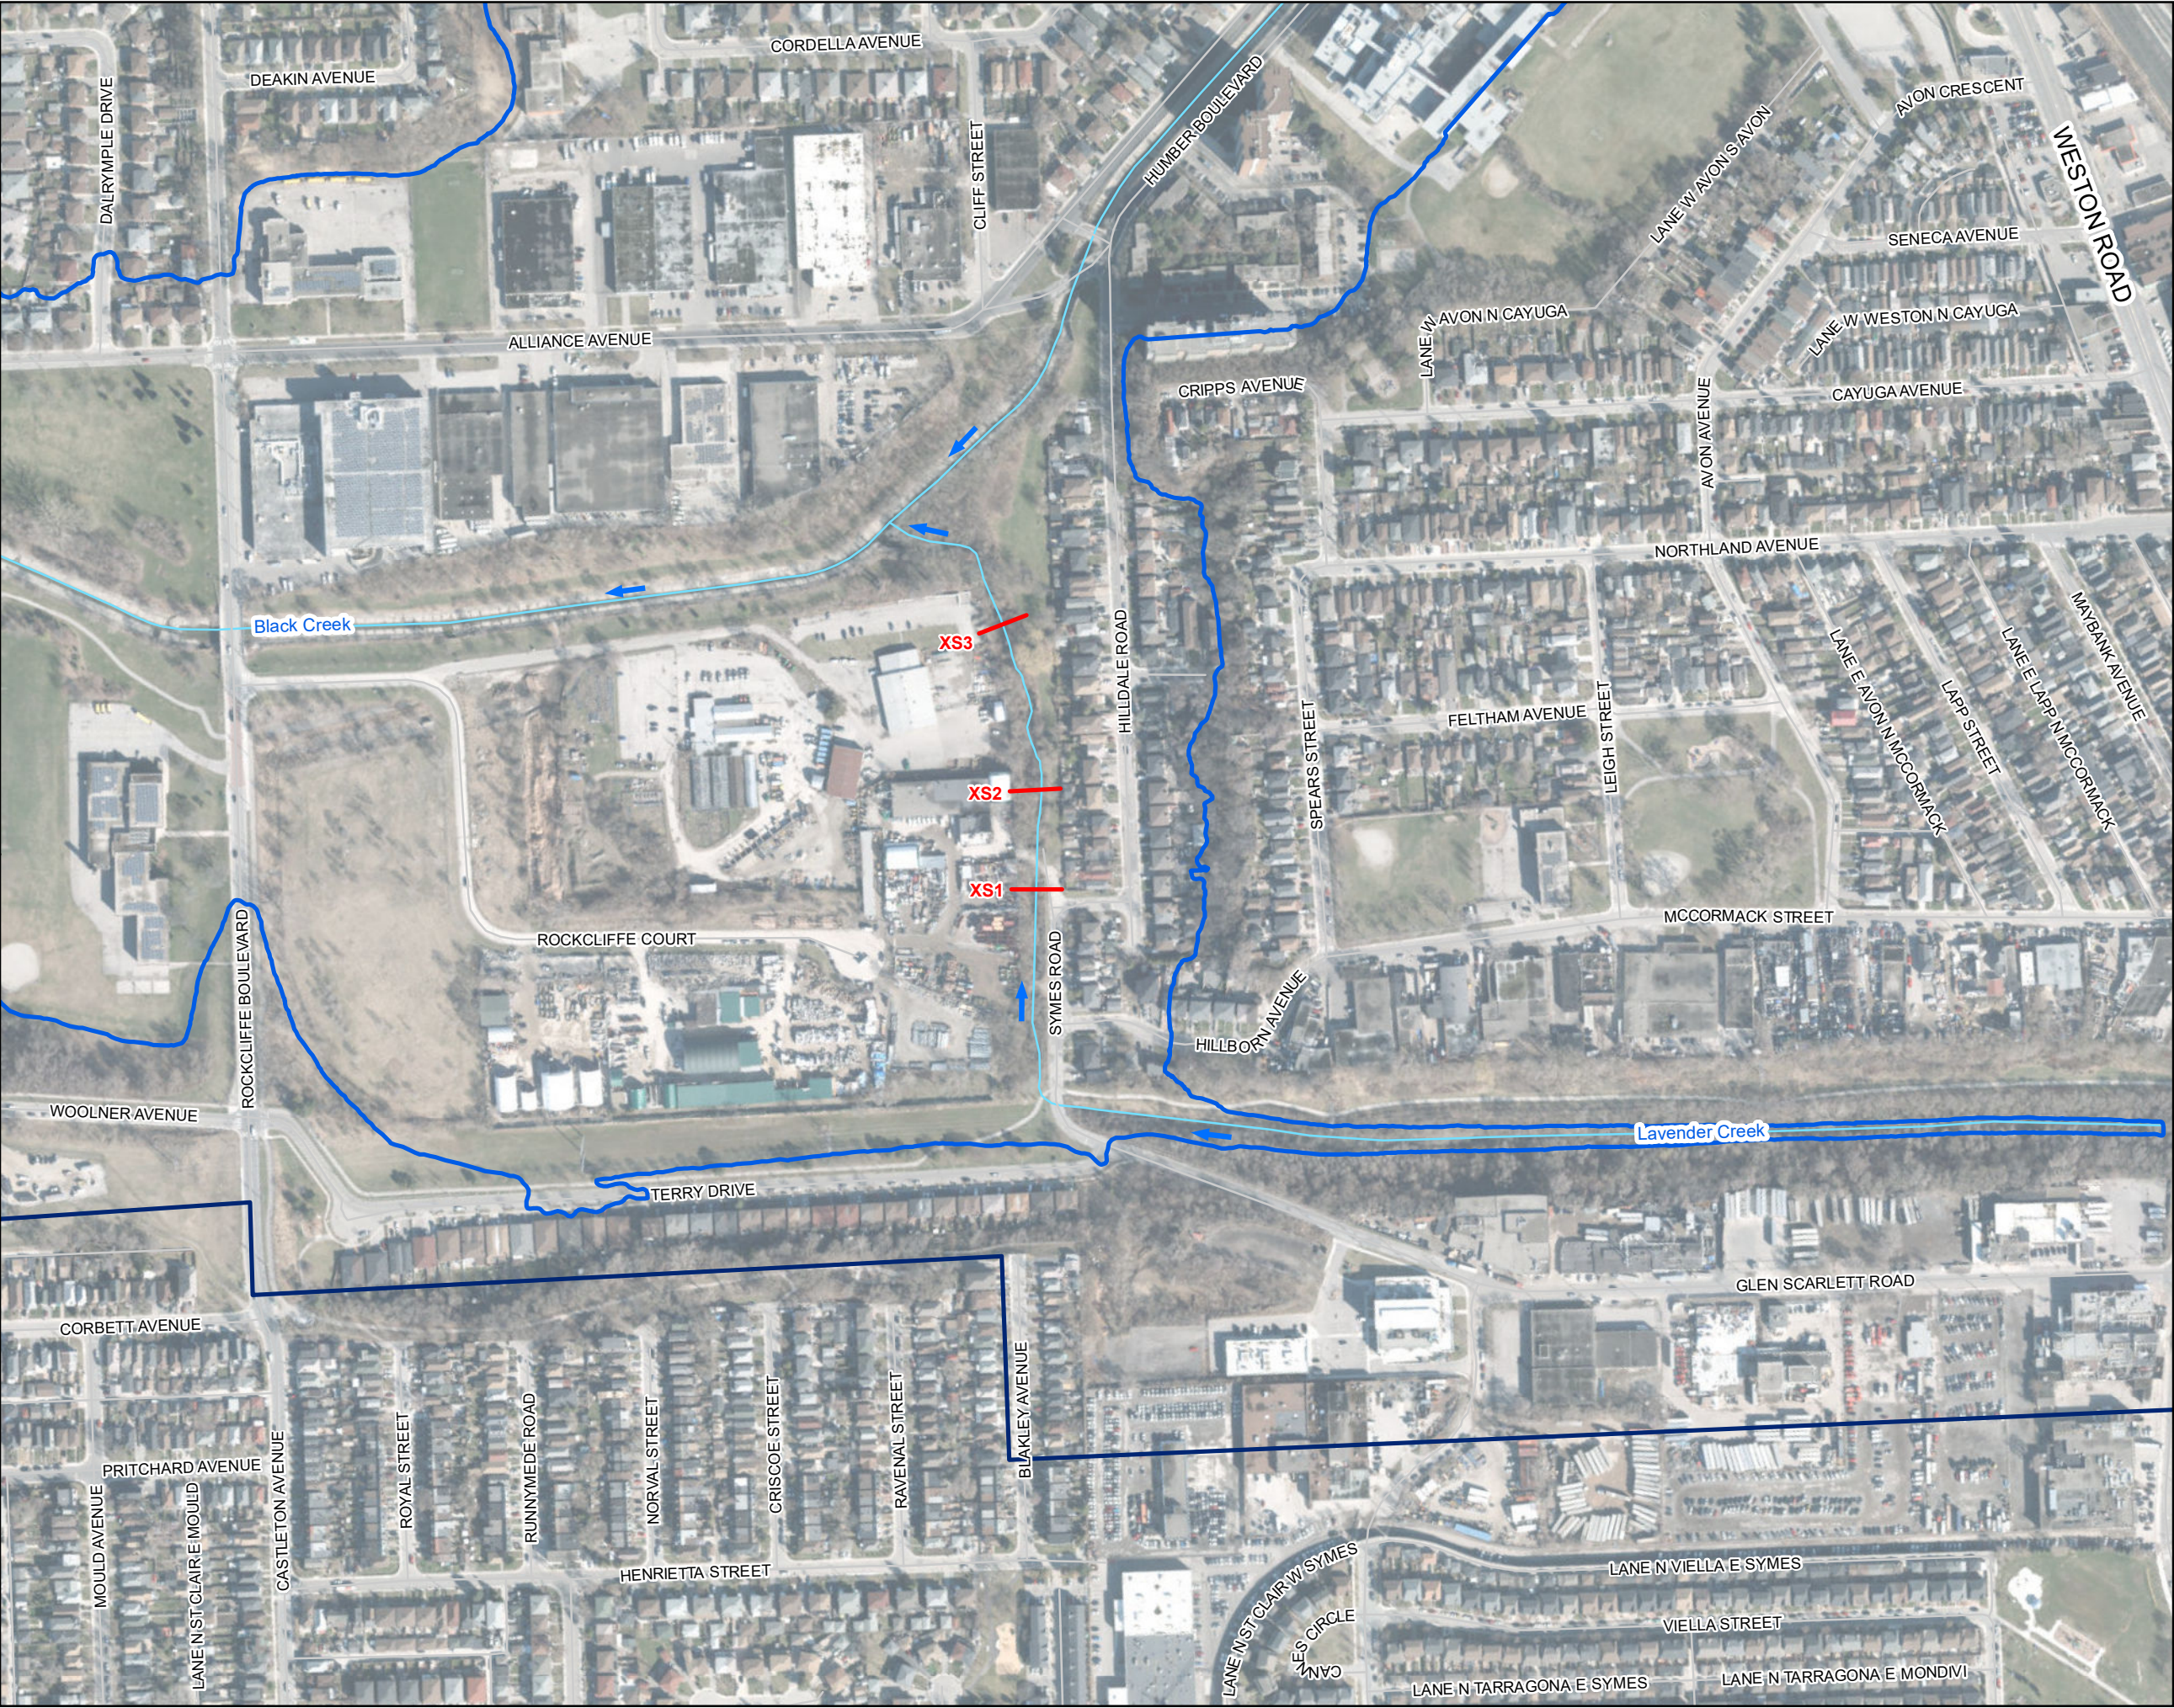
**Geomorphic Cross-Section
Locations in Lavender Creek**

A geomorphic field investigation was undertaken for the alluvial reach of Lavender Creek on December 3, 2020, to characterize channel parameters, substrate, and document indicators of instream erosion (Figure 1). Field work was limited to the segment of channel downstream of Symes Road, where the watercourse is not lined with concrete but consists of native alluvial materials, variable fill, and localized rock and concrete debris. The following geomorphic assessment includes a) a rapid field assessment (Rapid Geomorphic Assessment [RGA]/Rapid Stream Assessment Technique [RSAT]), and b) bankfull hydraulics and instream erosion threshold analyses. Lavender Creek upstream of Symes Road was not assessed as it is engineered with concrete-lined bed and banks.
