## Appendix D

### Reach 30 Detailed Analysis

**Reference # 13579.101.L05.Rev0**

**RE: HAZARD MAPPING REACH 30 DETAILED ASSESSMENT**

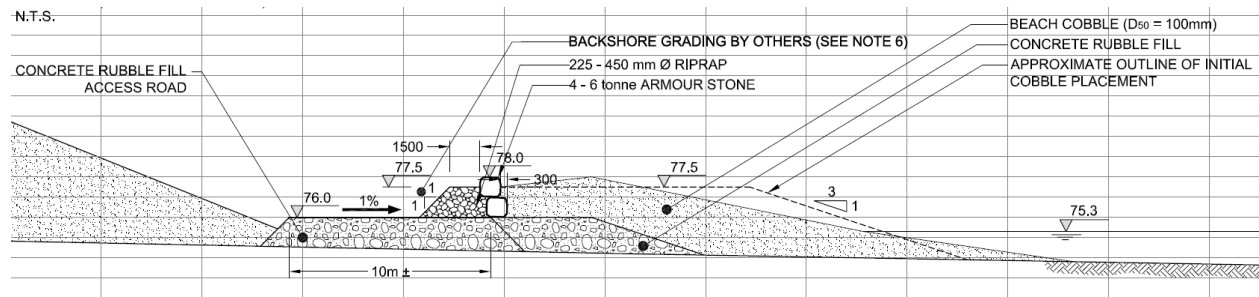
**Figure 4: Cross Section of Cobble Beach in Sub-reach A**

The bigger concerns with these structures are the toe scour protection and general degradation of the stones over time. The toe of the structure has two armour stones excavated into the lakebed. These would likely move (slump or roll lakeward) if, over the next 100 years, 2 m of downcutting was experienced. On the armour stone face, the method of packing smaller chinking between larger (loosely packed) armour stone is not a common practice in typical coastal works and gradual loss of this chinking is expected. Overall, we expect some slumping of these structures over the next 100 years; however, they are expected to remain mostly in place albeit at a lower elevation. This could impact the extent to which they protect the tombolo formation and the stability of the cobble beach.

Bricks and concrete were visible in some areas of the beach, suggesting that the profile has already been reshaped enough to reach into the lower layer below the cobbles. Any significant downcutting of the shoreline would likely result in loss of cobbles into the nearshore scoured area and a reduction in the height and width of the crest.
